[Docket No. FAA-2004-19969; Directorate Identifier 2004-SW-43-AD; Amendment 39-13923; AD 2004-26-11]

Airworthiness Directives; Bell Helicopter Textron Canada Model 222, 222B, 222U, 230, and 430 Helicopters

ACTION: Final rule; request for comments.

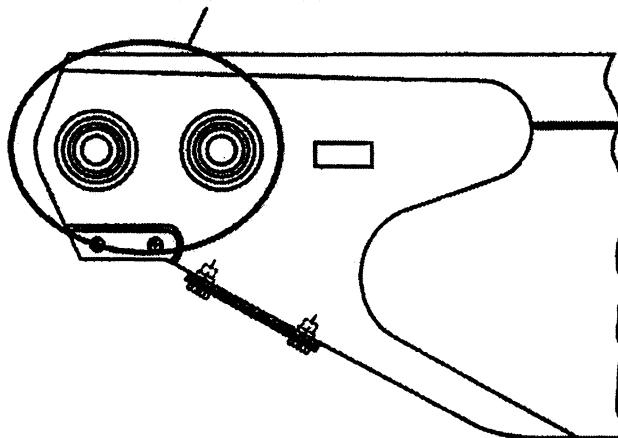
222-016-001-123 and -127

Transport Canada, the airworthiness authority for Canada, notified the FAA that an unsafe condition may exist on the specified BHTC model helicopters. Transport Canada advises of the discovery of cracked blades during scheduled inspections on three occasions. Two cracks originated from the outboard feathering bearing bore underneath the flanged sleeves. The third crack started from the inboard feathering bearing bore. Investigation found that the cracks originated from either a machining burr or a corrosion site in the bearing bore underneath the flanged sleeves.

- (a) Within 3 hours time-in-service (TIS) and at intervals not to exceed 3 hours TIS, clean and visually check both sides of each blade for a crack in the paint in the areas shown in Figure 1 of this AD. An owner/operator (pilot), holding at least a private

AREA OF INSPECTION

(i) If a crack is found, before further flight, replace the blade with an airworthy blade.

(ii) If no crack is found in the blade surface, refinish the blade by applying one coat of MIL-P-23377 or MIL-P-85582 Epoxy Polyamide Primer so that the primer overlaps

the existing coats just beyond the abraded area. Let the area dry for 30 minutes to 1 hour. Then, apply one sealer coat of Polyurethane MILC85285 TYI CL2, color Number 27925 (semi-gloss white) per Fed. Std. 595. Reinstall the blade.

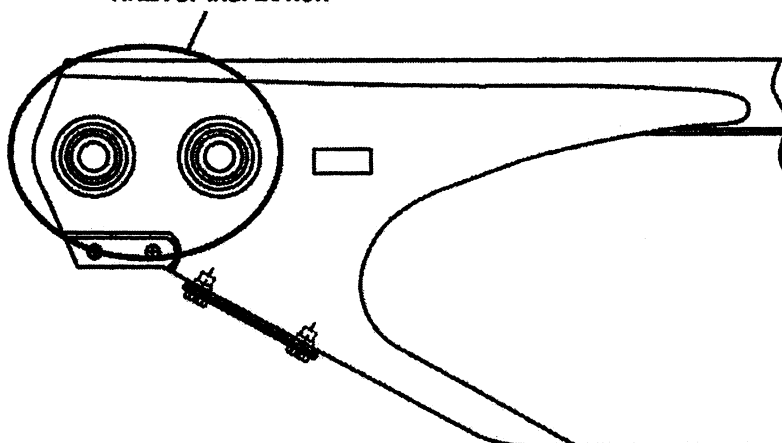
222-016-001-131 and -135

AREA OF INSPECTION
