Federal Register

[Docket No. FAA-2004-19960; Directorate Identifier 2004-CE-47-AD]

Airworthiness Directives; The New Piper Aircraft, Inc. PA-34 Series Airplanes

ACTION: Notice of proposed rulemaking (NPRM).

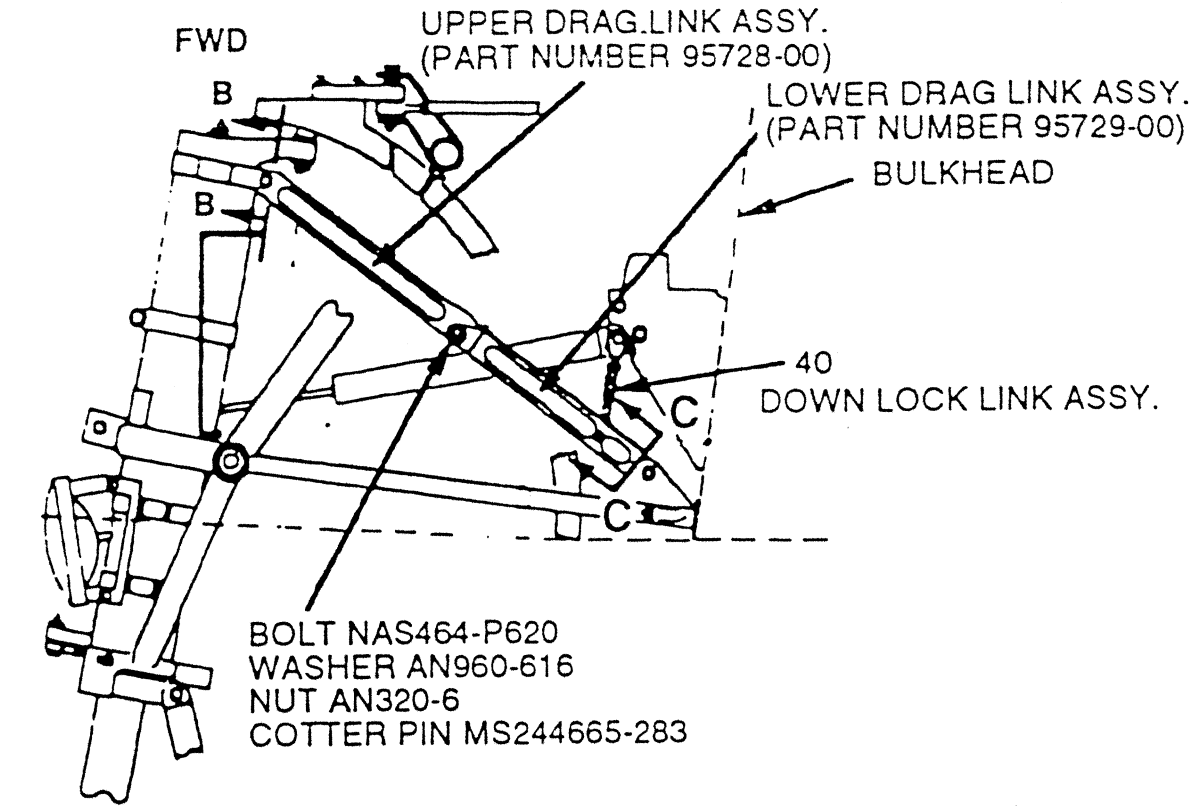
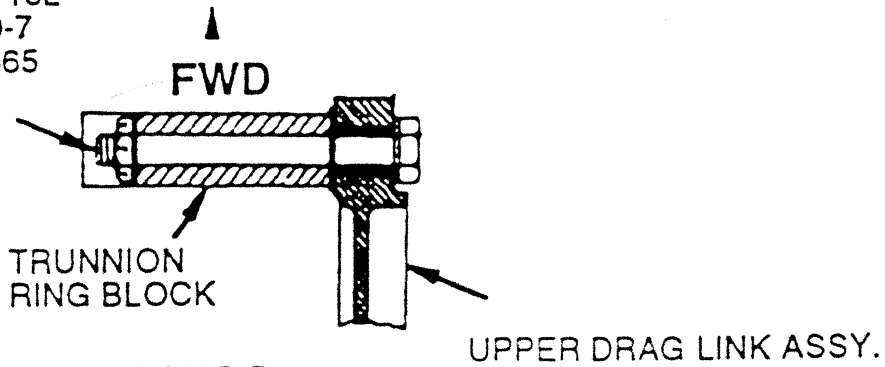
"UPPER" DRAG LINK - TO -
GEAR CONNECTION

Actions	Compliance	Procedures
(1) Replace the bolt and stack up that connects the upper drag link to the nose gear trunnion with new parts of the following: (i) Piper part number (P/N) 400 274 (AN7-35) bolt; (ii) Piper P/N 407 591 (AN960-716L) washer, as applicable; (iii) Piper P/N 407 568 (AN960-716); (iv) Piper P/N 404 396 (AN320-7) nut; and (v) Piper P/N 424 085 cotter pin.	Within the next 100 hours time-in-service (TIS) after January 28, 1994 (the effective date of AD 93-24-14), unless already done within the last 400 hours TIS before January 28, 1994 (compliance with AD 93-24-14). Repetitively replace thereafter at intervals not to exceed 500 hours TIS. Continue to repetitively replace until the actions in paragraph (e)(2) and (e)(3) of this AD begin.	Follow Figure 1 of this AD.
