Federal Register

Thursday, February 17, 2005

[Docket No. FAA-2005-20107; Directorate Identifier 2005-SW-02-AD; Amendment 39-13981; AD 2005-04-09]

#### Airworthiness Directives; Bell Helicopter Textron Canada Model 222, 222B, 222U, 230, and 430 Helicopters

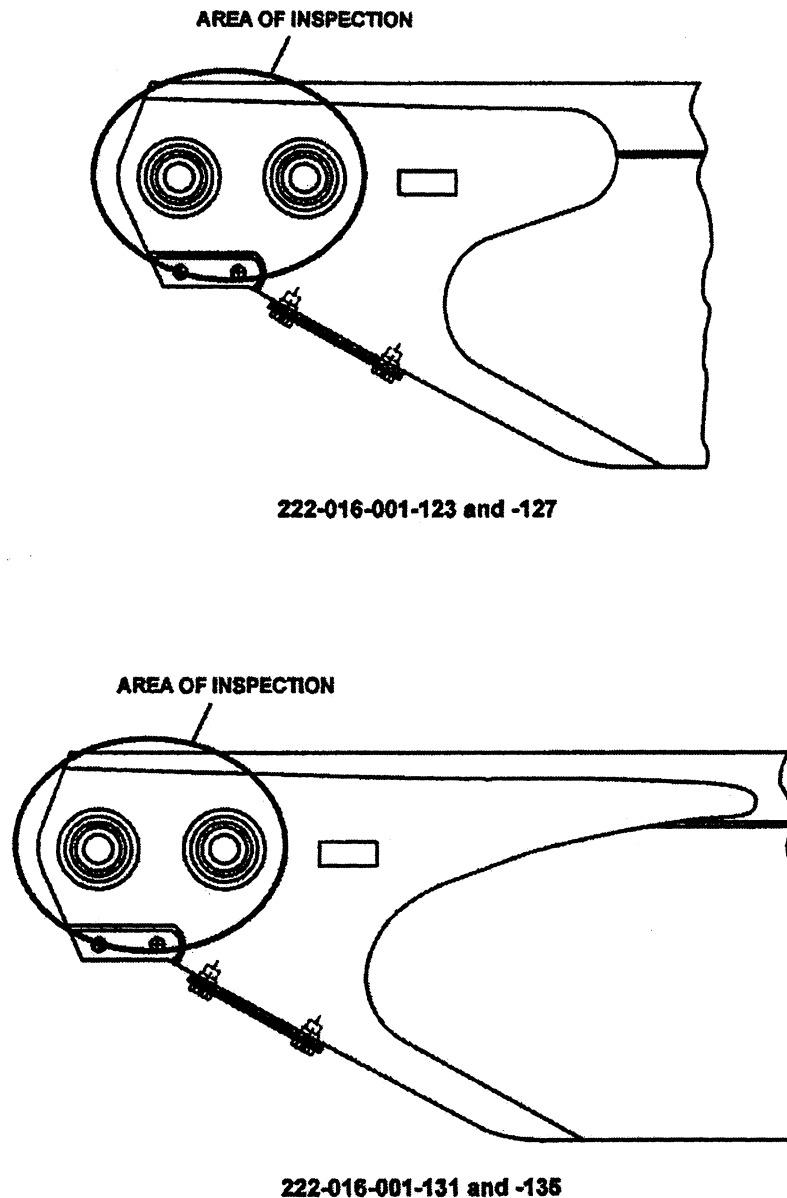
**Figure 1. Blade inspection area**

Transport Canada, the airworthiness authority for Canada, notified the FAA that an unsafe condition may exist on the specified BHTC model helicopters. Transport Canada advises of the discovery of cracked blades during scheduled inspections on three occasions. Two cracks originated from the outboard feathering bearing bore underneath the flanged sleeves. The third crack started from the inboard feathering bearing bore. Investigation found that the cracks originated from either a machining burr or a corrosion site in the bearing bore underneath the flanged sleeves.

(a) Within 3 hours time-in-service (TIS), and thereafter at intervals not to exceed 3 hours TIS, clean and visually check both sides of each blade for a crack in the paint in the areas shown in Figure 1 of this AD. An owner/operator (pilot), holding at least a

intervals not to exceed 50 hours TIS, clean the blade by wiping down both surfaces of each blade in the inspection area depicted in Figure 1 of this AD using aliphatic naphtha (C-305) or detergent (C-318) or an equivalent. Using a 10X or higher power magnifying glass, visually inspect both sides of the blade in the areas depicted in Figure 1 of this AD.

(1) If a crack is found, even if only in the paint, before further flight, remove the blade from the helicopter and proceed with the following:

(2) Remove the paint on the blade down to the bare metal in the area of the suspected crack by using plastic metal blasting (PMB) or a nylon web abrasive pad. Abrade the blade surface in a span-wise direction only.

(3) Using a 10X or higher power magnifying glass, inspect the blade for a crack.

(i) If a crack is found, replace the blade with an airworthy blade before further flight.

(ii) If no crack is found in the blade surface, refinish the blade by applying one coat of epoxy polyamide primer, MIL-P-23377 or MIL-P-85582, so that the primer overlaps the existing coats just beyond the abraded area. Let the area dry for 30 minutes to 1 hour. Then, apply one sealer coat of polyurethane, MILC85285 TYI CL2, color number 27925 (semi-gloss white), per Fed. Std. 595. Reinstall the blade.
