[Docket No. 83-ANE-14-AD; Amendment 39-14043; AD 83-08-01R2]

#### **Airworthiness Directives; Hartzell Propeller Inc. (Formerly TRW Hartzell Propeller) Models HC-B3TN-2, HC-B3TN-3, HC-B3TN-5, HC-B4TN-3, HC-B4TN-5, HC-B4MN-5, and HC-B5MP-3 Turbopropellers**

**ACTION:** Final rule.

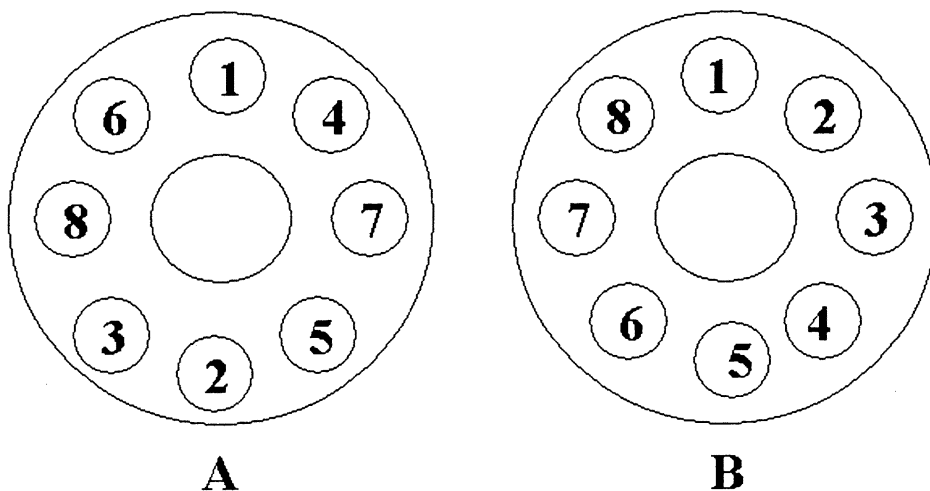
To preclude propeller attaching bolt failures or improperly secured propellers, which could lead to separation of the propeller from the airplane, do the following:

(1) Check the torque, with a torque wrench and an appropriate adapter, of all eight propeller attaching bolts (with washers installed). Torque should be 100 ft.-lbs. to 125 ft.-lbs., with dry threads. (Caution: Do not use any lubricant with the P/N A-2047 bolts. Safety wire all bolts in an FAA-approved manner.)

(2) If the torque of any one of the bolts is found to be less than 100 ft.-lbs., remove all eight bolts and washers and replace with P/N B-3339 bolts and P/N A-2048-2 washers, or other equivalent FAA-approved serviceable bolts and washers, using paragraphs (a)(1) through (a)(5) of this AD.

(3) Apply MIL-T-83483 Petrolated Graphite, or Hartzell Lubricant part number (P/N) A-3338, to threads of the eight P/N B-3339 attaching bolts (and remainder of bolt if desired) and to flat surfaces of the eight P/N A-2048-2 washers, or to other equivalent FAA-approved serviceable bolts and washers.

(4) Install the eight P/N B-3339 attaching bolts and eight P/N A-2048-2 washers, or other equivalent FAA-approved serviceable bolts and washers, that were prepared in paragraph (a)(3) of this AD, through the engine flange and into the propeller flange.

(5) Torque all attaching bolts with a torque wrench and an appropriate adapter, to 40 ft.-lbs., and then to 80 ft.-lbs., following sequence "A" (shown below). Final torque all attaching bolts using sequence "B" (shown below) to 100 ft.-lbs. to 105 ft.-lbs. Safety wire all attaching bolts in an FAA-approved manner.
