[Docket No. FAA-2005-21680; Directorate Identifier 2004-SW-48-AD]

### Airworthiness Directives; Bell Helicopter Textron Canada Model 206A, A-1, B, B-1, L, L-1, L-3, L-4 Helicopters

**ACTION:** Notice of proposed rulemaking (NPRM).

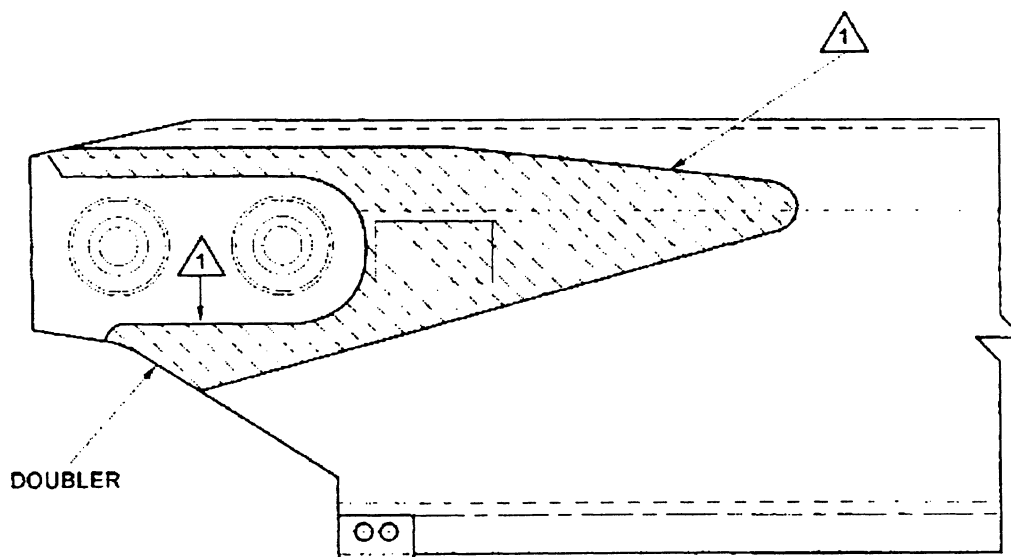
(a) Before the first flight of each day, clean each blade and visually check the blade root doublers for an edge void or de-bond on both sides of each blade as depicted in Figure 1 of this AD. An owner/operator (pilot), holding at least a private pilot certificate, may perform this visual check and must enter compliance with this paragraph into the helicopter maintenance records by following 14 CFR sections 43.11 and 91.417(a)(2)(v).

**1** Inspect the doubler for an edge void or de-bond on both sides of each blade.

(b) If an edge void or a de-bond is found, before further flight, replace the blade with an airworthy blade with a serial number other than those to which this AD applies.

(c) Within 100 hours time-in-service, replace all affected, serial-numbered blades with airworthy blades with a serial number other than those to which this AD applies.
