[Docket No. FAA-2005-22026; Directorate Identifier 2005-SW-05-AD; Amendment 39-14210; AD 2005-16-05]

#### Airworthiness Directives; Robinson Helicopter Company Model R-22 Series Helicopters

**2005-16-05 Robinson Helicopter Company:** Amendment 39-14210. Docket No. FAA-2005-22026; Directorate Identifier 2005-SW-05-AD.

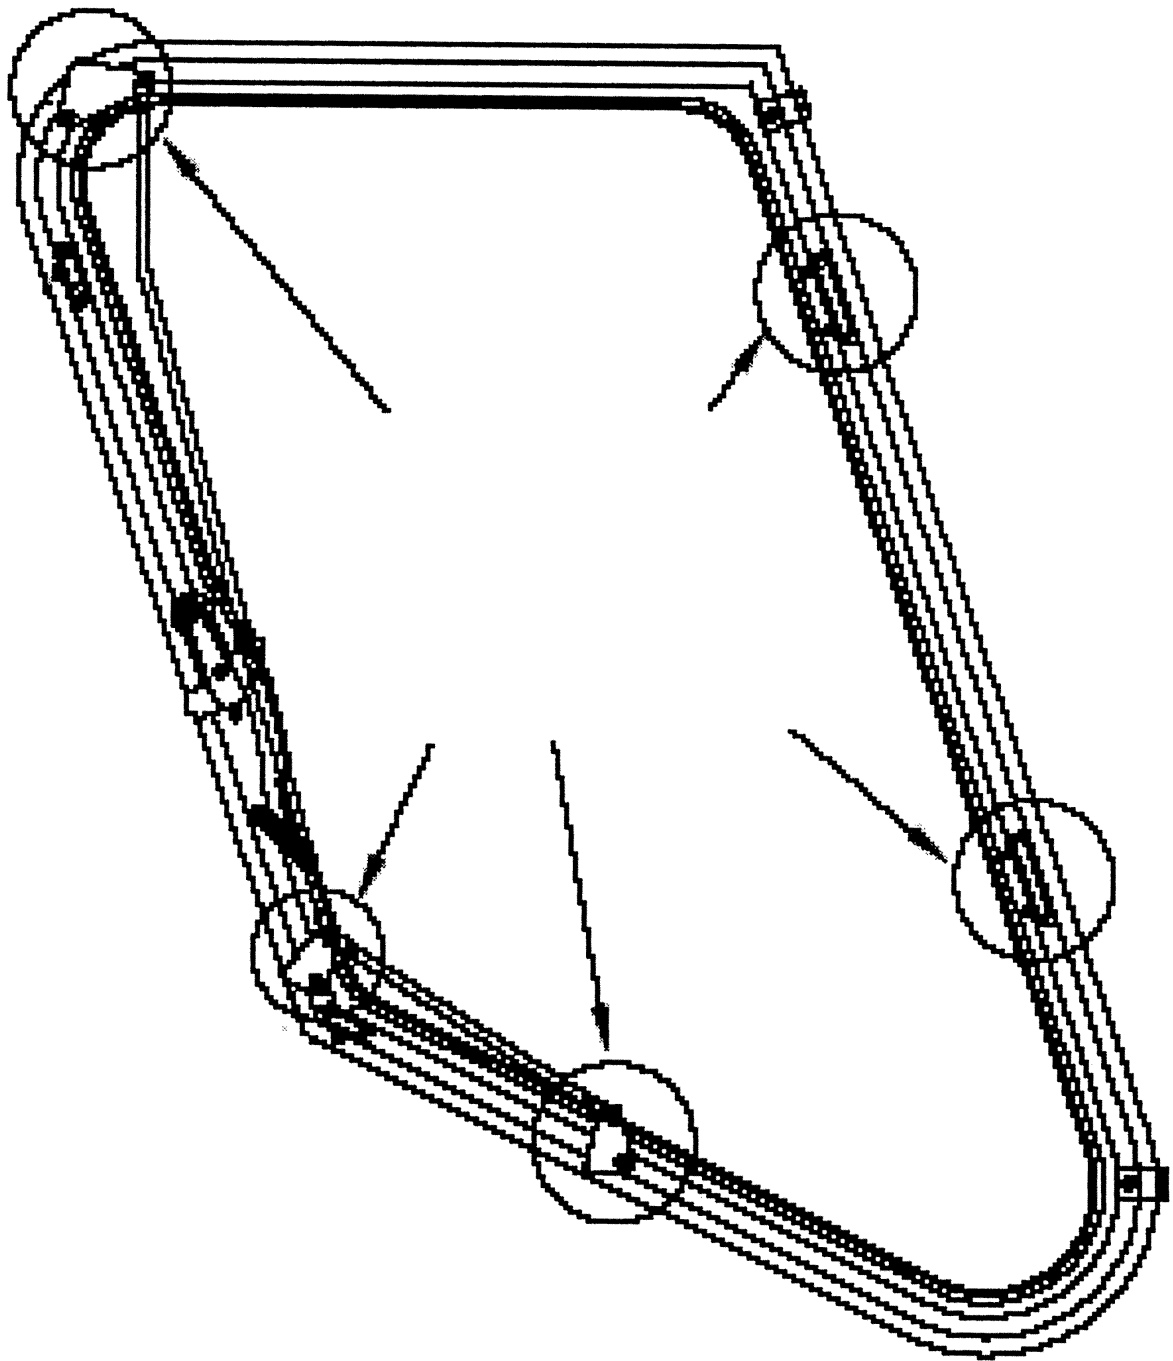
**Figure 1**

Subsequent investigation revealed cracking across the composite door assembly integral frame stiffener bead, just beneath the lower hinge on the forward edge of the door, and at the upper and lower door cam lock on the trailing edge of the door. Further investigation revealed that the door weather seal set was not the weather seal set supplied by the door assembly manufacturer. Additionally, the two nylon adjustment screws, which are required to relieve excessive force on the door hinges, were broken or missing. Finally, the door may not have been trimmed to the cabin door opening as stated in the manufacturer's door assembly installation drawings. The actions specified in this AD are intended to prevent separation of a door window or door assembly from the helicopter, which could damage the tail rotor during flight and result in loss of control of the helicopter.

(1) Visually inspect each pilot and copilot door assembly integral frame for a crack in the locations depicted in Figure 1 of this AD. If a crack is found, before further flight, replace the cracked door assembly, part number (P/N) R-22-101-51 or P/N R-22-101-53 (left-hand door assembly), or P/N R-22-101-52 or P/N R-22-101-54 (right-hand door assembly), with an airworthy door assembly. If you use door assembly, P/N R-22-101-51 or P/N R-22-101-53 (left-hand door assembly), or P/N R-22-101-52 or P/N R-22-101-54 (right-hand door assembly) as the replacement, then install it in accordance with Tech-Tool Plastics, Inc. Installation Instructions TTP-1R, Revision A, dated November 21, 1997, and with the sections titled "Door Weather Seal Installation" and "Cotter Pin Installation" in Tech-Tool Plastics, Inc. Service Bulletin No. TTP2005-01, Revision A, dated February 1, 2005 (SB).

(b) After accomplishing the inspections in paragraphs (a) through (a)(2)(ii) of this AD, at intervals not to exceed 100 hours time-in-service, visually inspect each pilot and copilot door assembly integral frame for a crack in the locations depicted in Figure 1 of this AD.

(c) If a crack is found, before further flight, replace the cracked door assembly, P/N R-22-101-51 or P/N R-22-101-53 (left-hand door assembly), or P/N R-22-101-52 or P/N R-22-101-54 (right-hand door assembly), with an airworthy door assembly. If the replacement door assembly is P/N R-22-101-51 or P/N R-22-101-53 (left-hand door assembly), or P/N R-22-101-52 or P/N R-22-101-54 (right-hand door assembly), then install it in accordance with Tech-Tool Plastics, Inc. Installation Instructions TTP-1R, Revision A, dated November 21, 1997, and "Door Weather Seal Installation" and "Cotter Pin Installation" sections of the SB.
