DEPARTMENT OF TRANSPORTATION**Federal Aviation Administration****14 CFR Part 39**

[Docket No. FAA-2005-22481; Directorate Identifier 2004-NM-176-AD]

Airworthiness Directives; Bombardier Model CL-600-2B19 (Regional Jet Series 100 & 440) Airplanes**AGENCY:** Federal Aviation Administration (FAA), Department of Transportation (DOT).**ACTION:** Notice of proposed rulemaking (NPRM).

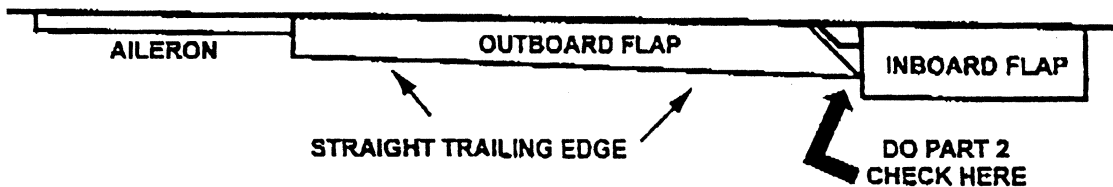
Figure 1. Normal/Abnormal Outboard flap Configuration in Take-off Position”

NORMAL/ABNORMAL OUTBOARD FLAP CONFIGURATION IN TAKE-OFF POSITION

Note: View looking forward on left wing trailing edge (right side opposite).

1. NORMAL

A normal outboard flap has a straight trailing edge, and the inboard corner is slightly above (*i.e.* higher) than the inboard flap.

2. ABNORMAL

The following are indications of an outboard flap with a twist, skew or abnormal deformation:

- Noticeable curve in the trailing edge
- Buckled top or bottom surface
- Higher than normal position of the inboard trailing edge corner

(b) An external visual check must be accomplished to detect any twisting, skewing, or abnormal deformation of the flaps, using the information given in Figures 1 and 2.

4. If there is evidence of twisting, skewing, or abnormal deformation, PRIOR TO FURTHER FLIGHT, perform the actions required in the following Maintenance Action section.

2. If there is evidence of twisting, skewing, or abnormal deformation, replace both actuators and any discrepant flap panel with new or serviceable components. In addition,

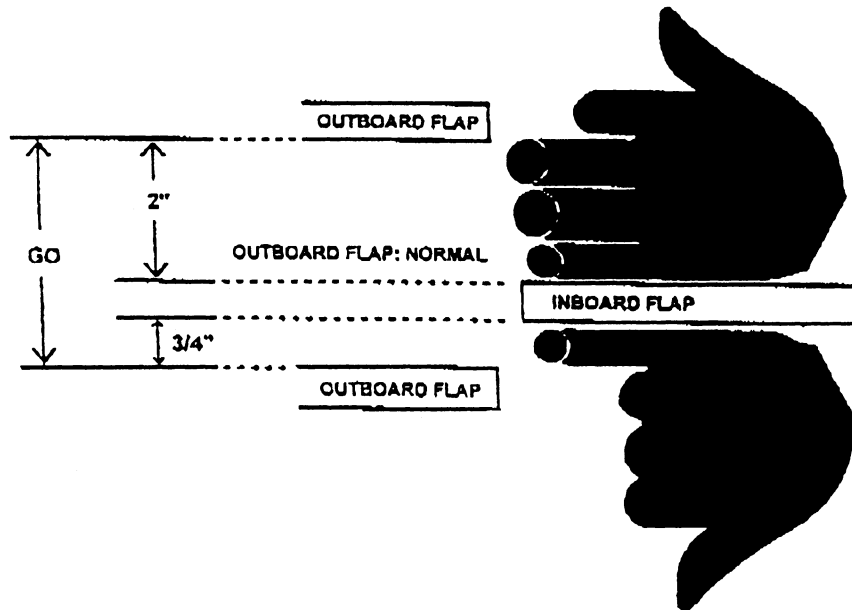
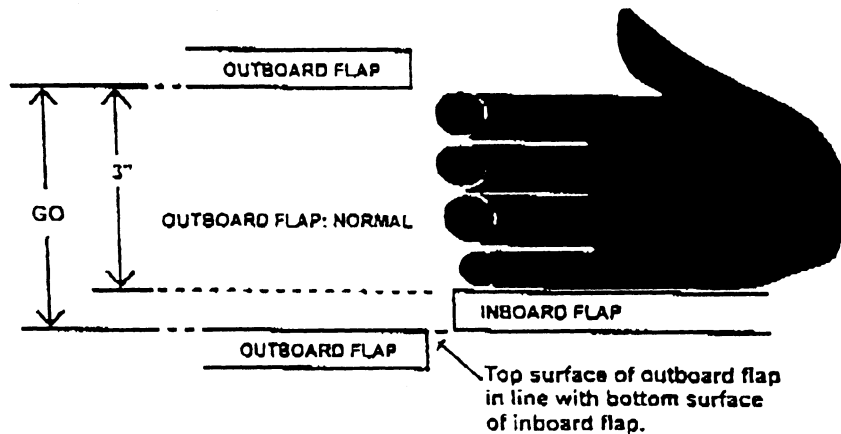
Figure 2. Outboard Flap Go/No-Go Criteria in Take-off Position"

OUTBOARD FLAP GO/NO-GO CRITERIA IN TAKE-OFF POSITION

- NOTE 1. These criteria are applicable for any size of hand.
2. View looking forward on left wing trailing edge (right side opposite).

If the outboard flap position is outside the "GO" range as shown below further flight is prohibited.

1. FLAPS AT 8 DEGREES

**2. FLAPS AT 20 DEGREES**

IMPORTANT: *If the outboard flap position is outside the 'GO' range, as shown in figure 2., further flight is prohibited until required maintenance actions have been accomplished.*

Whenever the outboard flap position indicator is outside the 'GO' range as shown in Figure 2, or whenever directed to do so by the Maintenance Procedure above, perform the following procedures:

A. Interrogate the flap electronic control unit (FECU) per Fault Isolation Manual, Section 27-50-00, 'Flaps Fault Isolation,' and rectify as applicable.
