[Docket No. FAA–2005–22534; Directorate Identifier 2005–NE–27–AD; Amendment 39–14305; AD 2005–20–11]

#### Airworthiness Directives; Rolls-Royce Corporation (RRC) (formerly Allison Engine Company, Allison Gas Turbine Division, and Detroit Diesel Allison) Models 250–C28, –C28B, and –C28C Turbohaft Engines

**SUMMARY:** The FAA is adopting a new airworthiness directive (AD) for Rolls-Royce Corporation (formerly Allison Engine Company, Allison Gas Turbine Division, and Detroit Diesel Allison) (RRC) Models 250-C28, -C28B, and -C28C turboshaft engines. This AD requires a onetime visual inspection of the seal joint in each passage between airfoils at the hub and shroud of third-stage turbine wheels, part number (P/N) 6899383. This AD results from reports of three failed third-stage turbine wheels and from the manufacturer's analysis of those failures. We are issuing this AD to prevent loss of power and uncommanded engine shutdown due to failure of the third-stage turbine wheel.

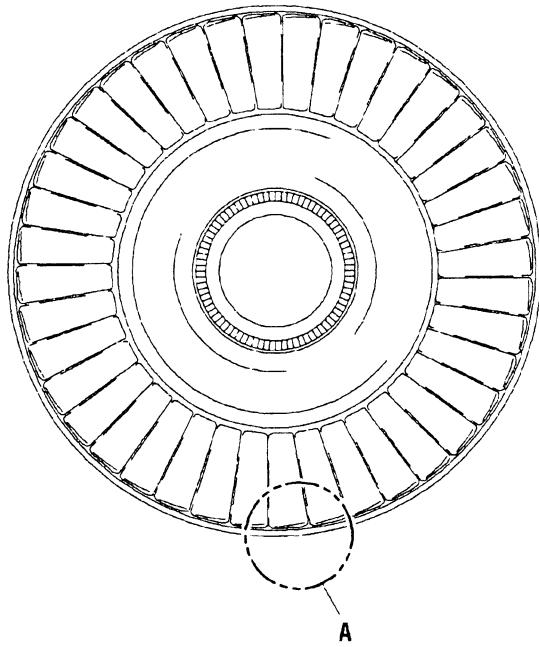
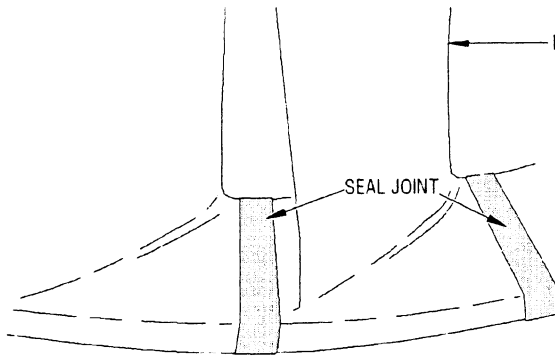
Figure 1.

**SUPPLEMENTARY INFORMATION:** In April 2005, we became aware of reports of three failed third-stage turbine wheels, P/N 6899383. The third-stage turbine wheels had partial loss of the blades and shroud. RRC conducted an analysis and found the failures were caused by compromised third-stage blade fillet radii, which led to increased stresses to the third-stage blades and shroud. RRC categorized this finding as a

(h) Remove the third-stage turbine wheel and perform a onetime visual inspection of the seal joint in each passage between airfoils at the hub and shroud. Seal joint evidence must not be present within blade fillet radii. See Figure 1 of this AD for reference.

PRINT CONDITION (GOOD)  
ASSEMBLY SEAL JOINT EVIDENCE

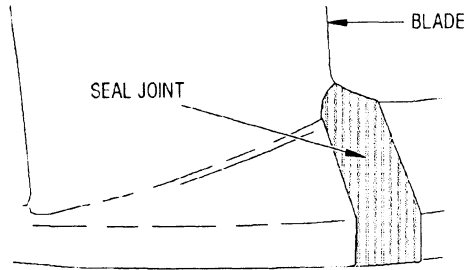
DETAIL A

NON-CONFORMING (BAD)  
ASSEMBLY SEAL JOINT EVIDENCE

(i) Remove from service any turbine wheel that has seal joint evidence present within blade fillet radii.
