Federal Register

[Docket No. FAA-2005-21680; Directorate Identifier 2004-SW-48-AD; Amendment 39-14341; AD 2005-21-03]

#### Airworthiness Directives; Bell Helicopter Textron Canada Model 206A, A-1, B, B-1, L, L-1, L-3, L-4 Helicopters

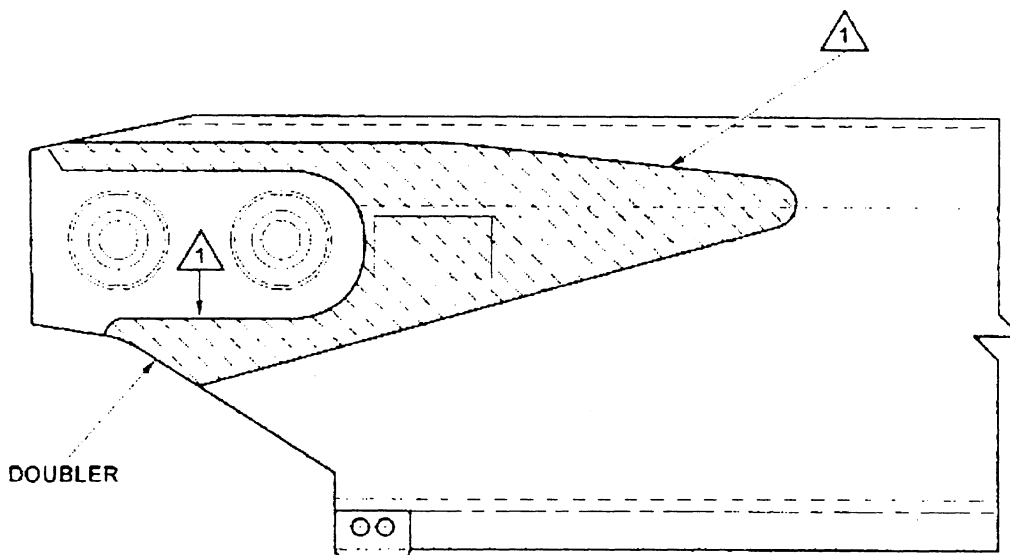
(a) Before the first flight of each day, clean each blade and visually check the blade root doublers for an edge void or de-bond on both sides of each blade as depicted in Figure 1 of this AD. An owner/operator (pilot), holding at least a private pilot certificate, may perform this visual check and must enter compliance with this paragraph into the helicopter maintenance records by following 14 CFR sections 43.11 and 91.417(a)(2)(v).

**1** Inspect the doubler for an edge void or de-bond on both sides of each blade.

(b) If an edge void or a de-bond is found, before further flight, replace the blade with an airworthy blade with a serial number other than those to which this AD applies.

(c) Within 100 hours time-in-service, replace all affected, serial-numbered blades with airworthy blades with a serial number other than those to which this AD applies.
