#### 14 CFR Part 39

[Docket No. FAA-2005-23221; Directorate Identifier 2005-CE-51-AD; Amendment 39-14459; AD 2006-02-51]

#### Airworthiness Directives; Raytheon Aircraft Company Model 390 Airplanes

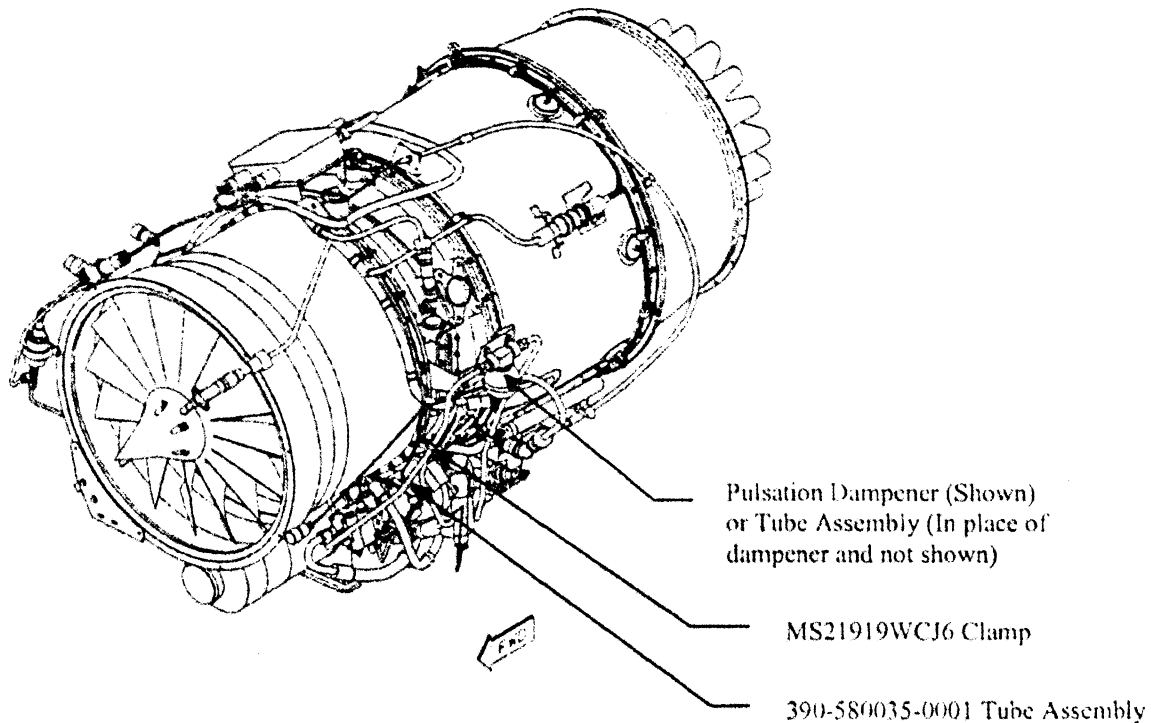
The FAA received reports of four failures of the part number (P/N) 390-580035-0001 hydraulic tube assembly located on the left engine assembly of Raytheon Model 390 airplanes. The failures resulted in in-flight loss of hydraulic fluid. The tube is installed between the hydraulic pump and the hydraulic pulsation damper and carries hydraulic pump output pressure.

(d) This AD is the result of failure of the hydraulic tube assembly, which caused in-flight loss of hydraulic fluid. We are issuing this AD to prevent failure of the hydraulic tube assembly and the clamp and consequent leaking of hydraulic fluid. This failure could result in loss of hydraulic system functions and risk of fire because of flammable fluid leakage in the engine nacelle and lead to loss of control of the airplane.

Figure 1. Hydraulic Tube Assembly with Clamp on Left Hand Engine.

Actions	Compliance	Procedures
<p>(1) Perform a one-time visual inspection of the hydraulic tube assembly and clamp using Raytheon Safety Communique No. 267, dated January 2006. Perform repetitive detailed inspections thereafter per Raytheon Mandatory Service Bulletin No. SB 29-3771, dated January, 2006.</p> <p>(i) The tube assembly part number is P/N 390-580035-0001 or P/N 390-580035-0005).</p> <p>(ii) The clamp part number is P/N MS21919WCJ6 or P/N MS21919WCJ7.</p> <p>(2) Replace the hydraulic tube assembly (P/N 390-580035-0001 or P/N 390-580035-0005) and the clamp (P/N MS21919WCJ6 or P/N MS21919WCJ7) (or FAA-approved equivalent part numbers) with new P/N 390-580035-0001 or P/N 390-580035-0005 and P/N MS21919WCJ7 (or FAA-approved equivalent part numbers) or used parts.</p> <p>(3) Report the results to FAA of each inspection or replacement required in paragraphs (e)(1) and (e)(2) of this AD. The Office of Management and Budget (OMB) approved the information collection requirements contained in this regulation under the provisions of the Paperwork Reduction Act of 1980 (44 U.S.C. 3501 and those following sections) and assigned OMB Control Number 2120-0056.</p>	<p>Visually inspect before further flight after February 2, 2006 (the effective date of this AD), except for those who received emergency AD 2006-02-51, issued January 19, 2006, unless already done. Perform the detailed inspection within 10 hours time-in-service (TIS) after February 2, 2006 (the effective date of this AD), except for those who received emergency AD 2006-02-51, issued January 19, 2006, unless already done. Inspect thereafter at intervals not to exceed 50 hours TIS. You may perform the detailed inspection before further flight instead of the visual inspection. Emergency AD 2006-02-51 contained the requirements of this amendment and became effective immediately upon receipt.</p> <p>Replace the clamp at each inspection. Replace the tube assembly prior to further flight after any inspection where evidence of chafing, excessive vibration, wear, deterioration, or hydraulic fluid leakage is found. Refer to SB 29-3771, dated January, 2006 for acceptance/rejection information for the tube assembly.</p> <p>Within 10 days after the inspection or replacement or within 10 days after February 2, 2006 (the effective date of this AD), except for those who received emergency AD 2006-02-51, issued January 19, 2006, whichever occurs later.</p>	<p>For the visual inspection, use Raytheon Safety Communique No. 267, dated January, 2006. For the detailed inspections, use the procedures in Raytheon Mandatory Service Bulletin No. SB 29-3771, dated January, 2006.</p> <p>Follow the procedures in Raytheon Mandatory Service Bulletin No. SB 29-3771, dated January, 2006.</p> <p>Include in your report the airplane serial number, the TIS of the airplane, and the TIS of the hydraulic tube assembly (P/N 390-580035-0001 or P/N 390-580035-0005) (or FAA-approved equivalent part number). E-mail/send your report to James P. Galstad, Propulsion Aerospace Engineer, ACE 116W, Wichita Aircraft Certification Office, 1801 Airport Road, Room 100, Wichita, Kansas 67209; e-mail: <a href="mailto:james.galstad@faa.gov">james.galstad@faa.gov</a>; telephone: 316-946-4135; facsimile: 316-946-4107.</p>
