Federal Railroad Administration

Notice of Safety Advisory 2006-02

SUMMARY: This safety advisory provides recommended practices for the testing, classification, and reuse of second-hand rail.¹ The purpose of this safety advisory is to reduce the number of rail defects that occur when second-hand rail is used.

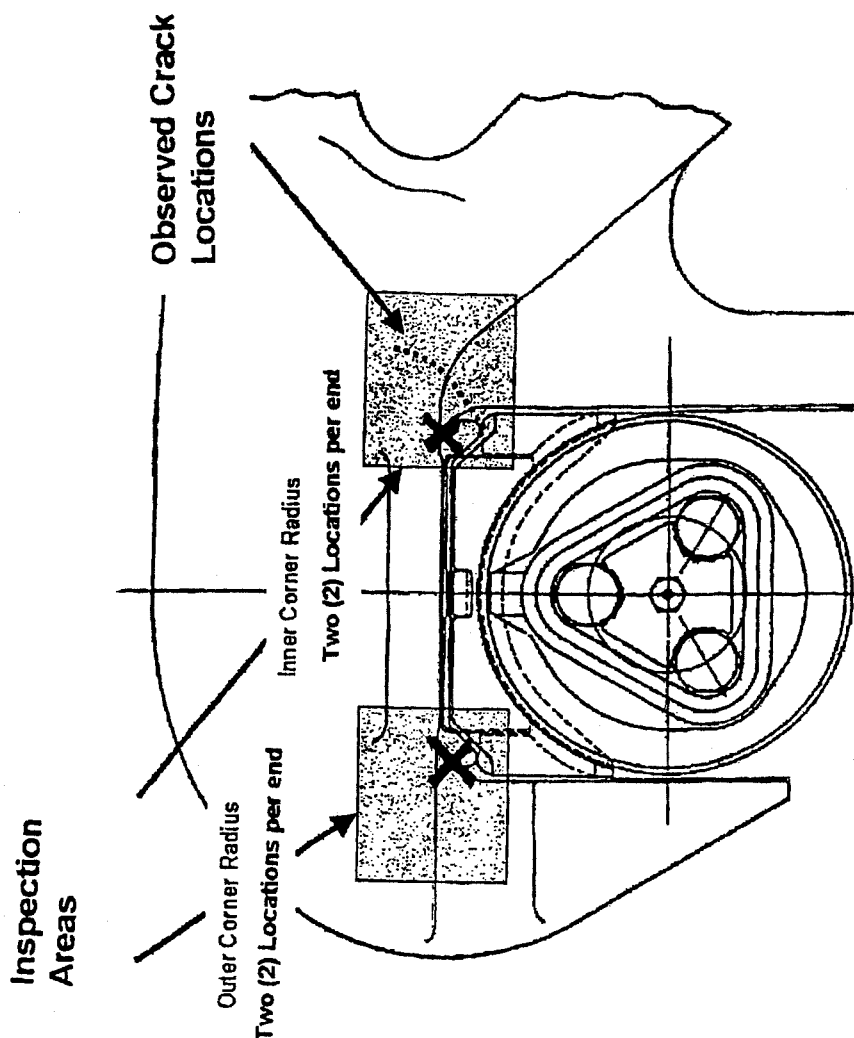
Fig. 1 Showing Eight Inspection Locations Per Side Frame
