Airworthiness Directives; Eurocopter France Model AS-365N2, AS 365 N3, EC 155B, EC155B1, SA-365N, N1, and SA-366G1 Helicopters

ACTION: Notice of proposed rulemaking (NPRM).

Airworthiness Directives; Air Tractor, Inc. Models AT-602, AT-802, and AT-802A Airplanes

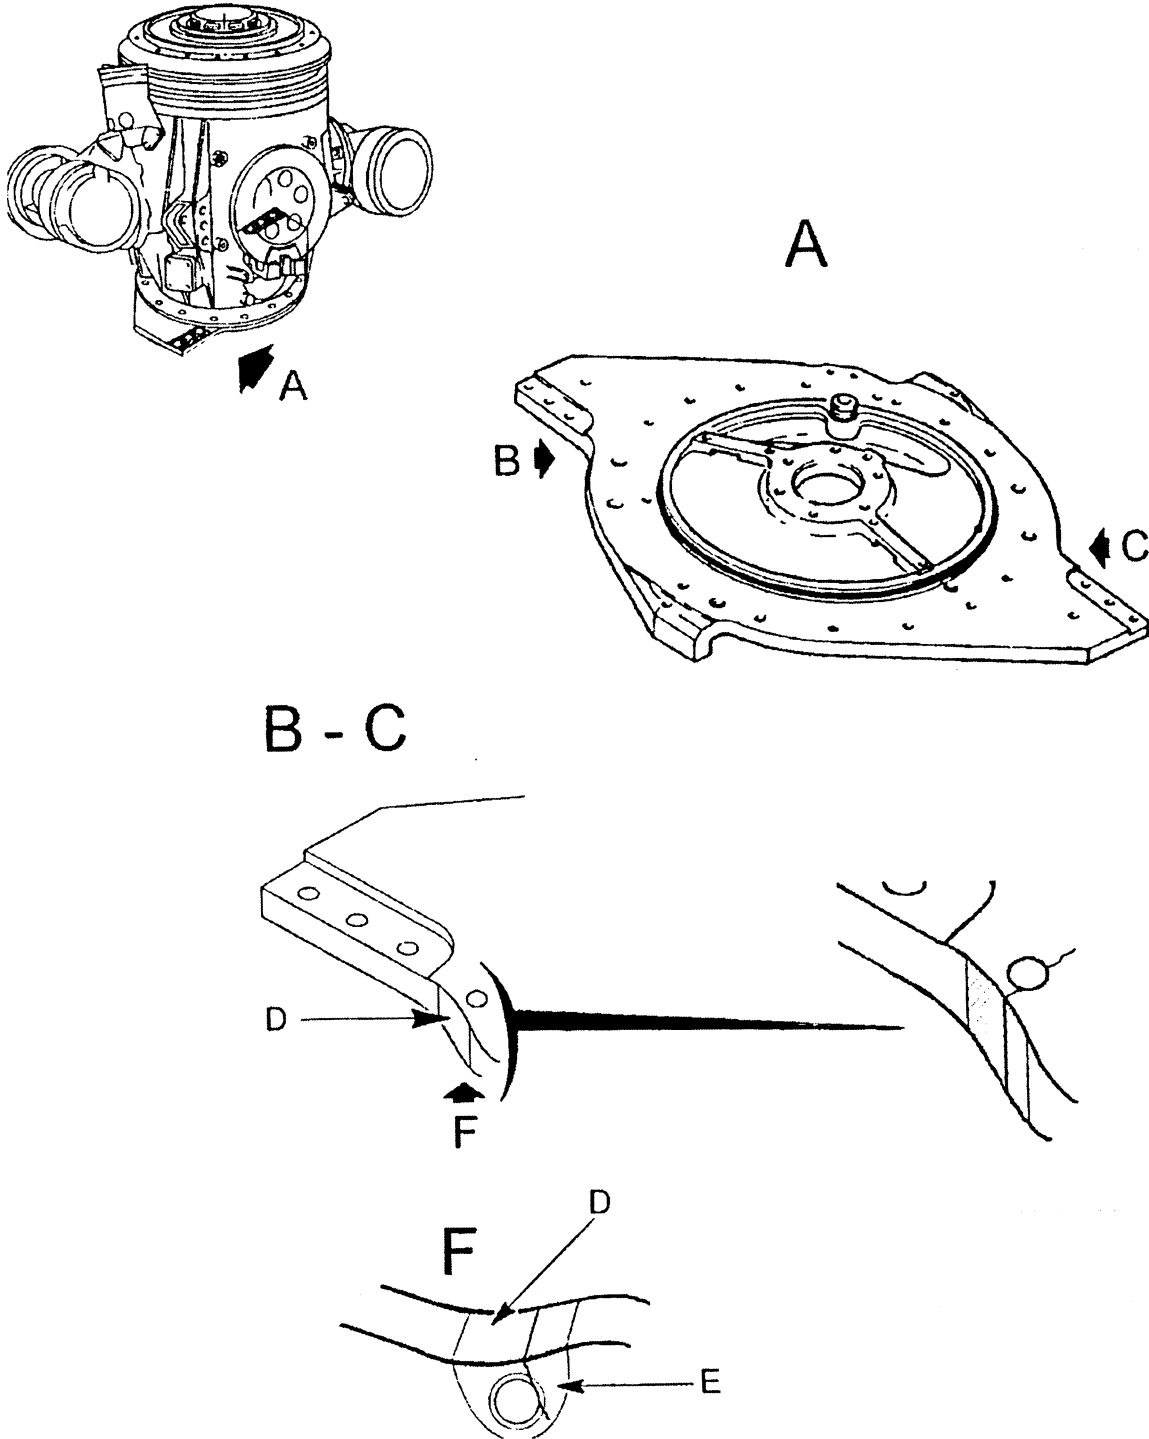
The Direction Générale de L'Aviation Civile (DGAC), the airworthiness authority for France, notified the FAA that an unsafe condition may exist on Eurocopter Model SA 365N, N1, SA 366 G1, AS 365 N2, N3, EC 155 B, and B1 helicopters, all serial numbers. The DGAC advises that a crack was detected in the MGB base plate of an AS 365 N2 helicopter. The crack was detected in the MGB base plate web, very close to the attachment of one of the laminated pads, and runs to the inside of the MGB base plate and then on the MGB casing.

strip the paint from area "D" on both sides ("B" and "C") of the MGB base plate as depicted in Figure 1 of this AD.

(b) At the times indicated in the compliance table, inspect area "D" of the MGB base plate for a crack using a 10x or higher magnifying glass. Area "D" to be inspected is depicted in Figure 1 of this AD.

(c) If a crack is found in a MGB base plate, remove and replace the MGB with an airworthy MGB before further flight.
