[Docket No. FAA-2005-22481; Directorate Identifier 2004-NM-176-AD; Amendment 39-14647; AD 2006-12-21]

#### Airworthiness Directives; Bombardier Model CL-600-2B19 (Regional Jet Series 100 & 440) Airplanes

**2006-12-21 Bombardier, Inc. (Formerly Canadair):** Amendment 39-14647. Docket No. FAA-2005-22481; Directorate Identifier 2004-NM-176-AD.

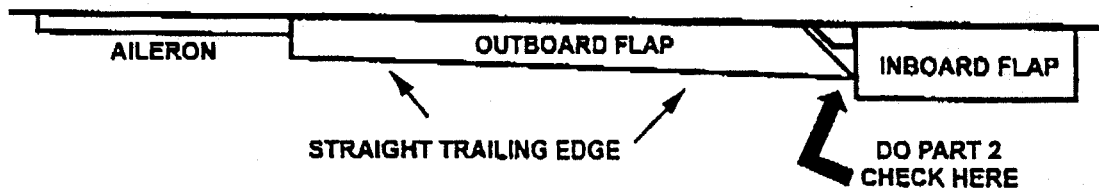
**1. NORMAL**

A normal outboard flap has a straight trailing edge, and the inboard corner is slightly above (i.e. higher) than the inboard flap.

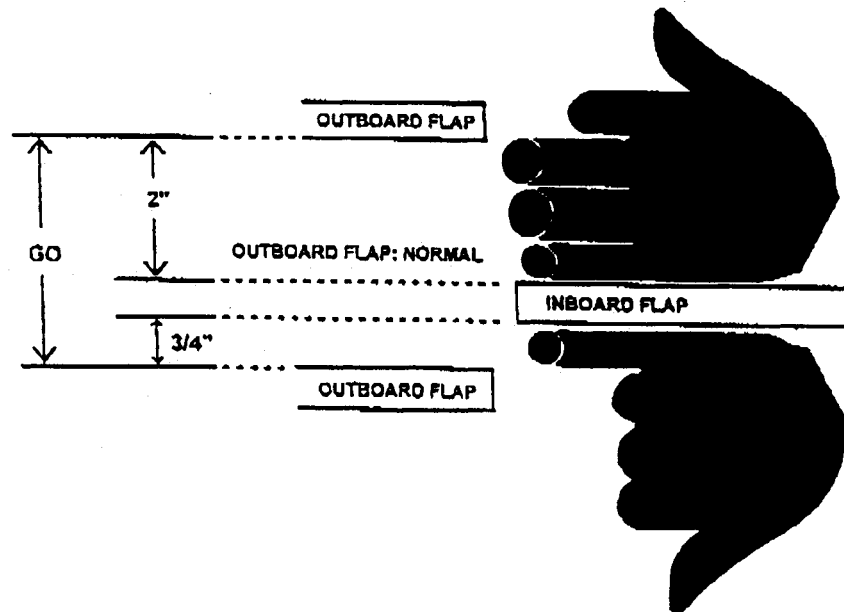
**1. FLAPS AT 8 DEGREES**

If the outboard flap position is outside the "GO" range as shown below further flight is prohibited.
