[Docket No. FAA-2006-25097; Directorate Identifier 2005-SW-19-AD]

Airworthiness Directives; Arrow Falcon Exporters, Inc. (Previously Utah State University); Firefly Aviation Helicopter Services (Previously Erickson Air-Crane Co.); California Department of Forestry; Garlic Helicopters, Inc.; Global Helicopter Technology, Inc.; Hagglund Helicopters, LLC (Previously Western International Aviation, Inc.); International Helicopters, Inc.; Precision Helicopters, LLC; Robinson Air Crane, Inc.; San Joaquin Helicopters (Previously Hawkins and Powers Aviation, Inc.); S.M.&T. Aircraft (Previously US Helicopters, Inc., UNC Helicopter, Inc., Southern Aero Corporation, and Wilco Aviation); Smith Helicopters; Southern Helicopter, Inc.; Southwest Florida Aviation International, Inc. (Previously Jamie R. Hill and Southwest Florida Aviation); Tamarack Helicopters, Inc. (Previously Ranger Helicopter Services, Inc.); US Helicopter, Inc. (Previously UNC Helicopter, Inc.); West Coast Fabrication; and Williams Helicopter Corporation (Previously Scott Paper Co.) Model HH-1K, TH-1F, TH-1L, UH-1A, UH-1B, UH-1E, UH-1F, UH-1H, UH-1L, and UH-1P Helicopters; and Southwest Florida Aviation Model SW204, SW204HP,

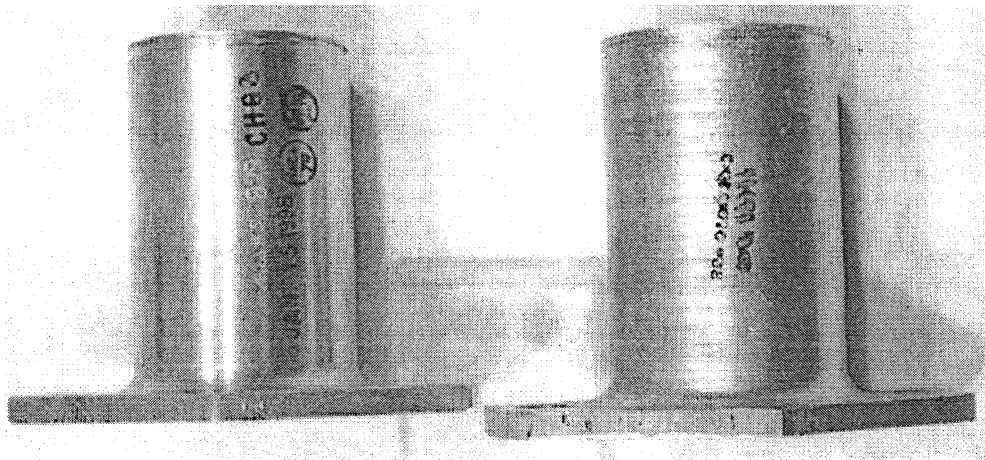
FIGURE 1

excess surface roughness. This proposal is prompted by two accidents attributed to sub-standard T/R sliders that failed during flight. This condition, if not corrected, could result in cracking in the T/R slider, loss of T/R control, and subsequent loss of control of the helicopter.

Note 1: T/R sliders manufactured by Forest Scientific, Inc., were produced under a military contract and do not meet the OEM specifications. The machining process resulted in excess surface roughness. See Figure 1 of this AD.

Tail rotor sliders manufactured by Bell Helicopter Textron, Inc. (left) and Forest Scientific, Inc. (right). Note the rough finish of the Forest Scientific, Inc.-manufactured T/R slider compared to the one shown on the left.

(i) Before further flight, unless accomplished previously, and thereafter at intervals not to exceed 25 hours TIS, magnaflux inspect the T/R slider for a crack.

(ii) If a crack is found, before further flight, replace the cracked T/R slider with an airworthy T/R slider.

(iii) On or before accumulating 1000 hours TIS or on or before 12 months, whichever occurs first, replace each T/R slider that

has an illegible CAGE code or Code 15716 or 26098 with an FAA approved airworthy slider without a CAGE code or with a legible CAGE code other than 15716 or 26098. Any T/R slider removed from service based on the requirements of this paragraph is not eligible for installation on any helicopter.
