[Docket No. FAA-2006-24074; Directorate Identifier 2005-NM-213-AD; Amendment 39-14676; AD 2006-14-05]

Airworthiness Directives; Bombardier Model CL-600-2C10 (Regional Jet Series 700, 701, and 702) Airplanes, Model CL-600-2D15 (Regional Jet Series 705) Airplanes, and Model CL-600-2D24 (Regional Jet Series 900) Airplanes

2006–14–05 Bombardier, Inc. (Formerly Canadair): Amendment 39–14676. Docket No. FAA–2006–24074; Directorate Identifier 2005–NM–213–AD.

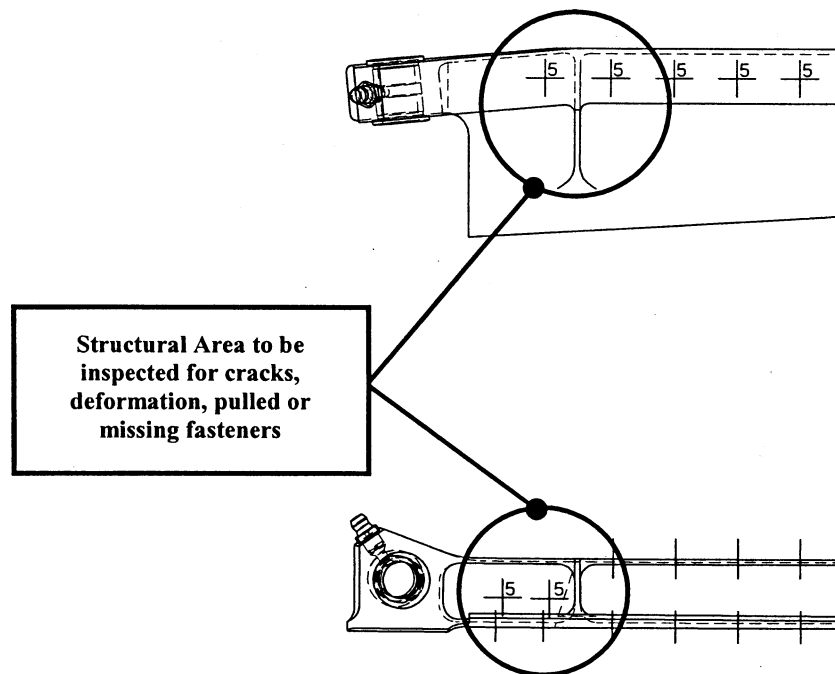
Figure 3
View LKG INBD
LH side Shown
RH side Opp

(4) Inspect the forward member, P/N CC670–10570, and aft member, P/N CC670–10571, of the MLG door lower panel for cracking or deformation, or pulled or missing fasteners, in accordance with Figure 3 of this AD. Figures 1 through 3 of this AD follow.

(i) If any cracking or deformation, or pulled or missing fastener, as applicable, is found during any inspection done in accordance with paragraph (g) or (h) of this AD: Before further flight, accomplish paragraph (i)(1), (i)(2), or (i)(3) of this AD.

(2) Replace the lower panel assembly, P/N CC670-10520, of the affected MLG door with a new or serviceable lower panel assembly having the same P/N, according to a method approved by either the Manager, New York ACO, FAA; or TCCA (or its delegated agent). Task Cards 32-12-01-000-801-A01 and 32-12-01-400-801-A01 of the CRJ 700/900
