[Docket No. FAA-2006-25724; Directorate Identifier 2006-NM-197-AD; Amendment 39-14742; AD 2006-18-04]

Airworthiness Directives; Bombardier Model CL-600-2B16 (CL-604) Airplanes and Model CL-600-2B19 (Regional Jet Series 100 & 440) Airplanes

2006-18-04 Bombardier, Inc. (Formerly Canadair): Amendment 39-14742.

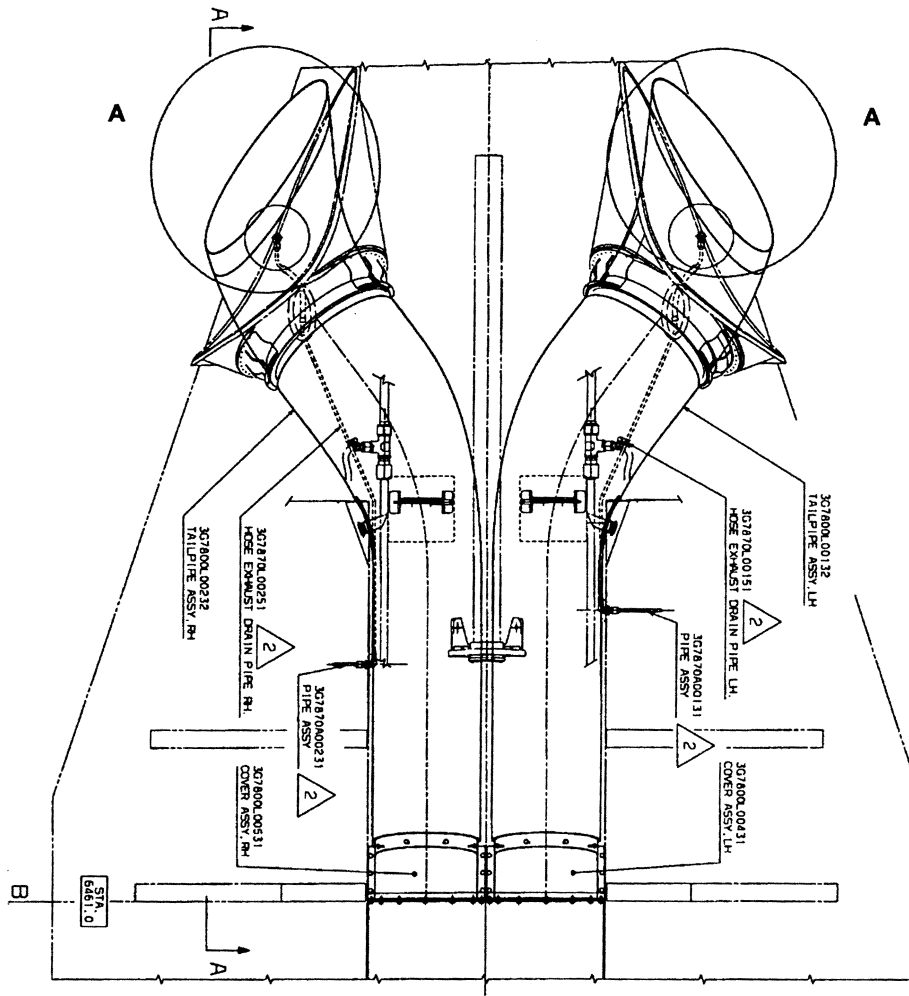
Figure 1

(i) Clean the end of each tailpipe assembly with a cloth. While applying slight pressure on it, inspect for a crack using a flashlight.

(ii) Inspect each tailpipe assembly toward the centerline of the helicopter for a crack using a flashlight.

(iii) Inspect each tailpipe assembly toward the outboard side of the helicopter for a crack using a mirror and a flashlight.

(3) If you find a crack, before further flight, replace the tailpipe assembly with an airworthy tailpipe assembly.
