BILLING CODE 3410–34–P**DEPARTMENT OF TRANSPORTATION****Federal Aviation Administration****14 CFR Part 39**

[Docket No. FAA–2006–25760; Directorate Identifier 2006–CE–48–AD; Amendment 39–14757; AD 2006–18–51]

RIN 2120–AA64**Airworthiness Directives; Raytheon Aircraft Company Models 1900, 1900C, and 1900D Airplanes****AGENCY:** Federal Aviation Administration (FAA), DOT.**ACTION:** Final rule; request for comments.

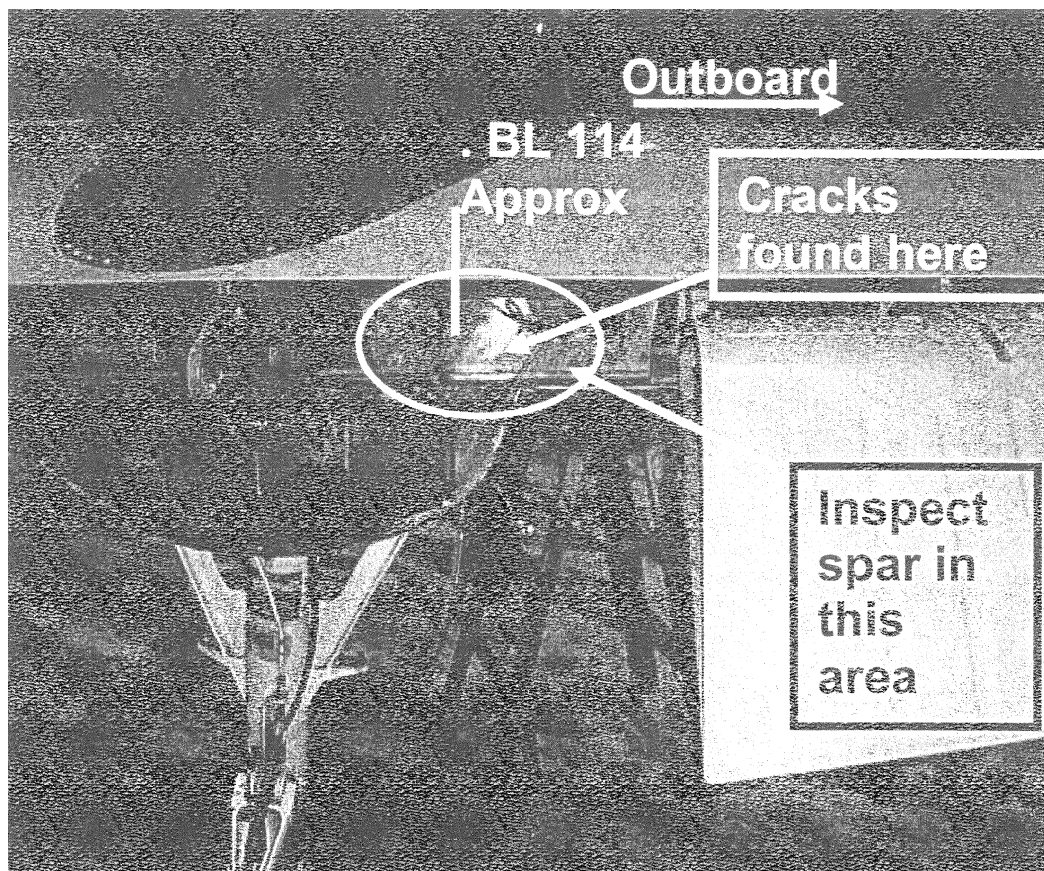
Figure 1: View of R/H wing rear spar at BL 114 area looking forward (The inboard flap is removed in this figure, but removal of the flap is not required to do the inspection).

Step 1. Lower the wing flaps to provide visual access to the wing rear spar cove area. Although the pictures show the flaps removed, this AD does not require flap removal to do the inspection.

Step 2. Using a strong, high-intensity light visually inspect the area of the wing rear spar

identified in Figure 1. There is ample visually visual access from above the upper surface of the flap. Look for cracks (like those shown in Figures 2 and 3) and loose or missing fasteners.
