Airworthiness Directives; Rolls-Royce Deutschland Ltd & Co KG Tay 650-15 and Tay 651-54 Turbofan Engines

2006-18-14 Rolls-Royce Deutschland Ltd & Co KG (formerly Rolls-Royce plc):
Amendment 39-14753. Docket No. FAA-2006-25513; Directorate Identifier 99-NE-61-AD.

Airworthiness Directives; Gulfstream Model GV and GV-SP Series Airplanes

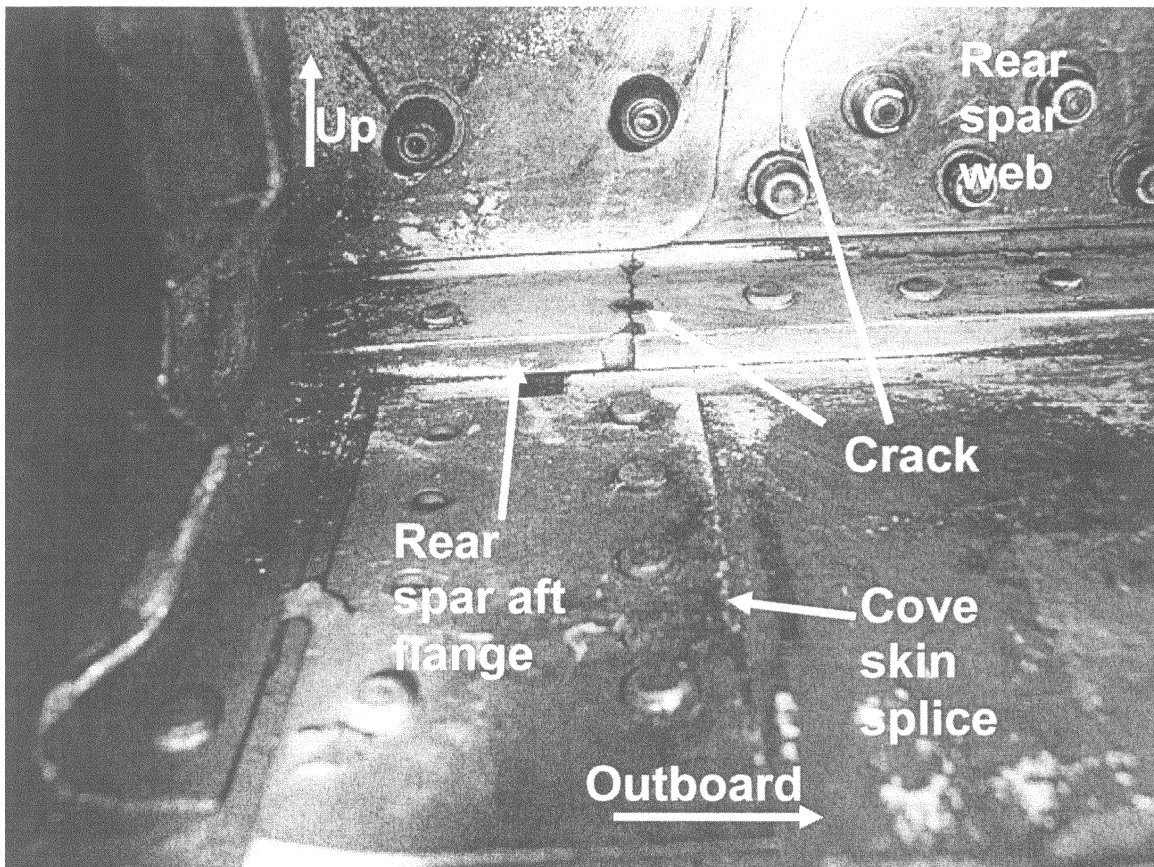
Figure 3: Closeup view of R/H wing rear spar cracks at BL 114 area looking forward (The inboard flap is removed in this figure, but removal of the flap is not required to do the inspection).
