[Docket No. FAA-2006-25773; Directorate Identifier 2006-SW-16-AD; Amendment 39-14758; AD 2006-19-01]

**Airworthiness Directives; Eurocopter Model AS350B, B1, B2, B3, BA, D, and AS355E Helicopters**

**2006-19-01 Eurocopter:** Amendment 39-14758. Docket No. FAA-2006-25773; Directorate Identifier 2006-SW-16-AD.

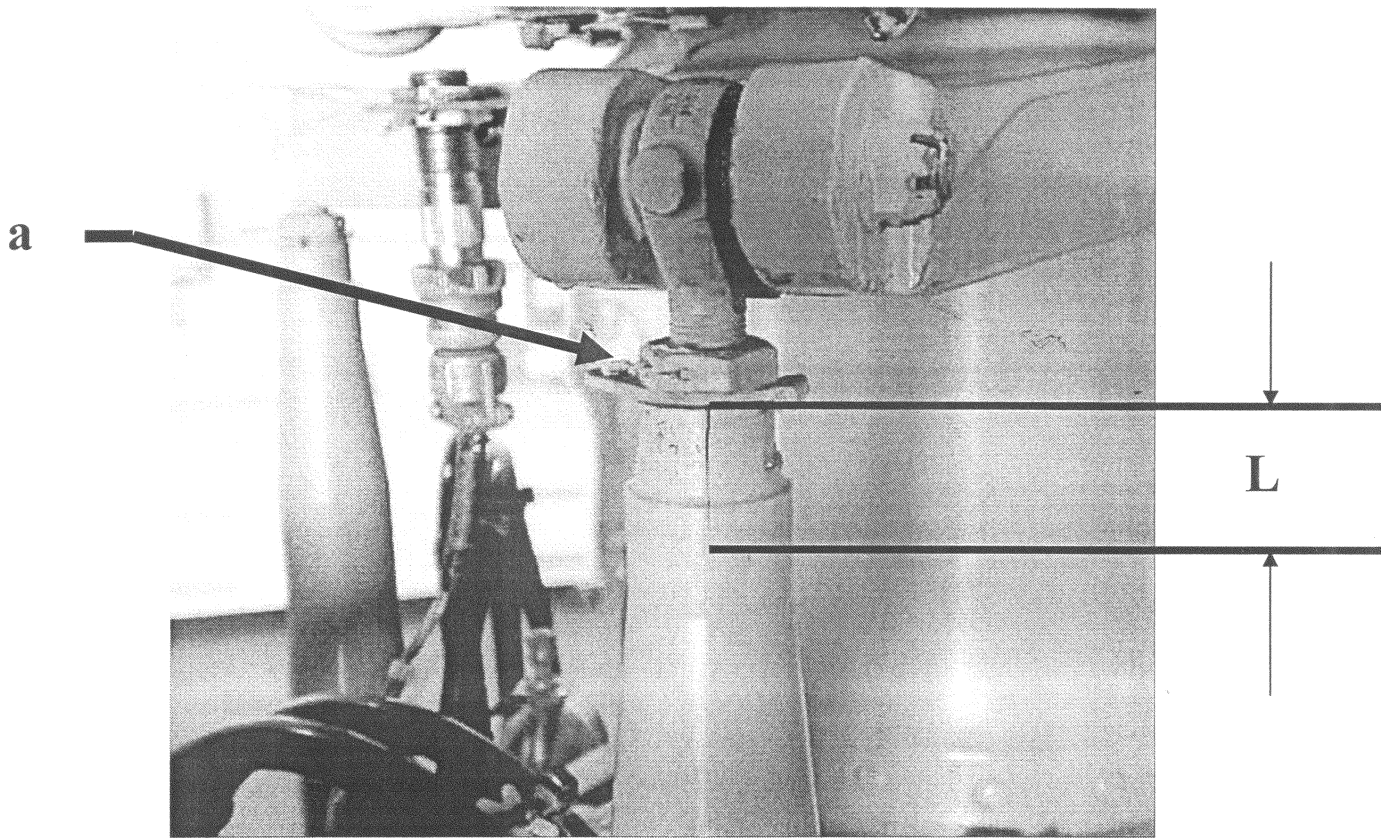
**Figure 1**

(3) Loosen attachment nut "a" shown in Figure 1 of this AD and lift the positioning lock washer under the attachment nut so the edge below the lock washer at the top of the tapered housing is visible around the entire periphery.

(4) Visually inspect each MSC tapered housing for a crack using a 10-power or higher magnifying glass paying particular attention to area "L" and to the edge of the tapered housing located under the lock washer under attachment nut "a" as depicted in Figure 1 of this AD.

(1) Adjust the tightening torque on the attachment nut that secures the upper ball end of the MSC to between 177-199 in-lbs (2-2.25 decanewton meters (daN·m)).

(c) If you find any crack (oblique, horizontal, or vertical), before further flight, replace the MSC with an airworthy MSC and adjust the tightening torque of the attachment nut to between 177-199 in-lb (2-2.25 daN·m)).
