## DEPARTMENT OF TRANSPORTATION

[Docket No. FAA-2006-23871; Directorate  
Identifier 2006-NE-01-AD]

#### Airworthiness Directives; General Electric Company (GE) CF6-80C2 Turbofan Engines

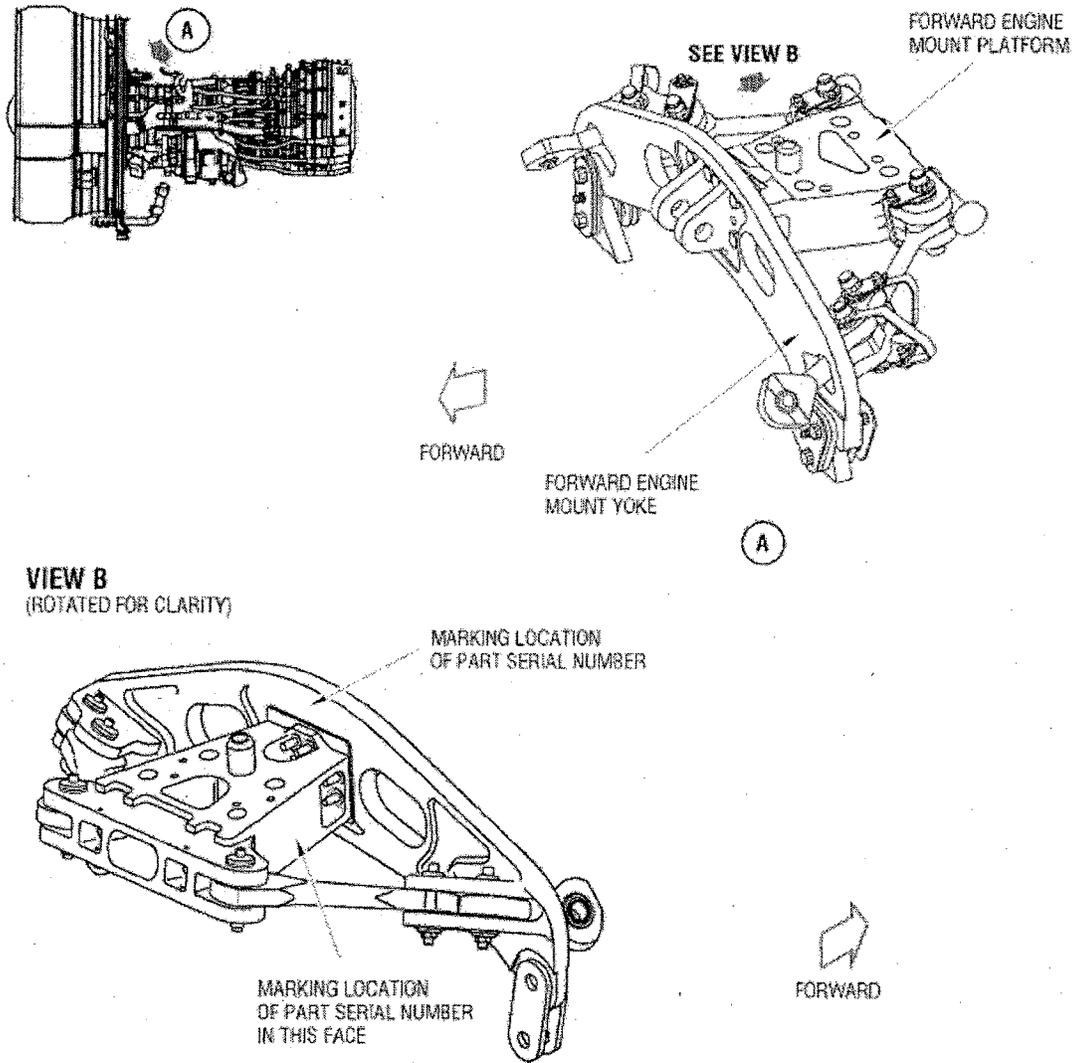
Location of Forward Engine Mount Platform and Forward Engine Mount Yoke  
Figure 1

(d) This AD results from the discovery of cracks in a forward engine mount platform and a forward engine mount yoke found during fluorescent penetrant inspection (FPI). We are issuing this AD to prevent cracks in the forward engine mount platform and forward engine mount yoke that could result in possible separation of the engine from the airplane.

(p) Location of the forward engine mount platform and forward engine mount yoke and SN are illustrated in the following Figure 1.

(n) Replace the affected forward engine mount platform and or the affected forward engine mount yoke with a non-weld-repaired cast titanium forward engine mount platform and or the forward engine mount yoke or a forged titanium forward engine mount platform or a forged titanium forward engine mount yoke.
