**[Docket No. FAA-2006-23871; Directorate Identifier 2006-NE-01-AD; Amendment 39-14975; AD 2007-05-14]**

#### **Airworthiness Directives; General Electric Company (GE) CF6-80C2 Turbofan Engines**

#### 2007-05-14 General Electric Company:

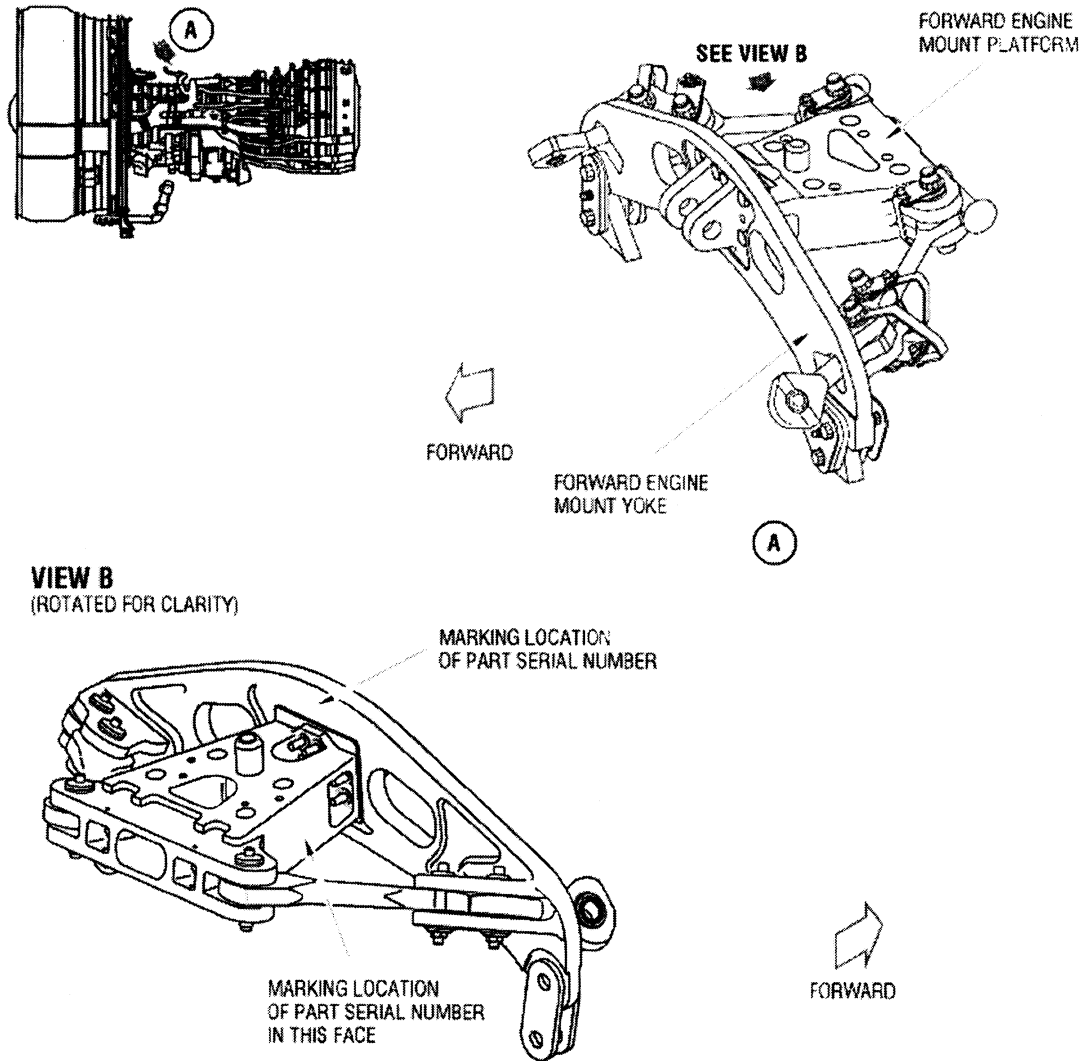
Location of Forward Engine Mount Platform and Forward Engine Mount Yoke  
Figure 1

(d) This AD results from the discovery of cracks in a forward engine mount platform and a forward engine mount yoke found during fluorescent penetrant inspection (FPI). We are issuing this AD to prevent cracks in the forward engine mount platform and forward engine mount yoke that could result in possible separation of the engine from the airplane.

(p) Location of the forward engine mount platform and forward engine mount yoke and SN are illustrated in the following Figure 1.

(n) Replace the affected forward engine mount platform and or the affected forward engine mount yoke with a non-weld-repaired

cast titanium forward engine mount platform and or the forward engine mount yoke or a forged titanium forward engine mount platform or a forged titanium forward engine mount yoke.
