Airworthiness Directives; Eurocopter France Model AS350B, BA, B1, B2, B3, C, D, and D1; EC–130B4; and AS355E, F, F1, F2, and N Helicopters

ACTION: Notice of proposed rulemaking (NPRM).

Eurocopter France: Docket No. FAA-2007-27495; Directorate Identifier 2005-SW-14-AD.

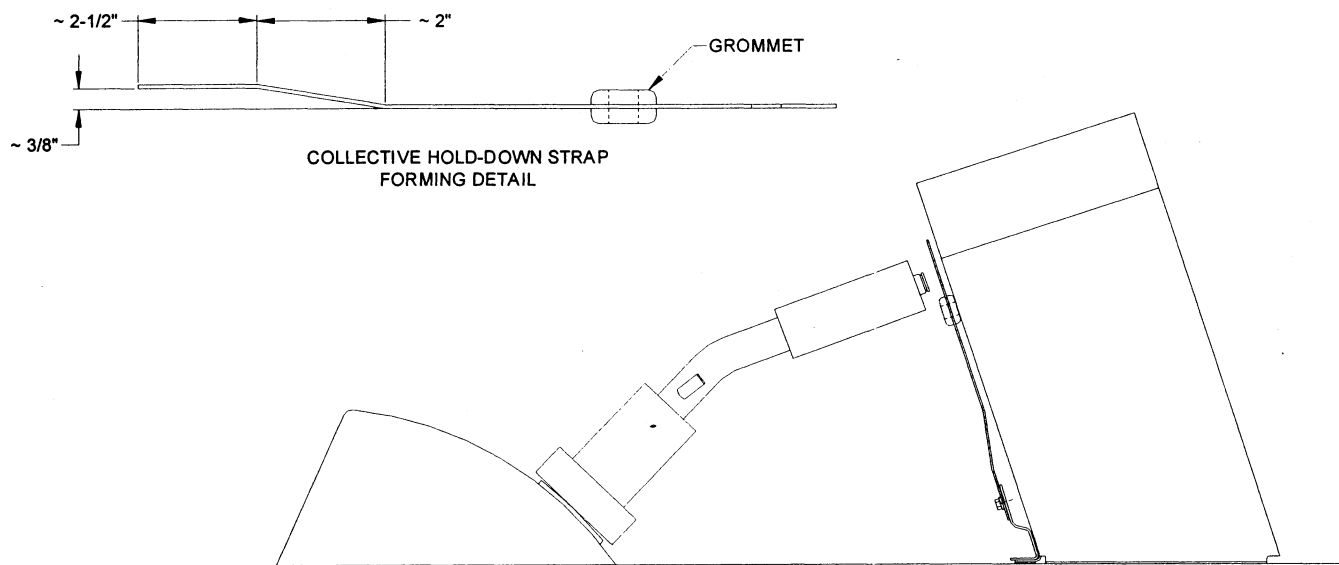
To ensure that the strap does not inadvertently lock the collective during normal operation, the strap must be formed by joggling it as shown in the figure. When formed correctly, the strap will naturally touch the console aft wall, requiring it to be flexed in order to lock the collective.

- (a) Within the next 30 days, unless accomplished previously, modify the strap by forming the strap as depicted in Figure 1 of this AD. Install the modified strap so that the rubber grommet rests against the console. Thereafter, at intervals not to exceed 100 hours time-in-service, inspect the strap to ensure that the rubber grommet is resting against the console.
