[Docket No. FAA-2007-27343; Directorate Identifier 2007-SW-05-AD; Amendment 39-15030; AD 2007-05-51]

Airworthiness Directives; MD Helicopters Inc. (MDHI) Model MD600N Helicopters

2007-05-51 MD Helicopters Inc. (MDHI):
Amendment 39-15030. Docket No. FAA-2007-27343; Directorate Identifier 2007-SW-05-AD.

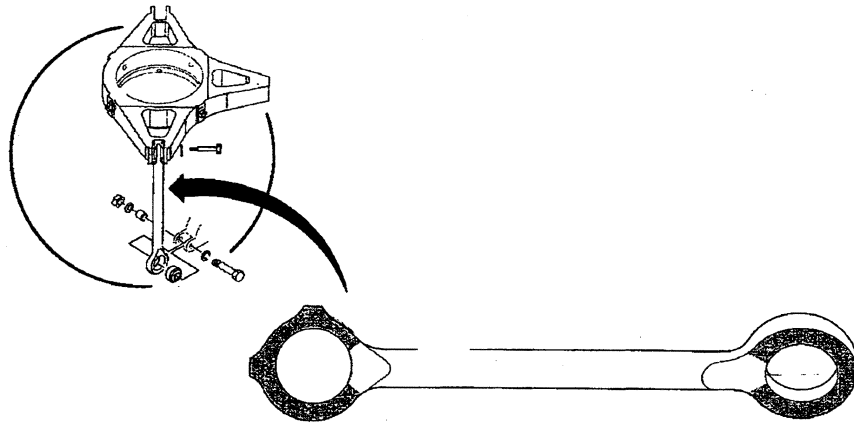
Figure 1

(1) Remove each mixer link and visually inspect, with a bright light and a 10x or higher magnifying glass, the shaded areas around the bearing bore for any crack as depicted in the following Figure 1:

Bearings have been removed for clarity.

(2) Perform an eddy current inspection of each mixer link in the bearing end areas.

(3) Replace any cracked mixer link with an airworthy mixer link on which an eddy current inspection has been performed.
