**DEPARTMENT OF TRANSPORTATION****Federal Aviation Administration****14 CFR Part 39**

[Docket No. FAA-2007-27229; Directorate Identifier 2007-NE-03-AD]

**Airworthiness Directives; CFM International, S.A. CFM56-7B Series Turbofan Engines**

**ACTION:** Notice of proposed rulemaking (NPRM).

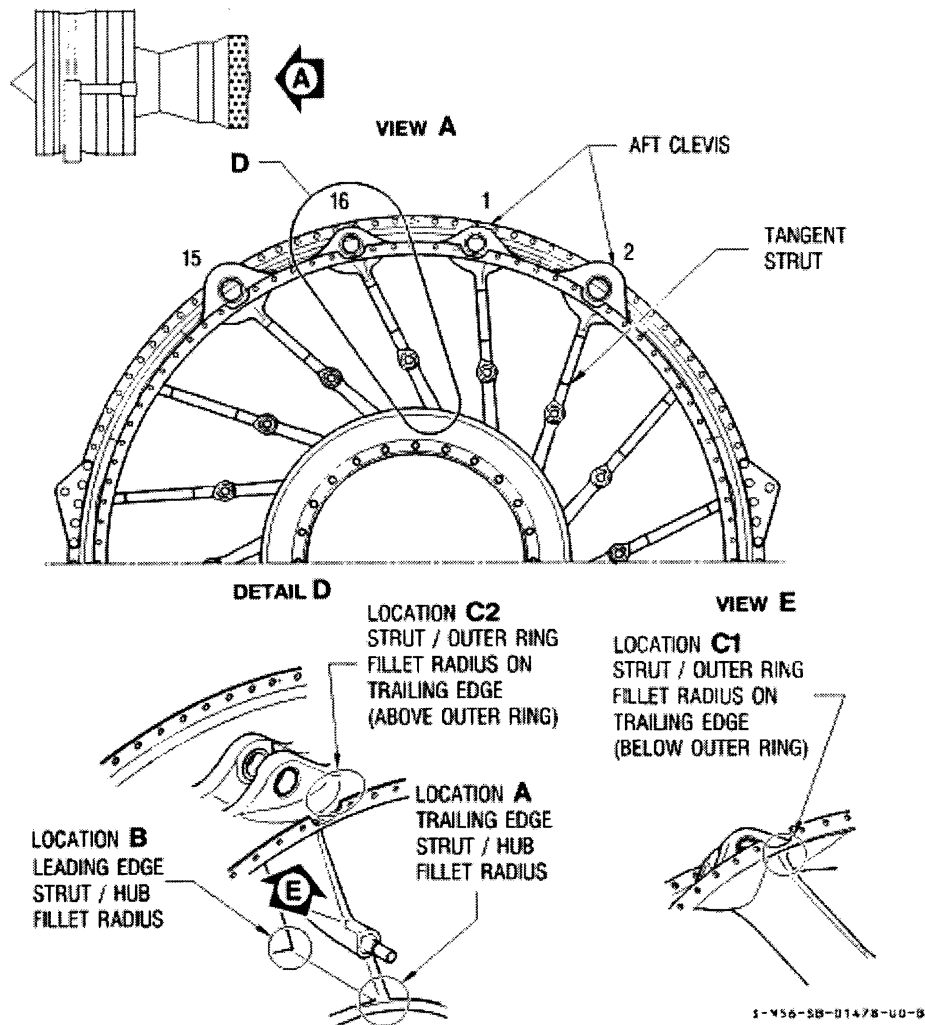
Figure 805,

manufacturer that shows the need to identify an initial threshold for inspecting certain TRFs. We are proposing this AD to prevent failure of the TRF from low-cycle fatigue cracks. Failure of the TRF could result in engine separation from the airplane, which could lead to loss of control of the airplane.

2. *Mandatory Inspection Intervals for the Critical Areas of the Turbine Rear Frame with Tangential Struts (4 Mount Struts, No. 1, 2, 15, and 16).*

C. Turbine Rear Frame Part Numbers 340-166-205-0, 340-166-206-0, 340-166-207-0, 340-166-208-0, 340-166-209-0, 340-166-210-0, for all CFM56-7B SAC engine models (except -7B27A engine models). Refer to figure 805.

Figure index No.	Inspection location	Inspection threshold (cycles since new)	Inspection intervals (cycles)	Inspection reference
805 .....	Strut/outer ring fillet radius on trailing edge (A).	25,000* for -7B SAC (except business jet) engine models.	Refer to Figure 806* for -7B SAC commercial applications.	Refer to SB 72-0579*.
	Strut/outer ring fillet radius on leading edge (B).	19,000* for -7B SAC business jet engine models.	Refer to Figure 807* for -7B SAC business jet applications.	
	Strut/outer ring fillet radius on trailing edge (C1 below outer ring).			
	Strut/outer ring fillet radius on trailing edge (C2 above outer ring).

Turbine Rear Frame with Tangential struts P/ N 340-166-205-0, 340-166-206-0, 340-166-207-0, 340-166-208-0, 340-166-209-0, 340-166-210-0—Areas to Be Inspected

**Note:** \* Applicable to all inspection locations. If inspection is not performed, part must be removed.
