Airworthiness Directives; Eurocopter France Model AS355E, F, F1, F2, and N Helicopters

ACTION: Notice of proposed rulemaking (NPRM).

Eurocopter France: Docket No. FAA–2007–28691; Directorate Identifier 2006–SW–22–AD. Supersedes AD 2003–21–09 R1, Amendment 39–14621, Docket No. 2003–SW–10–AD.

Applicability: Model AS355E, F, F1, F2, and N helicopters, with a main gear box (MGB) lubrication pump (pump), part number (P/N) 355A32-0700-01, 355A32-0700-02, or 355A32-0701-00, any serial number (S/N), certificated in any category.

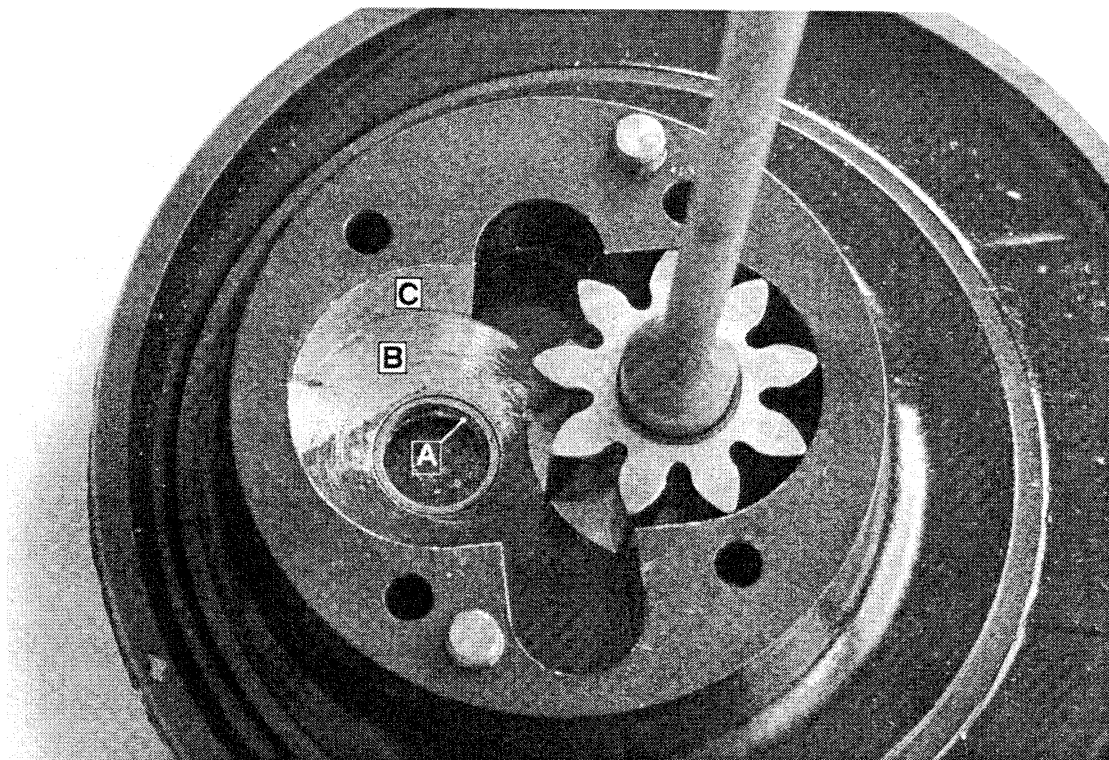
- (1) Crank pin play,
- (2) Out of round bronze bushing in area "A" of Figure 1 of this AD,
- (3) Offset of the driven gear pinion,
- (4) Metal chips, or
- (5) Wear in area "C" of Figure 1 of this AD.

Note 2: If wear is present in the B area only, as depicted in Figure 1, replacing the MGB and the pump is not required.

(d) While inspecting the pump, if you find any of the following, replace the MGB and the pump with an airworthy MGB and pump before further flight:
