Federal Register

Monday, July 16, 2007

[Docket No. FAA-2007-28688; Directorate Identifier 2005-SW-21-AD]

#### Airworthiness Directives; Bell Helicopter Textron Canada Model 430 Helicopters

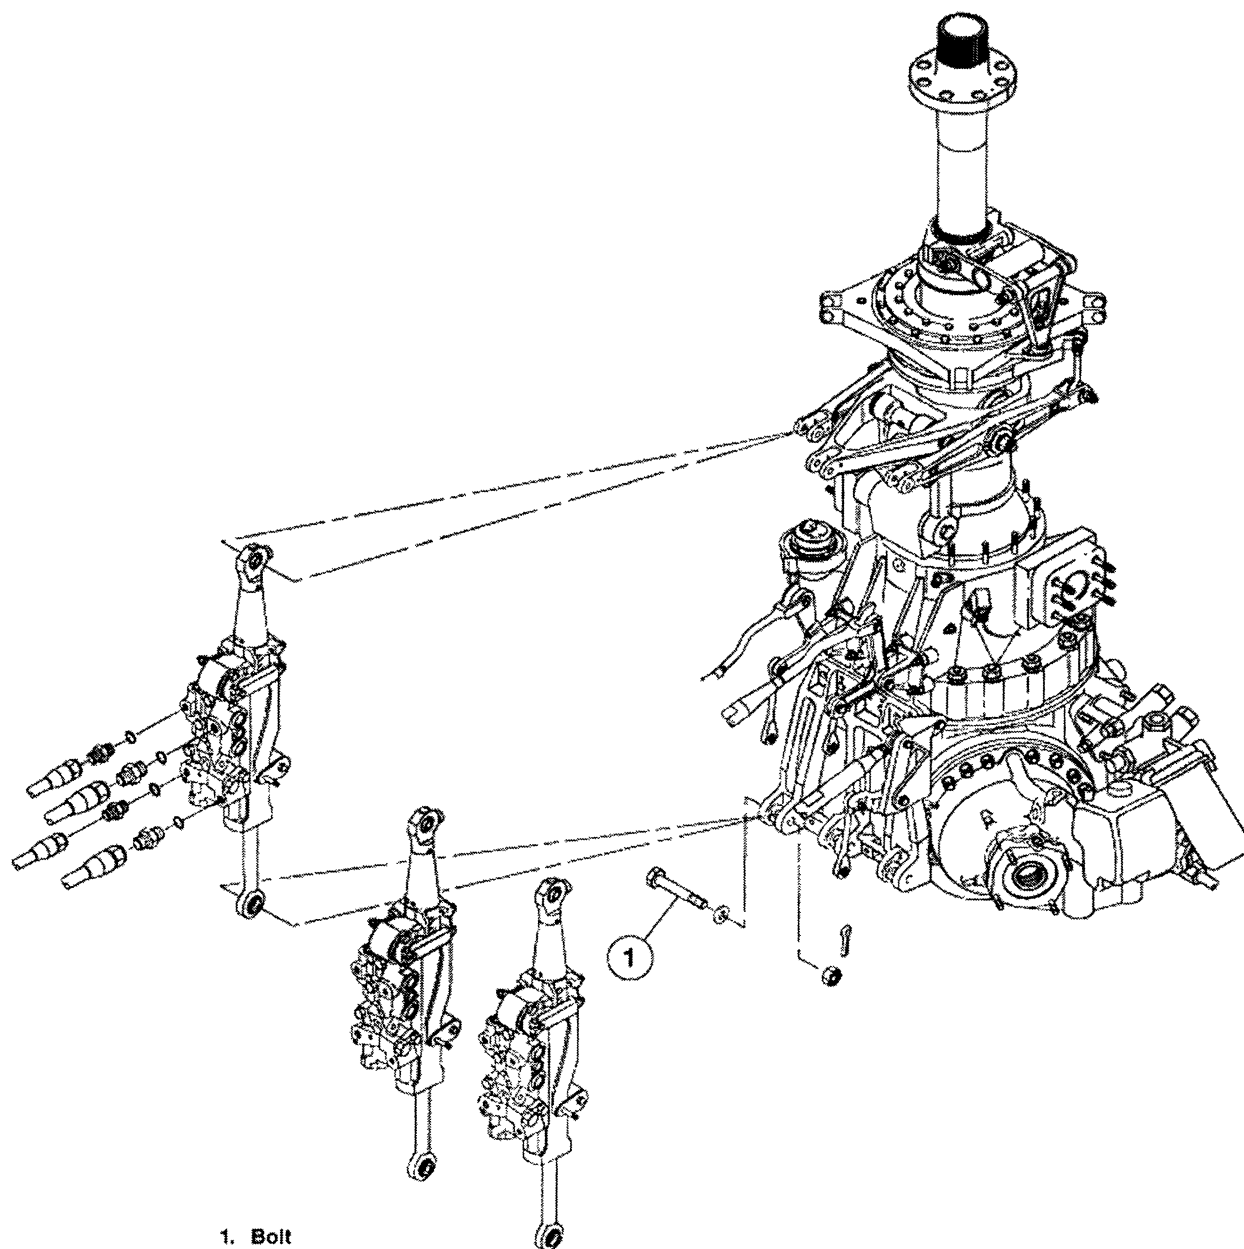
This previously described unsafe condition is likely to exist or develop on other helicopters of the same type design registered in the United States. Further evaluation of certain fatigue-critical parts resulted in establishing a life limit of 5000 hours for the affected bolts which is intended to prevent fatigue failure of the bolt and subsequent loss of control of the helicopter. Therefore, the proposed AD would require the following:

Note: Only the right servo lower attach bolt (1) is shown. The collective and left cyclic servo lower attach bolts are also to be replaced. (This AD does not apply to the same part-numbered bolts at the upper end of each servo.)

- (a) Within 150 hours time-in-service (TIS), replace all three affected bolts, as depicted for one of these bolts in Figure 1 of this AD, with airworthy, zero-time bolts, P/N 50-047C8-31.

(b) This AD revises the Airworthiness Limitations section of the maintenance manual by establishing a retirement life of 5000 hours TIS for each bolt.

(c) Record a 5000-hour TIS life limit for each bolt on the component history card or equivalent record.
