[Docket No. FAA–2007–29089; Directorate Identifier 2007–NM–215–AD; Amendment 39–15197; AD 2007–18–52]

### Airworthiness Directives; Boeing Model 737–600, –700, –700C, –800, –900, and –900ER Series Airplanes

**2007-18-52 Boeing:** Amendment 39-15197. Docket No. FAA-2007-29089; Directorate Identifier 2007-NM-215-AD.

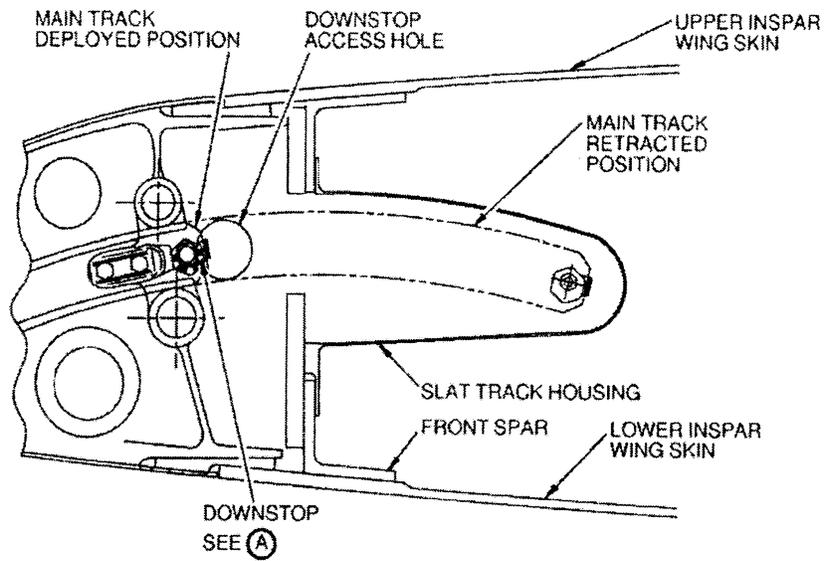
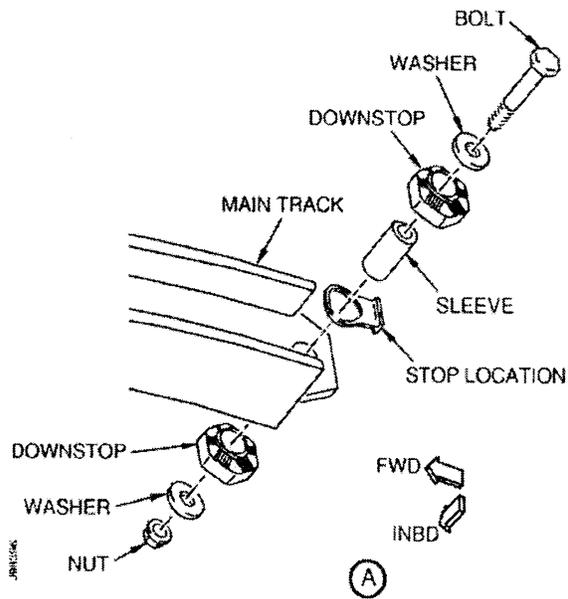
**Figure 1**

(d) This AD results from additional reports of parts coming off the main slat track downstop assemblies. We are issuing this AD to detect and correct loose or missing parts from the main slat track downstop assemblies, which could result in a fuel leak and consequent fire.

**Slat Track Downstop Assembly**

(f) Within 10 days after the effective date of this AD: Do a detailed inspection or a borescope inspection of each main slat track downstop assembly to verify proper installation of the slat track hardware (i.e., the bolt, washers, downstops, stop location, and nut shown in Figure 1 of Boeing Service Letter 737-SL-57-084-B, dated July 10, 2007, and in this AD). Proper installation of the sleeve need not be confirmed, and the stop location part may be installed on either the inboard or the outboard side of the slat track. If any part is missing or is installed improperly, before further flight, install a new or serviceable part using a method approved in accordance with the procedures specified in paragraph (h) of this AD; and do a detailed inspection of the inside of the slat can for foreign object debris (FOD) and

(g) Within 24 days after receipt of AD 2007-18-51: Apply a torque between 50 to 80 inch-pounds to the nut. The bolt head must be held with the torque applied to the nut.
