[Docket No. FAA–2008–0101; Directorate Identifier 2007–SW–76–AD; Amendment 39–15357; AD 2007–26–51]

Airworthiness Directives; Eurocopter Deutschland GmbH Model EC135 Helicopters

2007-26-51 Eurocopter Deutschland

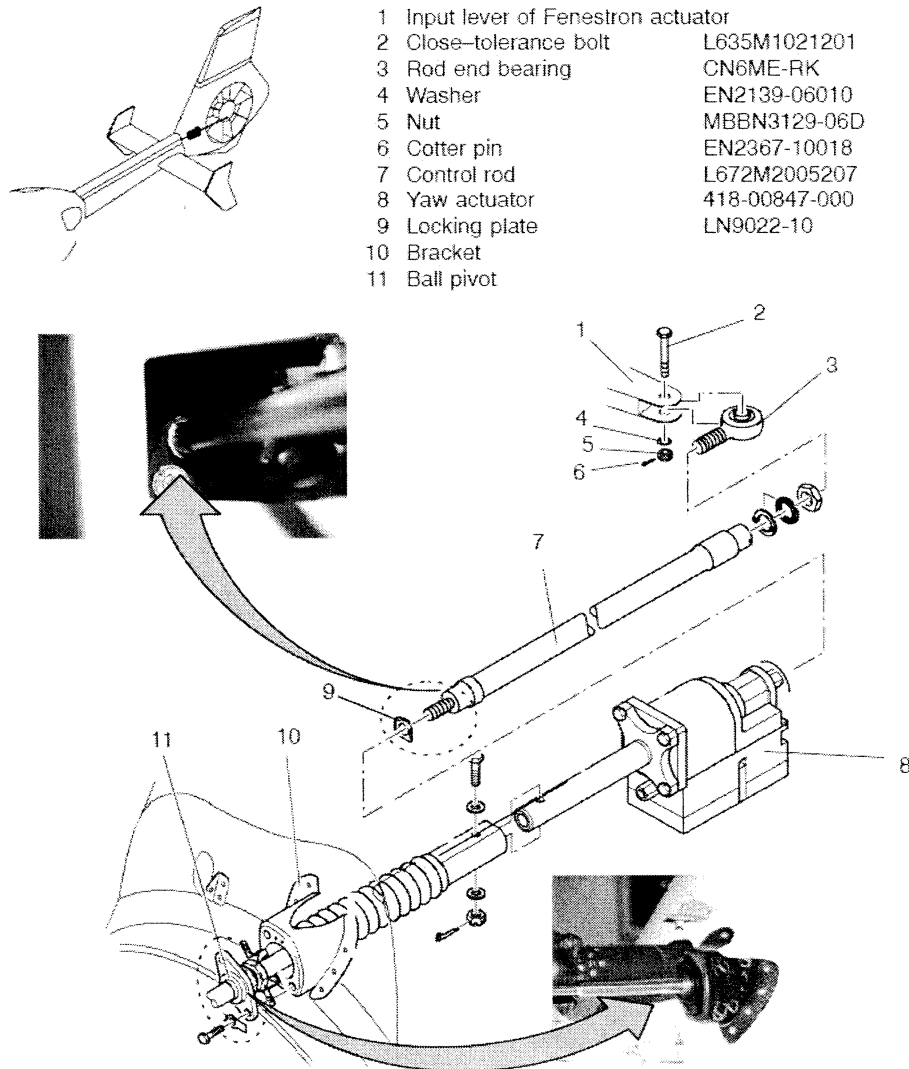
Ball Pivot and Control Rod
Figure 1

SUPPLEMENTARY INFORMATION: On December 14, 2007, the FAA issued Emergency AD 2007–26–51 for Eurocopter Model EC135 helicopters, which requires, within 5 hours TIS, inspecting the control rod and adjoining ball pivot and replacing any unairworthy parts before further flight. That action was prompted by a report of a fatal accident involving the failure of a control rod. This condition, if not corrected, could result in the failure of

The European Aviation Safety Agency (EASA), which is the Technical Agent for the Member States of the European Community, notified us that an unsafe condition may exist on Eurocopter EC135 and EC635 helicopters. EASA advises that an accident recently occurred with an EC135 helicopter in Japan. Preliminary investigation results indicate that the helicopter loss of control was due to the failure of the control rod.

(a) Within 5 hours time-in-service (TIS), inspect the control rod, shown in item 7, Figure 1, of this AD, with the parts identified in parenthesis as follows:

(1) Pull the control rod (7) until it reaches its stop position. Inspect attachment hardware of control rod (7) for a tight fit. Manually inspect for possible relative motion between control rod (7) and yaw actuator (8).

(2) Inspect the locking plate (9) for a tight fit.

(3) Visually inspect the attachment hardware between control rod (7) and yaw actuator (8) for play or thread exposure. If play or thread exposure is found, before further flight, replace the control rod with an airworthy control rod.

(b) Inspect the ball pivot as shown in item 11, Figure 1, of this AD by removing the tail rotor drive shaft fairing and inspecting for a loose bearing or play. If a loose bearing or play is found, before further flight, replace the ball pivot with an airworthy ball pivot.
