14 CFR Part 39

[Docket No. FAA-2008-0071; Directorate Identifier 2006-SW-27-AD]

Airworthiness Directives; Bell Helicopter Textron Canada Model 222, 222B, 222U, 230, and 430 Helicopters

ACTION: Notice of proposed rulemaking (NPRM).

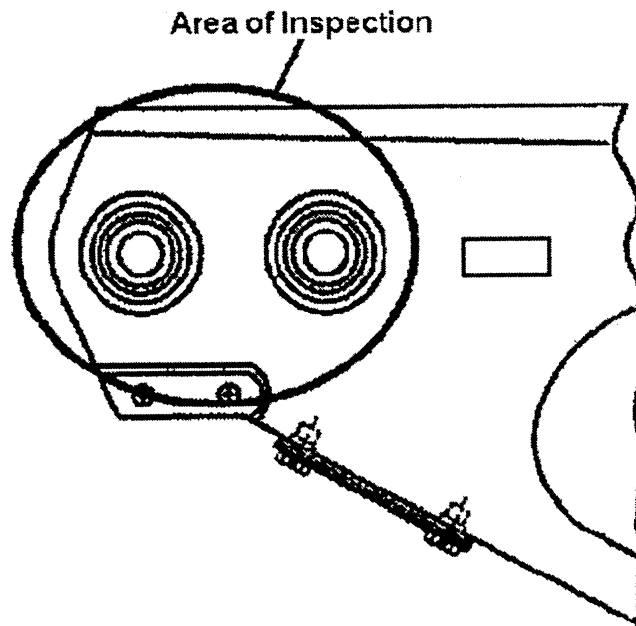
(a) Within 3 hours time-in-service (TIS), unless accomplished previously, and thereafter at intervals not to exceed 3 hours TIS, clean and visually check both sides of each blade for a crack in the paint in the areas shown in Figure 1 of this AD. An owner/operator (pilot), holding at least a private pilot certificate, may perform this visual check and must enter compliance with this paragraph into the helicopter maintenance records by following 14 CFR sections 43.11 and 91.417(a)(2)(v).

P/N 222-016-001 – all dash numbers

Blade Inspection Area

(c) Within the next 50 hours TIS, unless accomplished previously, and thereafter at intervals not to exceed 50 hours TIS, clean the blade by wiping down both surfaces of each blade in the inspection area depicted in Figure 1 of this AD using aliphatic naphtha (C-305) or detergent (C-318) or an equivalent. Using a 10X or higher power magnifying glass, visually inspect both sides of the blade in the areas depicted in Figure 1 of this AD.

(1) If a crack is found, even if only in the paint, before further flight, remove the blade from the helicopter and proceed with the following:

(2) Remove the paint on the blade down to the bare metal in the area of the suspected crack by using plastic media blasting (PMB) or a nylon web abrasive

(3) Using a 10X or higher power magnifying glass, inspect the blade for a crack.

(i) If a crack is found, replace the blade with an airworthy blade before further flight.

(ii) If no crack is found in the blade surface, refinish the blade by applying one coat of epoxy polyamide primer, MIL-P-23377 or MIL-P-85582, so that the primer overlaps the existing coats just beyond the abraded area. Let the area dry for 30 minutes to 1 hour. Then, apply one sealer coat of polyurethane, MILC85285 TYI CL2, color number 27925 (semi-gloss white), per Fed. Std. 595. Reinstall the blade.

(d) On or before 90 days after the effective date of this AD, replace any affected serial-numbered blade with an airworthy blade that has a S/N that is not subject to, or has been excepted from, the requirements of this AD. Installing an airworthy blade that is not subject to the requirements of this AD,
