[Docket No. FAA-2008-1311; Directorate Identifier 2007-NE-48-AD]

#### Airworthiness Directives; Honeywell International Inc., T5313 and T5317 Series Turboshift Engines

**ACTION:** Notice of proposed rulemaking (NPRM).

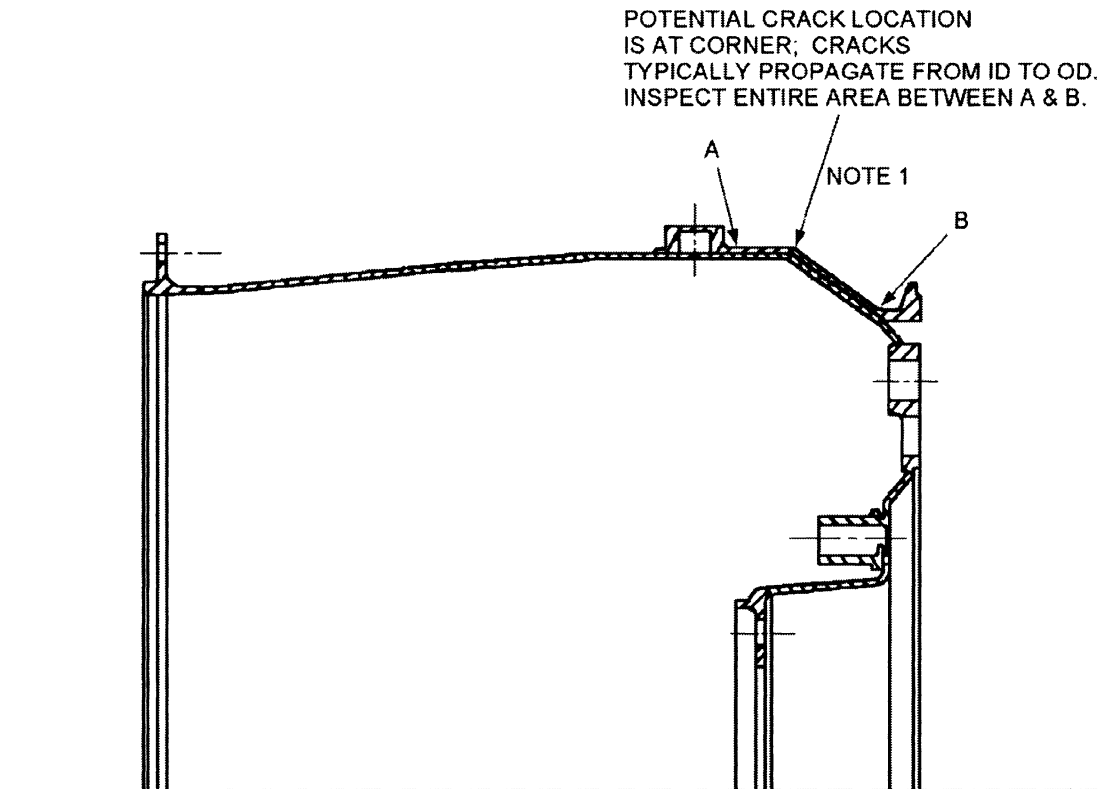
Figure 1. Visual Inspection of CCH

We have received reports of eight instances of cracks developing in CCHs, part numbers (P/Ns) 1-130-610-05 and 1-130-610-12. Two of the instances resulted in an engine shutdown during flight. The cracks developed between the seam welds on the rear outer flange, in the angled bend area, forward of the fuel manifold mounting flange. Fatigue cracking in the "doubler detail" develops from the inside of the CCH, typically starting from corrosion pitting. There have been several instances in which a crack was found during maintenance activities or preflight inspection of the engine. In one instance, with a previously weld-repaired CCH (assumed to be a repair of a crack), additional fatigue cracks grew sufficiently to result in a loss of CCH integrity, subsequent in-flight engine shutdown, and significant airframe damage. A previously weld-repaired CCH has a high potential for additional cracks that might or might not be visible. This condition, if not corrected, could result in rupture of the CCH

NOTE 1. NO WELD REPAIRS ALLOWED IN THIS AREA.

(f) For CCH, P/N 1-130-610-05 and 1-130-610-12, within 50 hours time-in-service (TIS) after the effective date of this AD, inspect the area between points A and B around the entire housing circumference in Figure 1 of this AD for weld repairs and cracks.

(1) If you find any cracks, replace the CCH before further flight. Honeywell International Inc. Alert Service Bulletin (ASB) T53-A0142, Revision 1, dated September 14, 2006, contains additional information on replacing the CCH.

(2) If you find any weld repairs, replace the CCH within 100 hours TIS after the visual inspection. Honeywell International Inc. ASB T53-A0142, Revision 1, dated September 14, 2006, contains additional information on replacing the CCH.

(g) For CCH, P/N 1-130-610-05 and 1-130-610-12, inspect the area between points A and B around the entire housing circumference in Figure 1 of this AD for cracks within 50 hours time-since-last inspection. Honeywell International Inc. Standard Practices Manual 70-20-02, SP 1302, contains additional information on visual inspection.

(h) If you find any cracks, replace the CCH before further flight. Honeywell International Inc. ASB T53-A0142, Revision 1, dated September 14, 2006, contains additional information on replacing the CCH.
