[Docket No. FAA-2009-0484; Directorate Identifier 2008-SW-44-AD; Amendment 39-15924; AD 2009-12-01]

Airworthiness Directives; Bell Helicopter Textron, Inc. Model 47, 47B, 47B3, 47D, 47D1, 47E, 47G, 47G-2, 47G-2A, 47G-2A-1, 47G-3, 47G-3B, 47G-3B-1, 47G-3B-2, 47G-3B-2A, 47G-4, 47G-4A, 47G-5, 47G-5A, 47H-1, 47J, 47J-2, 47J-2A, and 47K Helicopters

ACTION: Final rule; request for comments.

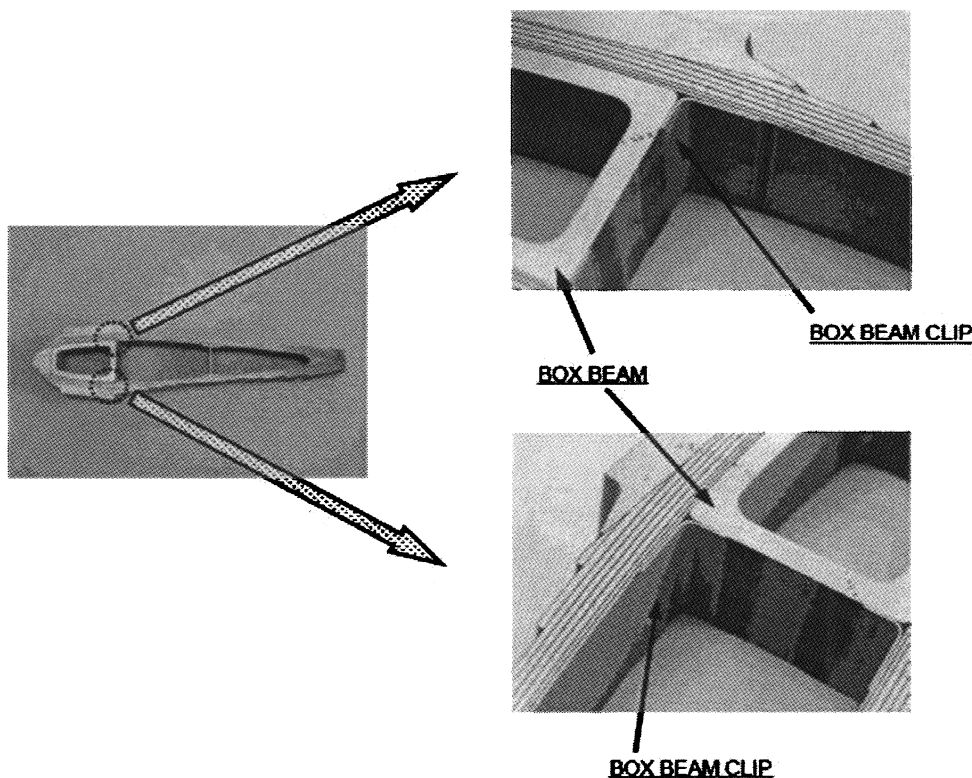
To prevent a main rotor blade spar crack as a result of an incorrectly installed main rotor blade box beam clip (clip), loss of a main rotor blade, and subsequent loss of control of the helicopter, do the following:

Figure 1 - Correct Installation of Clip for Box Beam

(a) Within 10 hours time-in-service (TIS), visually inspect the entire length of each upper and lower clip of each main rotor blade from the main rotor blade tip to the root by following Part II of the Accomplishment Instructions, paragraphs 1. through 8., of Bell Helicopter Textron, Inc. Alert Service Bulletin No. 47-08-25, dated May 26, 2008 (ASB) and referring to the depictions in Figures 1 and 2 of the ASB and Figure 1 of this AD for correct installation.

(b) Before further flight, if you find a main rotor blade with an incorrectly installed clip, replace that unairworthy main rotor blade with an airworthy main rotor blade that has a clip that is installed correctly.
