[Docket No. FAA-2008-1311; Directorate Identifier 2007-NE-48-AD; Amendment 39-15976; AD 2009-15-13]

Airworthiness Directives; Honeywell International Inc., T5313 and T5317 Series Turboshift Engines

2009-15-13 Honeywell International Inc. (Formerly AlliedSignal and Textron-Lycoming): Amendment 39-15976. Docket No. FAA-2008-1311; Directorate Identifier 2007-NE-48-AD.

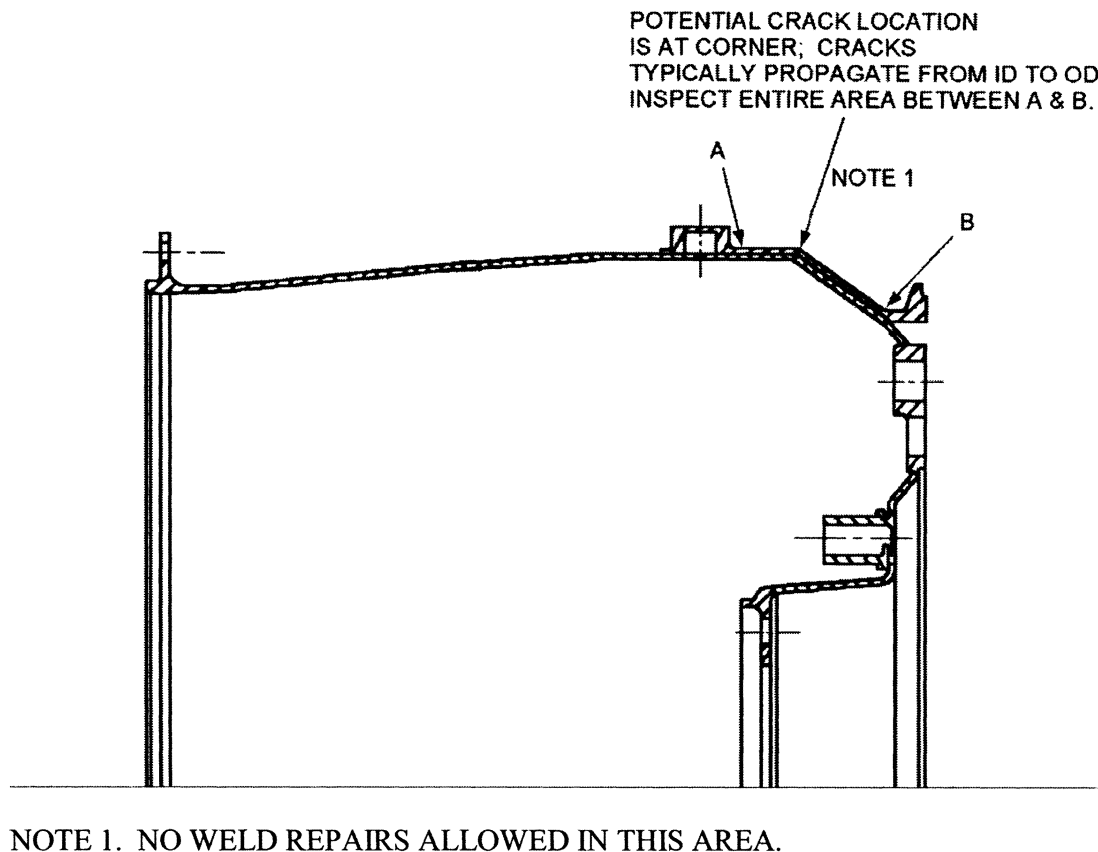
Figure 1. Visual Inspection of CCH

(d) This AD results from eight instances of cracks in CCHs. Two of the instances resulted in an engine shutdown during flight. We are issuing this AD to detect cracks in the CCH, which could result in rupture of the CCH, leading to loss of engine power and damage to the helicopter.

(f) For CCH, P/N 1-130-610-05 and 1-130-610-12, within 50 hours time-in-service (TIS) after the effective date of this AD, inspect the area between points A and B around the entire housing circumference in Figure 1 of this AD for weld repairs and cracks.

(g) For CCH, P/N 1-130-610-05 and 1-130-610-12, inspect the area between points A and B around the entire housing circumference in Figure 1 of this AD for cracks within every 50 hours time-since-last inspection. Honeywell International Inc. Standard Practices Manual 70-20-02, SP 1302, contains additional guidance on visual inspection.

(1) If you find any cracks, replace the CCH before further flight. Honeywell International Inc. Alert Service Bulletin (ASB) T53-A0142, Revision 1, dated September 14, 2006, contains additional guidance on replacing the CCH.

(2) If you find any weld repairs, replace the CCH within 100 hours TIS after the visual inspection. Honeywell International Inc. ASB T53-A0142, Revision 1, dated September 14, 2006, contains additional guidance on replacing the CCH.

(h) If you find any cracks, replace the CCH before further flight. Honeywell International Inc. ASB T53-A0142, Revision 1, dated September 14, 2006, contains additional guidance on replacing the CCH.
