[Docket No. FAA-2010-0342; Directorate Identifier 2002-NE-08-AD]

Airworthiness Directives; Bombardier-Rotax GmbH Type 912 F, 912 S, and 914 F Series Reciprocating Engines

ACTION: Notice of proposed rulemaking (NPRM).

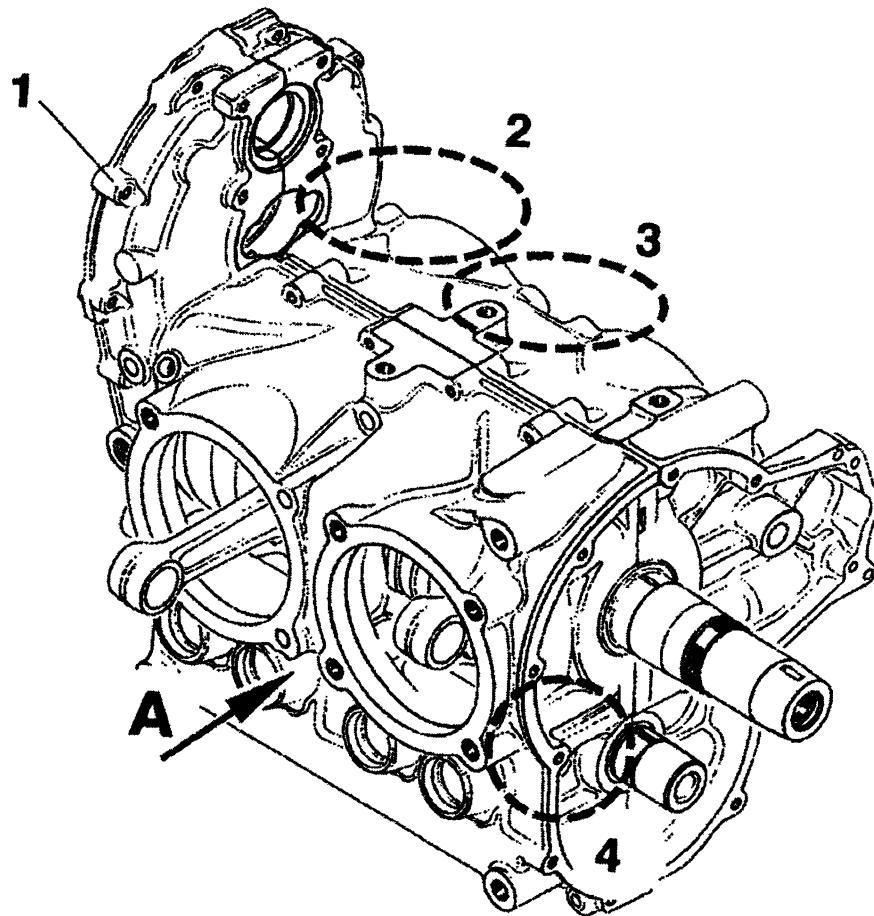
Figure 1. Engine Crankcase Inspection Areas

(1) Inspect the engine crankcase (item 1, Figure 1 of this AD) for cracks, especially in the area of cylinder 1 upper side (item 2), between cylinder 1 and 3 upper side (item 3), cylinder 4 lower-right side (item 4) and detailed inspection in the area identified in Figure 2 (item 5) of this AD. Information concerning this inspection can be found in Bombardier-Rotax Mandatory Service Bulletins No. SB–912–029, Revision 3, dated July 11, 2006 and No. SB–914–018, Revision 3, dated July 11, 2006.

(2) Cracks in crankcases of engines with a ROTAX cooling air baffle may not be easily visible, and oil leaks may be an indication of cracks. Visually inspect for oil leaks in areas of (item 2, Figure 1 of this AD) and (item 3).

(4) If the engine crankcase is cracked, replace the engine before further flight.

(h) Visually inspect the engine crankcase (item 1, Figure 1 of this AD) for cracks at each 100-hour, annual, or progressive inspection, or within 110 hours TIS since last inspection, whichever occurs first, in accordance with paragraphs (g)(1) through (g)(4) of this AD.

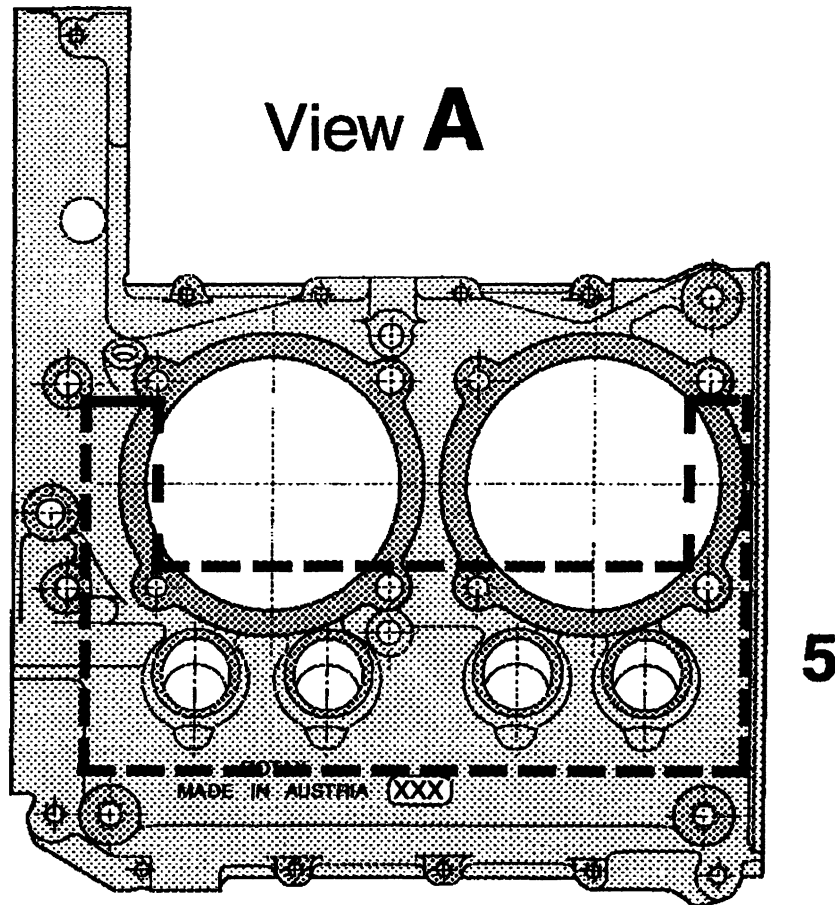
Figure 2. Engine Crankcase Inspection Areas – View A

(f) Determine if your crankcase is affected by looking at the S/N in the area indicated by XXX, following “Made in Austria,” as shown on Figure 2 of this AD. The marking is on both crankcase halves.

(k) Installing a crankcase that has a S/N above 27811 terminates the inspection requirements of paragraphs (g)(1) through (g)(4) and (h) of this AD.
