[Docket No. FAA-2010-0564; Directorate Identifier 2010-SW-13-AD]

#### Airworthiness Directives; Arrow Falcon Exporters, Inc. (Previously Utah State University), et al., Model HH-1K, TH-1F, TH-1L, UH-1A, UH-1B, UH-1E, UH-1F, UH-1H, UH-1L, and UH-1P Helicopters; and Southwest Florida Aviation Model UH-1B (SW204 and SW204HP) and UH-1H (SW205) Helicopters

**ACTION:** Notice of proposed rulemaking (NPRM).

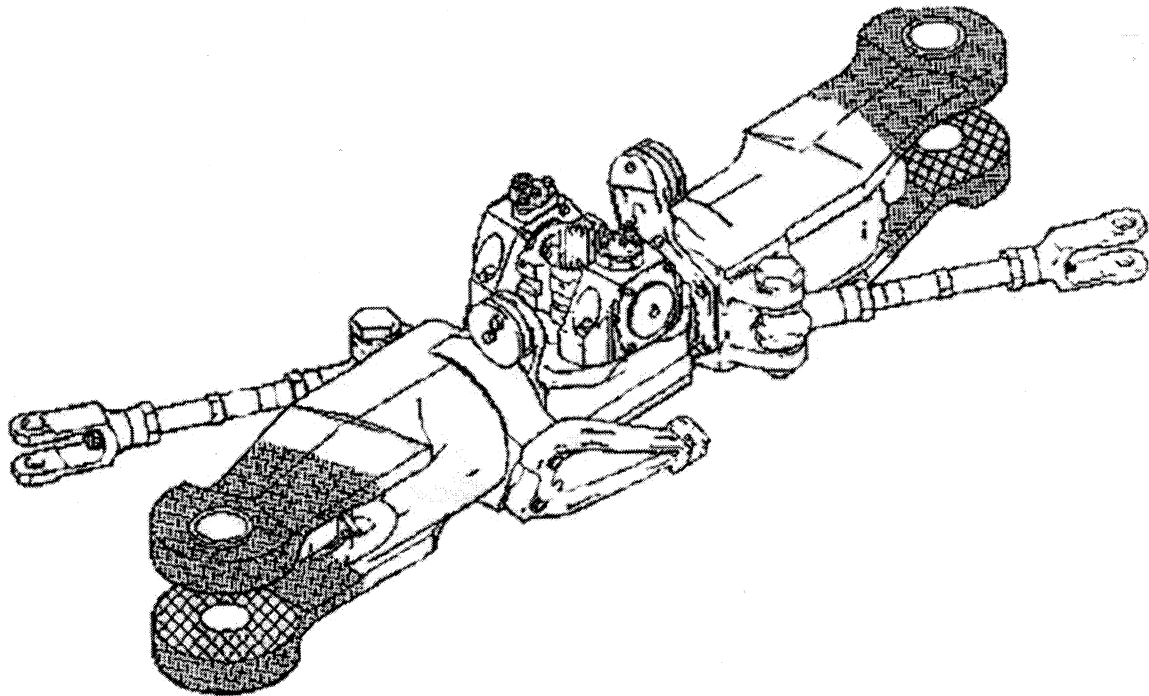
Figure 1. Inspection of Main Rotor Hub Grip Tangs

(2) Using a 10-power or higher magnifying glass, visually inspect the exposed surfaces of the upper and lower tangs of each grip for a crack. Pay particular attention to the lower surface of each lower grip tang from the main rotor blade bolt-bushing flange to the leading and trailing edge of each grip tang. See Figure 1 of this AD.

INSPECT BUFFER PAD FOR DELAMINATION (IF INSTALLED)

AREA TO BE INSPECTED UPPER AND LOWER TANGS ALL EXPOSED SURFACES

- (1) Remove each main rotor blade, and
- (2) Inspect each grip buffer pad on the inner surfaces of each grip tang for delamination (see Figure 1 of this AD). If there is any delamination, remove the buffer pad and inspect the grip surface for corrosion or other damage.

- (1) Replace any cracked grip with an airworthy grip.
- (2) Replace any grip with any corrosion or other damage with an airworthy grip, or repair the grip if the corrosion or other damage is within the maximum repair limitations found in the applicable Component and Repair Overhaul Manual.
