[Docket No. FAA-2010-1013; Directorate Identifier 2010-CE-048-AD; Amendment 39-16478; AD 2010-21-18]

Airworthiness Directives; Cessna Aircraft Company (Cessna) Models 336, 337, 337A (USAF 02B), 337B, M337B (USAF 02A), T337B, 337C, T337C, 337D, T337D, 337E, T337E, 337F, T337F, 337G, T337G, 337H, P337H, T337H, T337H-SP, F337E, FT337E, F337F, FT337F, F337G, FT337GP, F337H, and FT337HP Airplanes

2010–21–18 Cessna Aircraft Company:
Amendment 39–16478; Docket No. FAA–2010–1013; Directorate Identifier 2010–CE–048–AD.

Appendix 1 to AD 2010-21-18—General and Focused Inspection Procedures

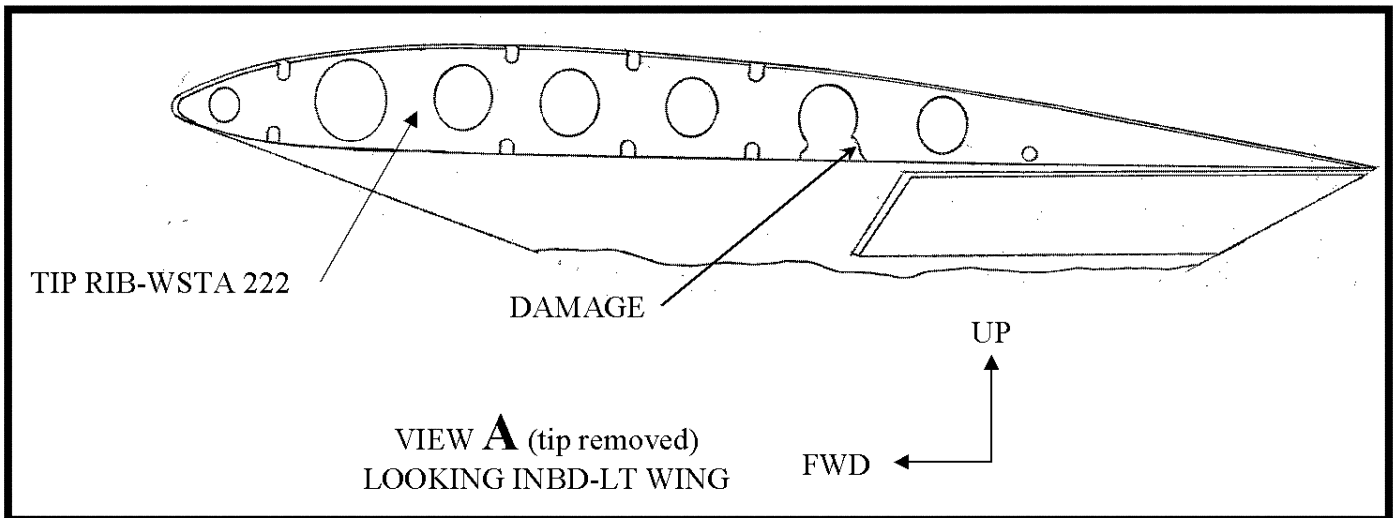
Figure 2

(11) Inspect rib at WSTA 222 for damage. Trimming of the rib may have been done to allow installation of fuel lines (*See View A, Figure 2*). Repair in accordance with AC 43.13-1B, Chapter 4, paragraph 4-58(g) and Figure 4-14, or by using another FAA-approved method that restores equivalent strength of the wing rib.

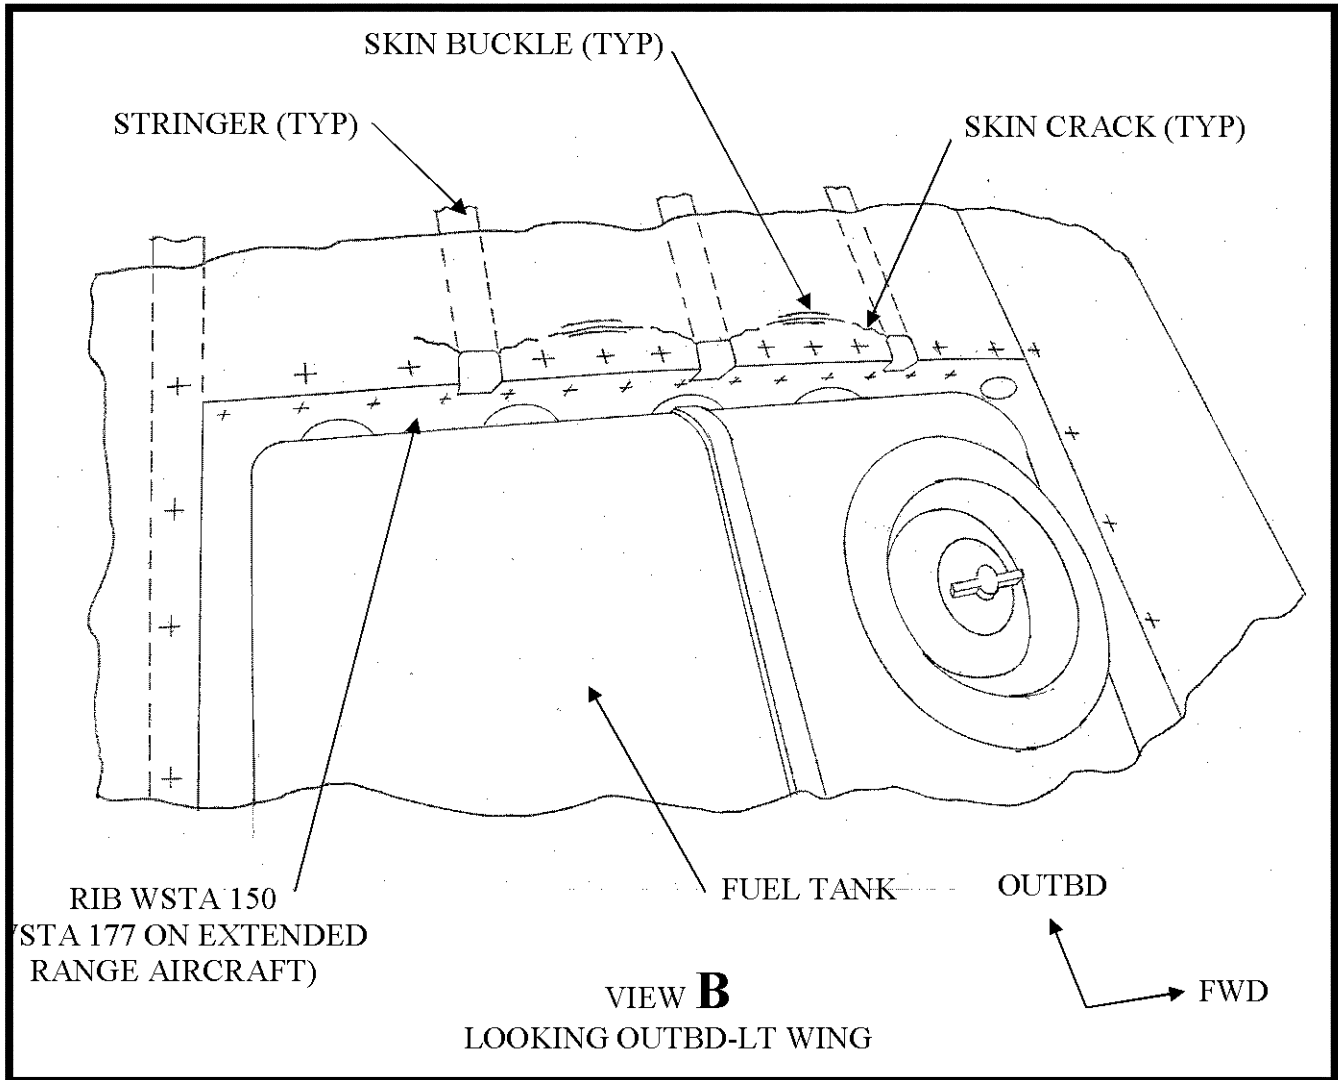
Figure 3

(1) Wrinkles in upper wing skins, from the outboard edge on the fuel tank access covers (WSTA 150 or 177) to the WSTA 222 (*See View B, Figure 3*).

(3) Cracking of the upper wing skins. Pay particular attention to any wrinkles, the radius between stiffeners at WSTA 150 (under fuel tank covers), and unreinforced access holes (*See View B, Figure 3*).

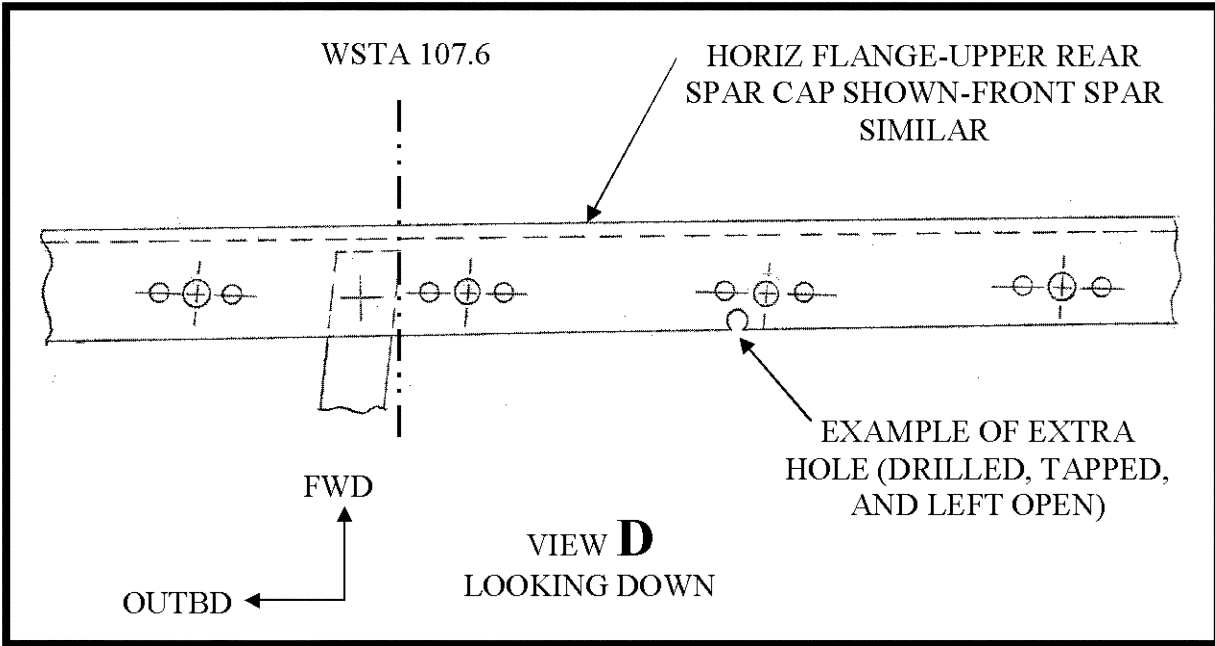
Figure 5

(3) Inspect the upper spar cap horizontal flanges for open holes (*See View D, Figure 5*).
