DEPARTMENT OF TRANSPORTATION

[Docket No. FAA-2010-1101; Directorate Identifier 2009-CE-013-AD]

Airworthiness Directives; Cessna Aircraft Company Models 150, 152, 170, 172, 175, 177, 180, 182, 185, 188, 190, 195, 206, 207, 210, T303, 336, and 337 Airplanes

ACTION: Notice of proposed rulemaking (NPRM).

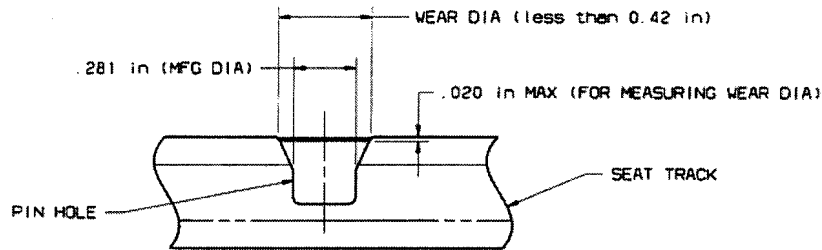
Figure 1. Diameter of seat pin locking engagement hole

(4) Inspect the diameter of each seat locking pin engagement hole in the pilot and copilot seat rails for excessive wear. Due to wear on the rail surface at the hole opening, we allow this measurement 0.020 of an inch

below the surface of the rail. You must take this measurement somewhere between the surface of the rail or no more than 0.020 of an inch below the surface of the rail.

(i) If the diameter of any of the holes is 0.42 of an inch or more (see figure 1), before further flight, replace the rail.

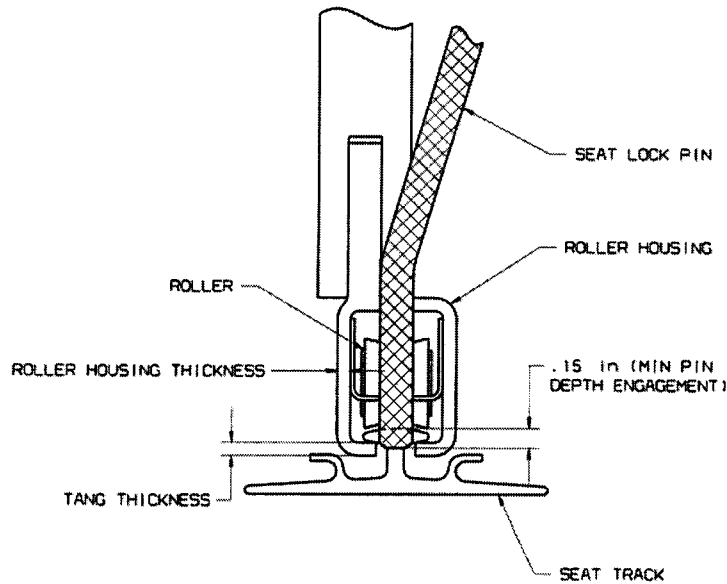
Figure 2. Seat locking pin depth engagement

(2) Lift up the forward edge of each seat to eliminate vertical play of the seat locking pin

in the engagement hole, and from this position, inspect the depth of engagement of each seat locking pin (see figure 2). If the rail is worn, this depth is measured from the worn surface, not the manufactured surface.

(i) If engagement of any of the seat locking pins measures less than 0.15 of an inch, before further flight, replace or repair any seat components necessary to achieve a seat pin engagement of a minimum of 0.15 of an inch.

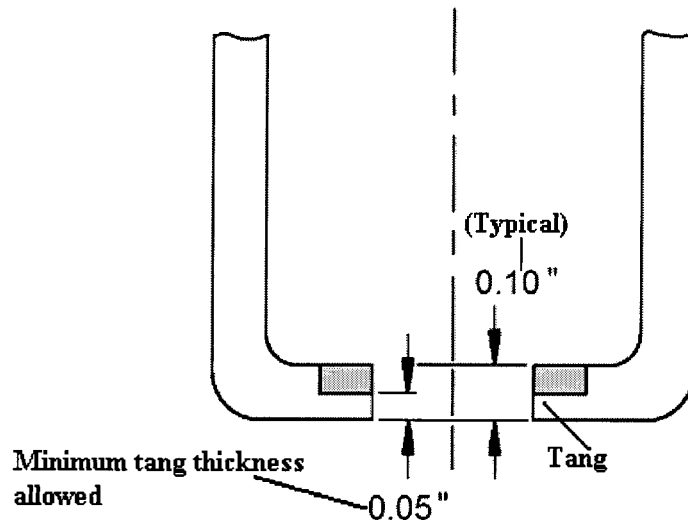
Figure 3. Closeup of seat roller housing and tang thickness

(6) Inspect the thickness of the tang (see figure 2 and figure 3). Due to wear of the tang chafing against the seat rail, measure the tang thickness where the tang inner edges contact the seat rail.

(i) If the tang thickness measures less than 0.05 of an inch, before further flight replace the roller housing.

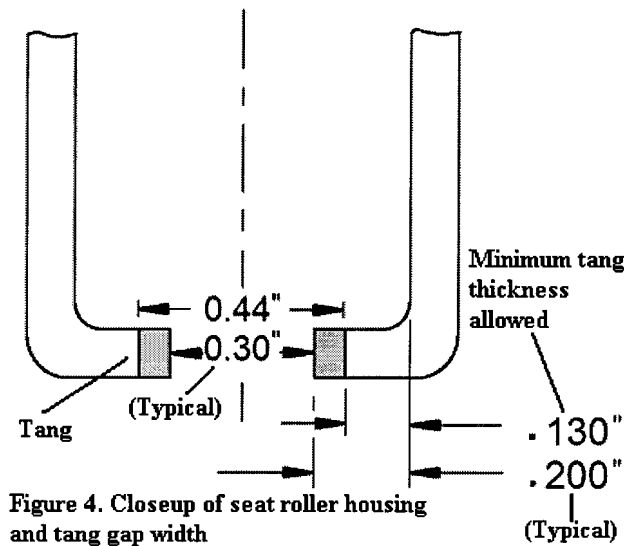
Figure 4. Closeup of seat roller housing and tang gap width

(7) Inspect the inner edges of the tangs. Due to wear or deformation of the tangs, measure the distance from one tang inner

edge to the other tang inner edge (see figure 4).

(i) The maximum distance allowed between tang edges is 0.44 inches. If the

distance between tang inner edges measures 0.44 of an inch or more, before further flight, replace the roller housing.

(ii) The minimum measurement allowed for the remaining tang is 0.130 inches remaining on either of the tangs, from the inner edge of the tang to the bend of the roller housing. If the measurement is less than 0.130 inches on either of the tangs, before further flight, replace the roller housing.
