[Docket No. FAA-2011-0054; Directorate Identifier 2010-CE-070-AD; Amendment 39-16582; AD 2011-01-53]

Airworthiness Directives; PIAGGIO AERO INDUSTRIES S.p.A Model PIAGGIO P-180 Airplanes

Appendix 1 to AD 2011-01-53

Functional Test of the Fuselage Drain Holes

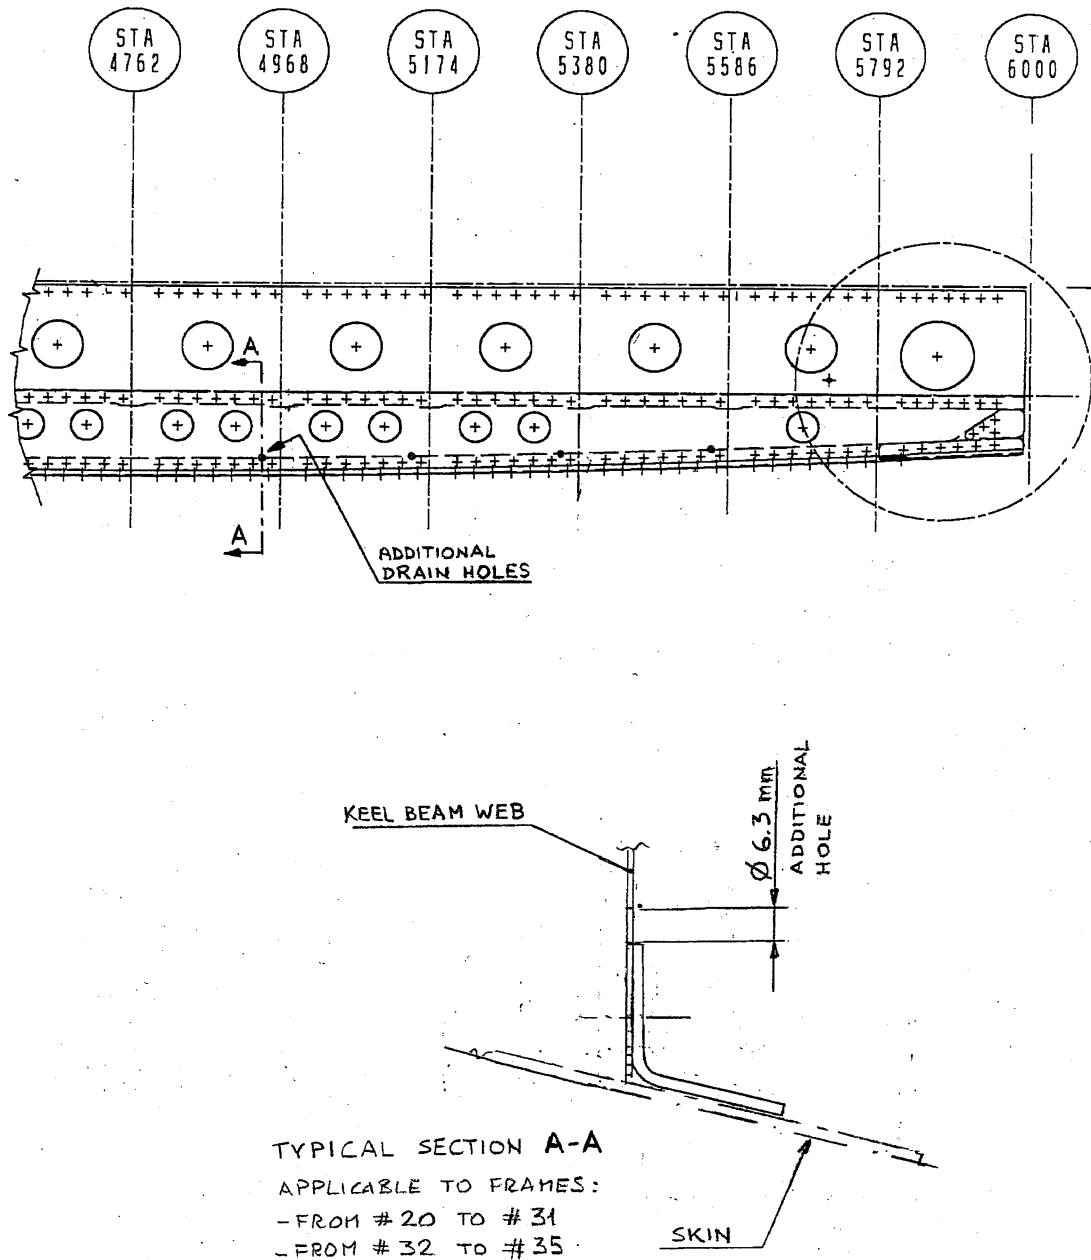
Figure 1. Additional drain holes on keel beam webs

ii. If water is found in excess of item above (4-c-i), do step 5.

5. Add 6.3 mm draining holes as per attached figure 1 (additional drain holes on keel beam webs) connecting the lateral bays to the center ones or, as alternative, apply Piaggio Aero Industries Service Bulletin 80-0291. Then proceed with step 6.
