## DEPARTMENT OF TRANSPORTATION

### Federal Aviation Administration

[Docket No. FAA-2007-28661; Directorate Identifier 2007-NM-013-AD]

#### Airworthiness Directives; The Boeing Company Model 737-600, -700, -700C, -800, and -900 Series Airplanes

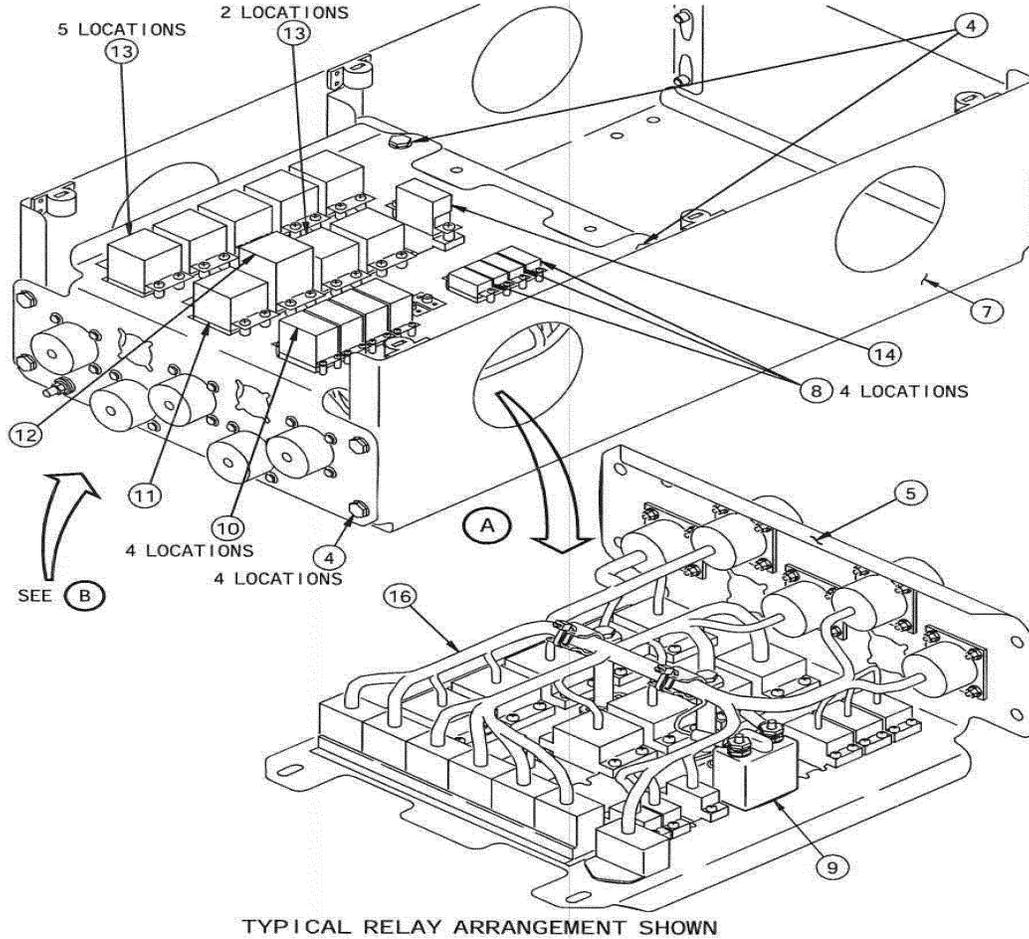
- Sheet 2 of 4 of Figure 11 of Boeing Alert Service Bulletin 737-28A1206, Revision 2, dated May 21, 2009, was inadvertently replaced with Sheet 2 of 4 of Figure 11 from Boeing Alert Service Bulletin 737-28A1206, dated January 11, 2006. That figure was corrected in Boeing Alert Service Bulletin 737-28A1206, Revision 1, dated January 30,

2008, and did not need to be changed in Boeing Alert Service Bulletin 737–28A1206, Revision 2, dated May 21, 2009. We have added Figure 1 in this supplemental NPRM to provide the correct Sheet 2 of 4 of Figure 11.
