[Docket No. FAA–2009–1253; Directorate Identifier 2009–NM–080–AD; Amendment 39–16629; AD 2011–06–05]

**Airworthiness Directives; The Boeing Company Model 737–600, –700, –700C, –800, –900, and –900ER Series Airplanes**

#### 2011-06-05 The Boeing Company:

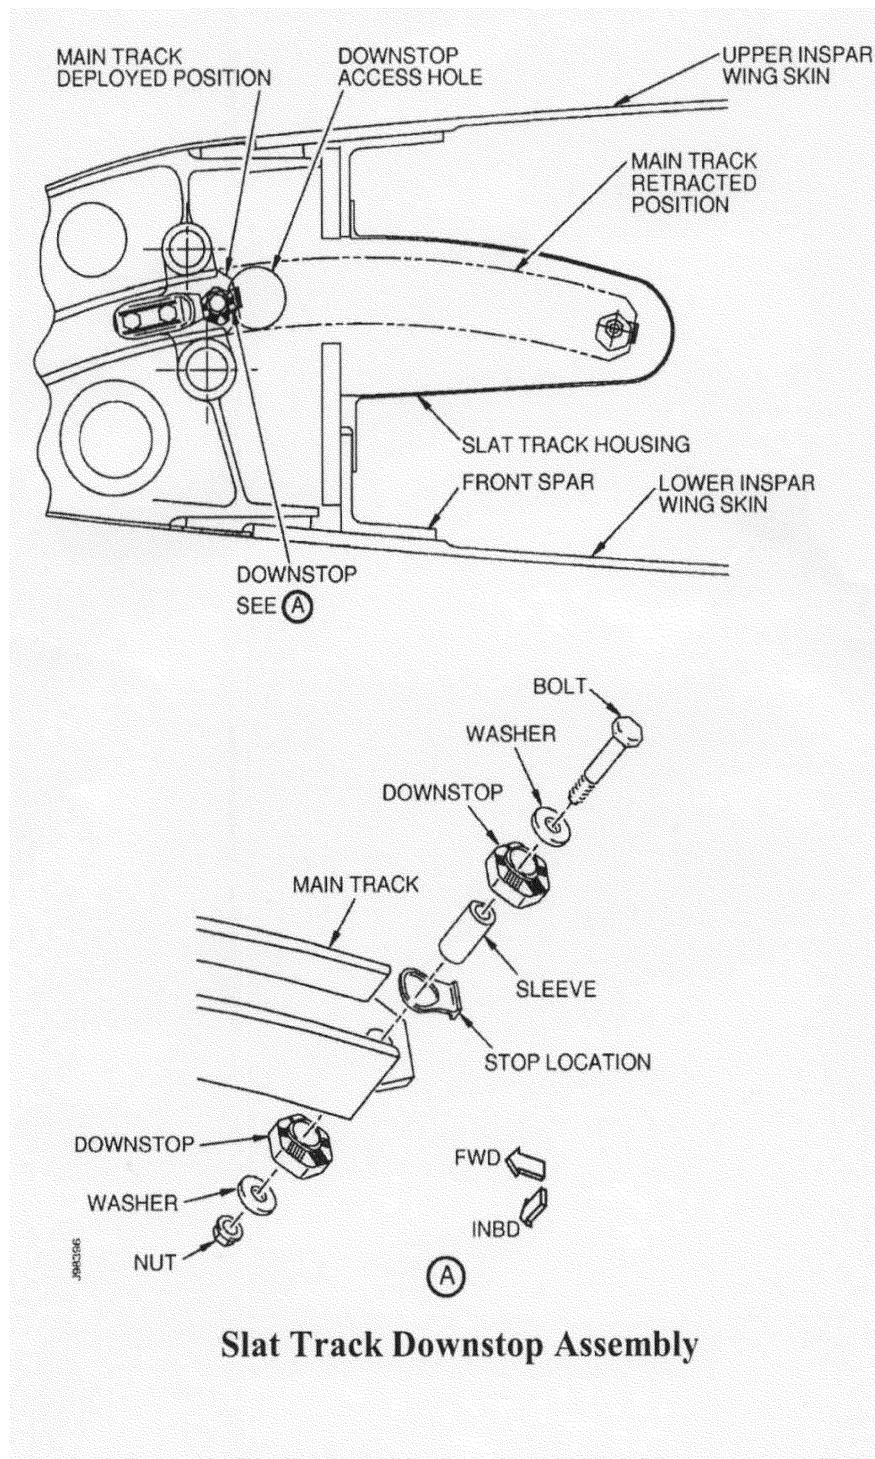
**Figure 1**

- (g) Within 10 days after September 26, 2007 (the effective date of AD 2007-18-52): Do a detailed inspection or a borescope inspection of each main slat track downstop assembly to verify proper installation of the slat track hardware (*i.e.*, the bolt, washers, downstops, stop location, and nut shown in Figure 1 of Boeing Service Letter 737-SL-57-084-B, dated July 10, 2007, and in this AD). Proper installation of the sleeve need not be confirmed, and the stop location part may be installed on either the inboard or the outboard side of the slat track. If any part is missing or is installed improperly, before further flight, install a new or serviceable part using a method approved in accordance with the procedures specified in paragraph (j) of this AD; and do a detailed inspection of the inside of the slat can for foreign object debris (FOD) and damage. Before further flight, remove any FOD found and repair any damage found using a method approved in accordance with the procedures specified in paragraph (j) of this AD. Verify proper installation; install a new or serviceable part; and inspect for damage and FOD, and remove FOD and repair damage; in accordance with a method by approved by the Manager, Seattle Aircraft Certification Office, FAA; or in accordance with Boeing Multi Operator Message Number 1-523812011-1, issued August 25, 2007, or 1-527463441-1, issued August 28, 2007. Repeat the actions required by paragraph (g) of this AD thereafter at intervals not to exceed 3,000 flight cycles.

- (h) Within 24 days after receipt of emergency AD 2007-18-51: Apply a torque between 50 to 80 inch-pounds to the nut. The bolt head must be held with the torque applied to the nut.
