[Docket No. FAA-2011-0450; Directorate Identifier 2011-CE-010-AD]

Airworthiness Directives; Cessna Aircraft Company (Cessna) Models 337, 337A (USAF 02B), 337B, 337C, 337D, 337E, T337E, 337F, T337F, 337G, T337G, M337B, F 337E, FT337E, F 337F, FT337F, F 337G, and FT337GP Airplanes

ACTION: Notice of proposed rulemaking (NPRM).

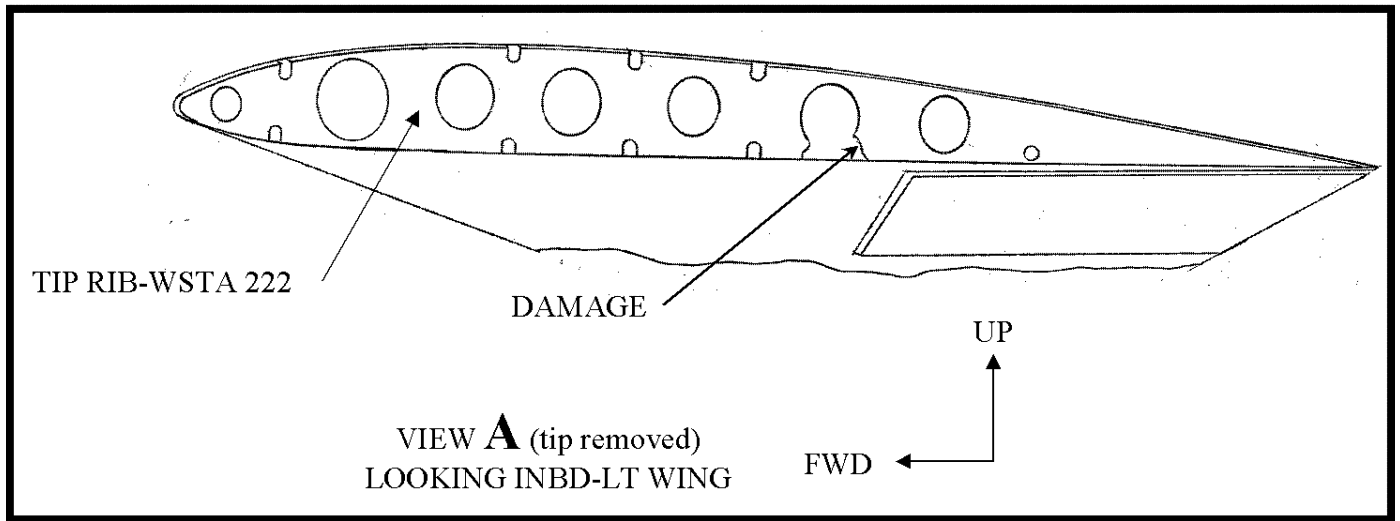
Figure 2

(11) Inspect rib at WSTA 222 for damage. Trimming of the rib may have been done to allow installation of fuel lines (See View A, Figure 2). Repair in accordance with AC 43.13–1B, Chapter 4, paragraph 4–58(g) and Figure 4–14, or by using another FAA-approved method that restores equivalent strength of the wing rib.

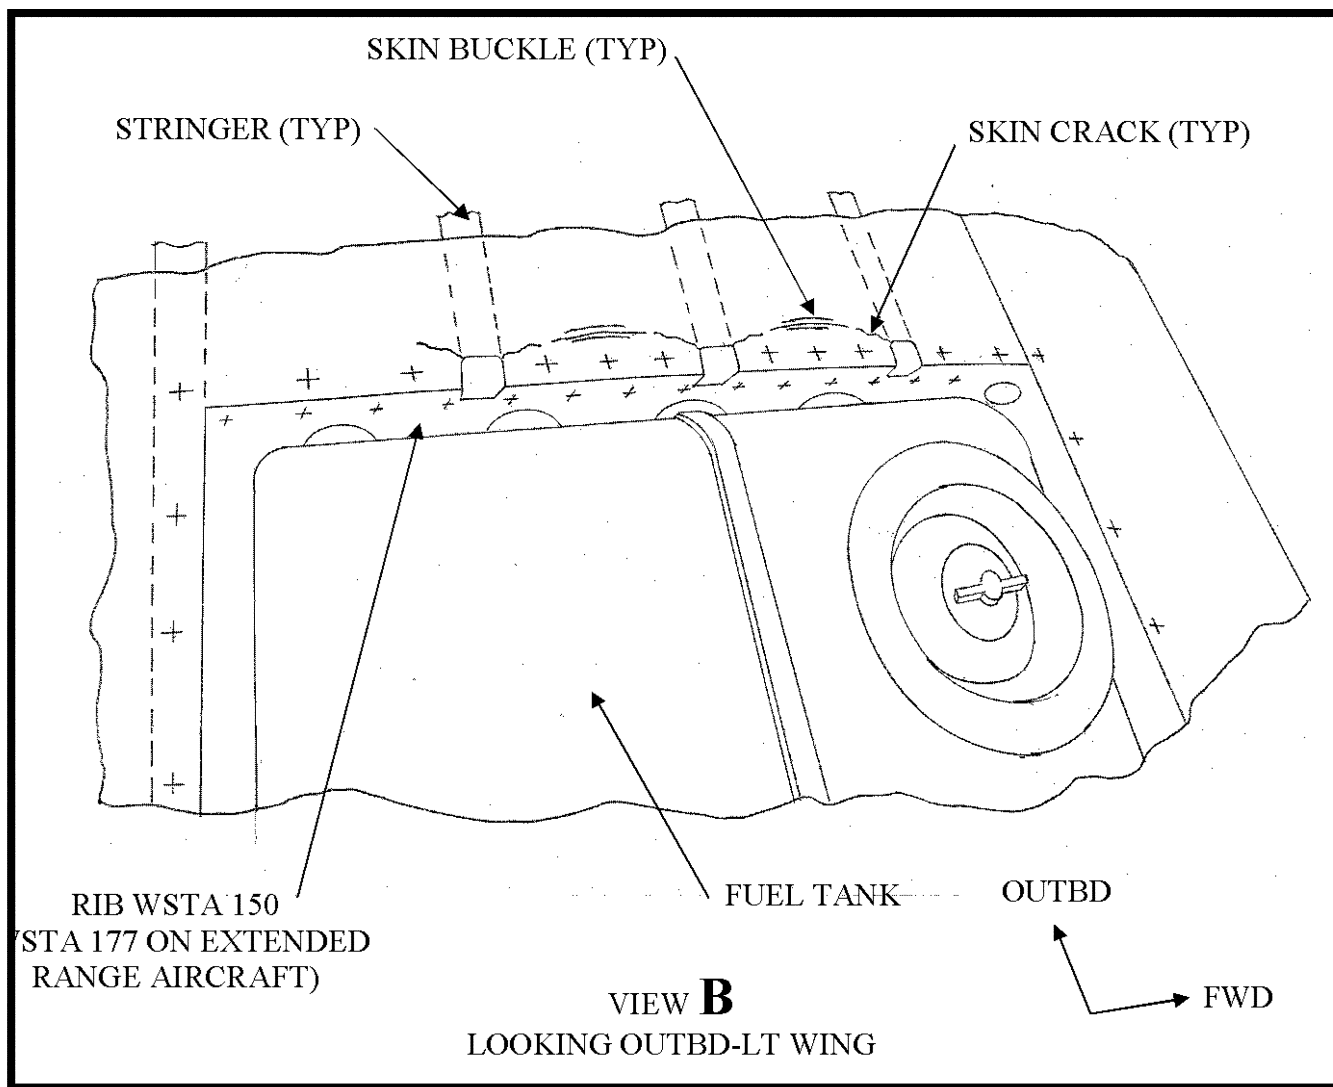
Figure 3

(1) Wrinkles in upper wing skins, from the outboard edge on the fuel tank access covers (WSTA 150 or 177) to the WSTA 222 (See View B, Figure 3).

(3) Cracking of the upper wing skins. Pay particular attention to any wrinkles, the radius between stiffeners at WSTA 150

(under fuel tank covers), and unreinforced access holes (See View B, Figure 3).

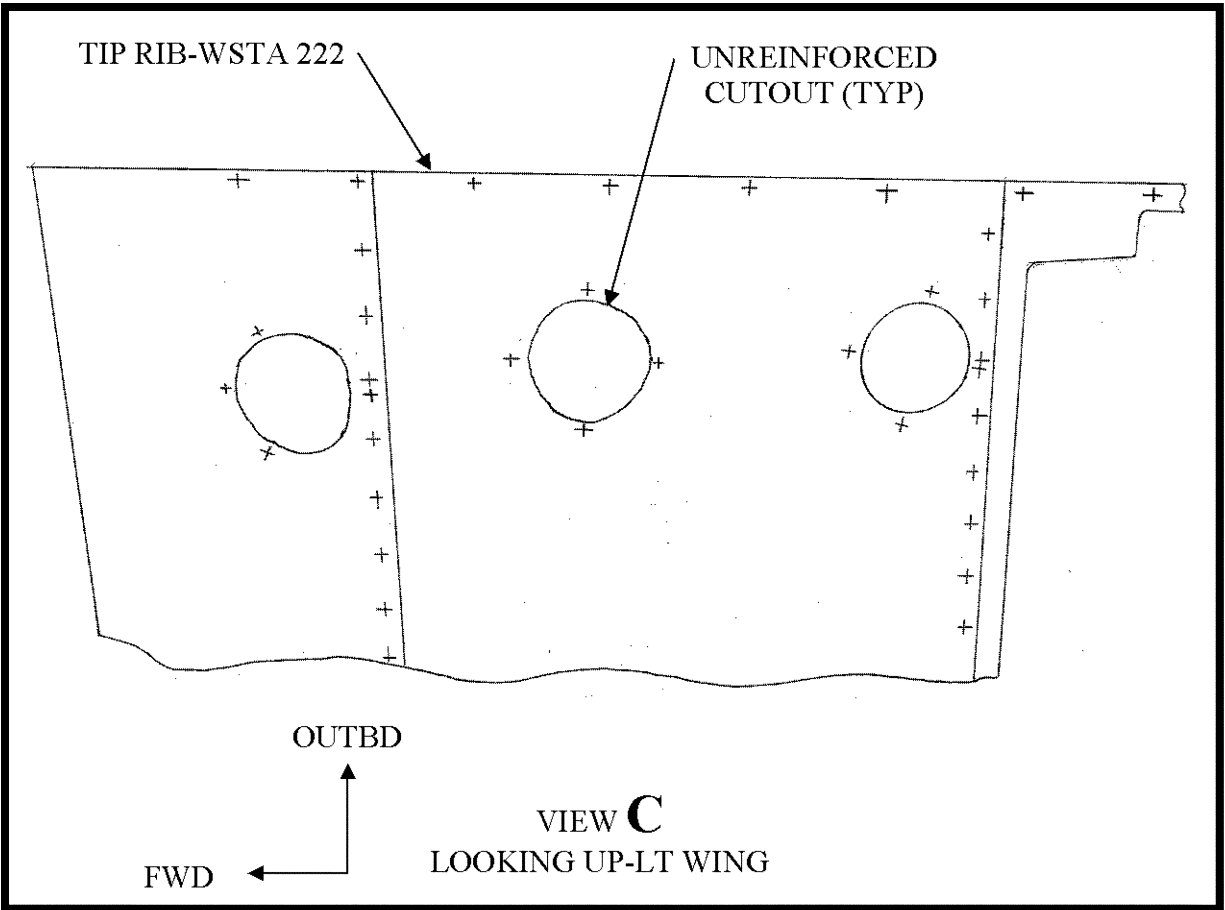
Figure 4

(13) Inspect wing skins for unreinforced cutouts. (See View C, Figure 4).

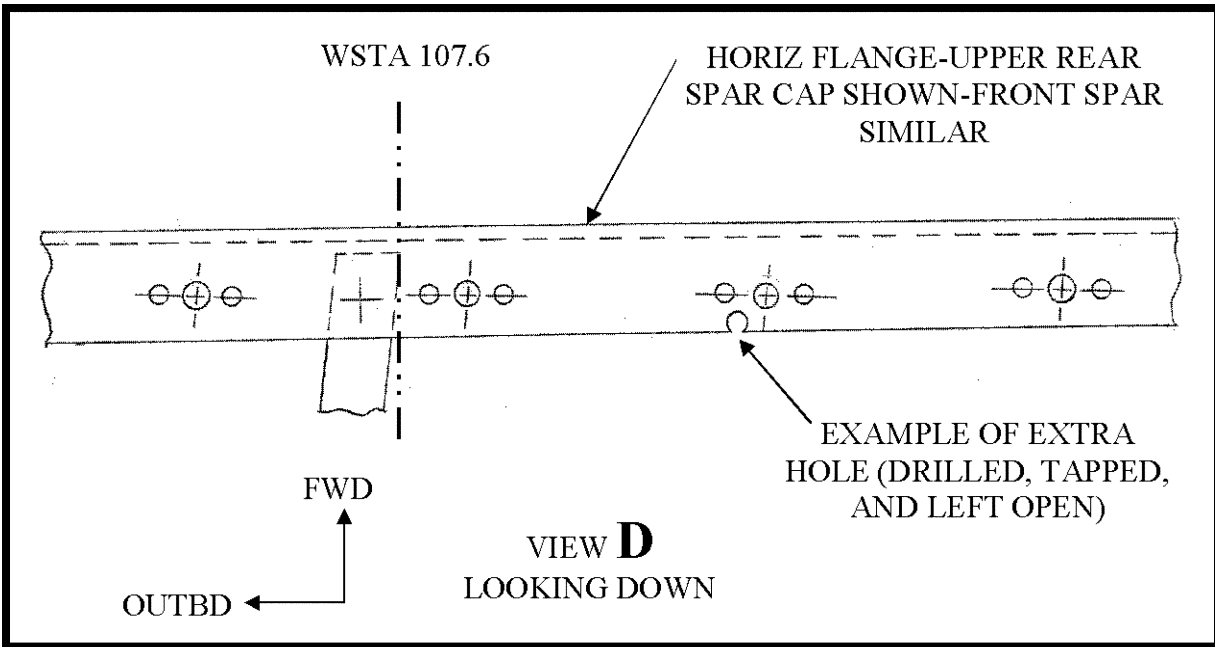
Figure 5

(14) Inspect the upper spar cap horizontal flanges for open holes (See View D, Figure 5).

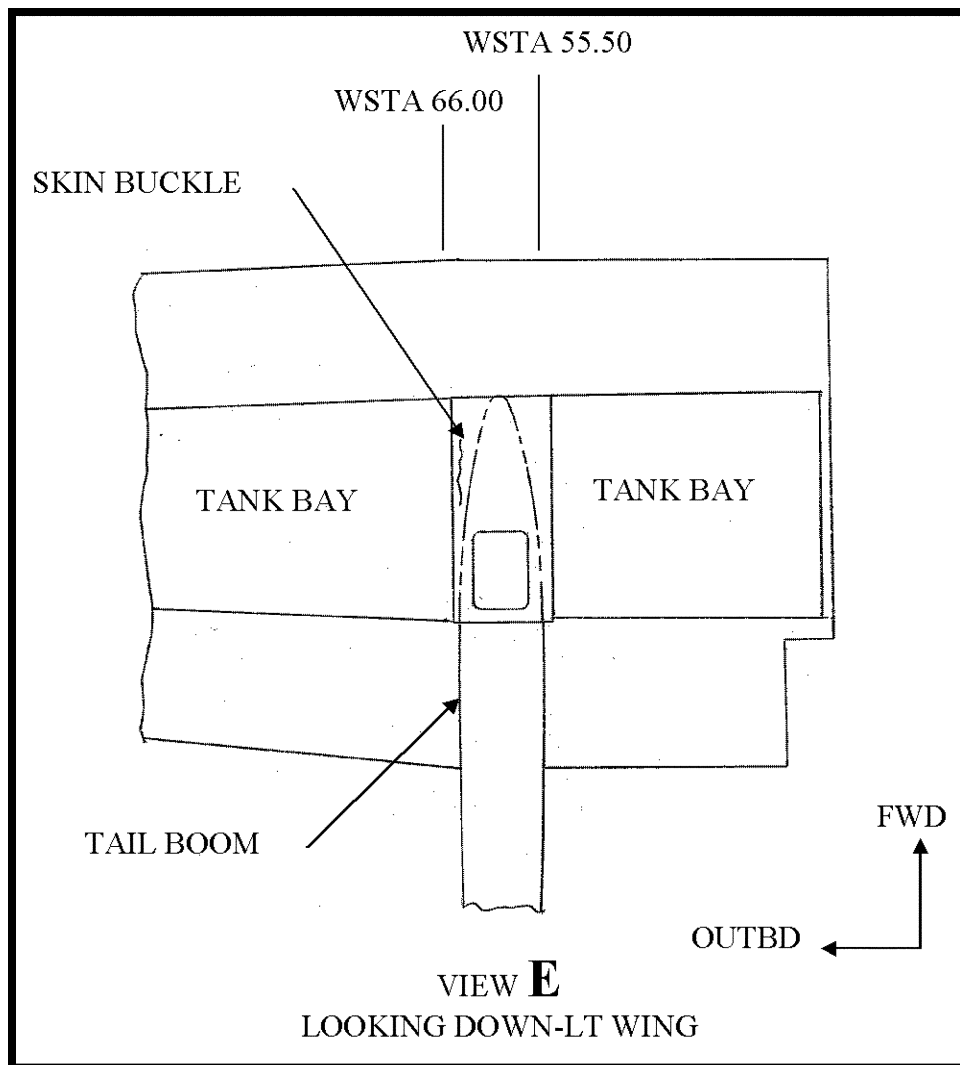
Figure 6

(2) Wrinkles in the upper wing skins from WSTA 55 to 66, adjacent to the booms (See View E, Figure 6).

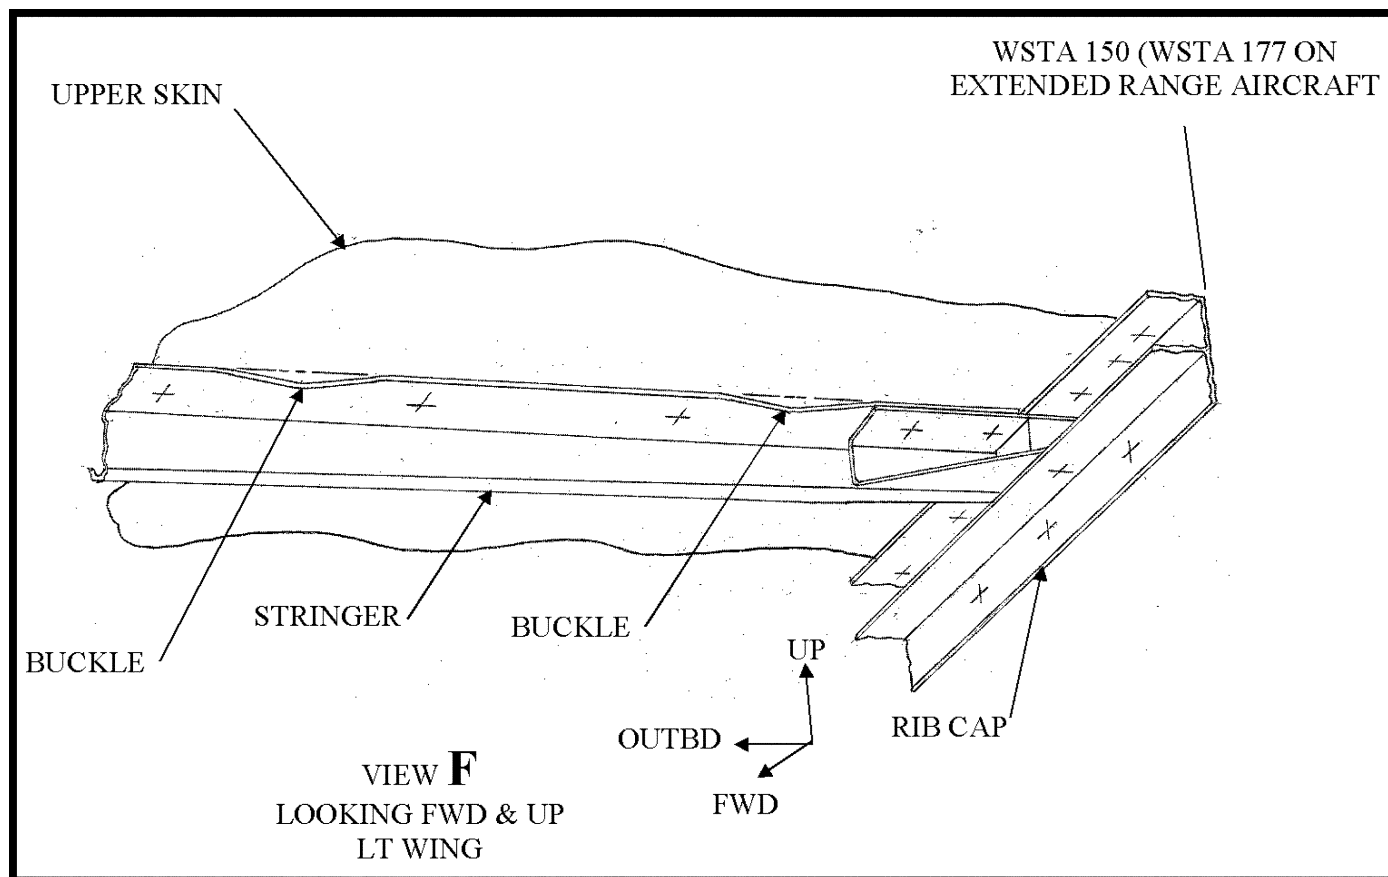
Figure 7

(10) Inter-rivet buckling of the stringers attached to the upper surface skin, outboard of the fuel tank access covers (See View F, Figure 7).
