[Docket No. FAA–2010–1101; Directorate Identifier 2009–CE–013–AD; Amendment 39–16690; AD 2011–10–09]

Airworthiness Directives; Cessna Aircraft Company Models 150, 152, 170, 172, 175, 177, 180, 182, 185, 188, 190, 195, 206, 207, 210, T303, 336, and 337 Airplanes

ACTION: Final rule.

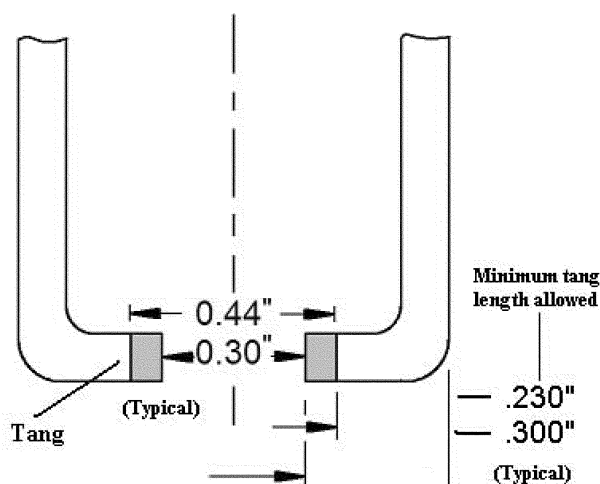
Figure 4. Closeup of seat roller housing and tang gap width

We have changed the callouts in figure 4 to measure the tang length from outside of the roller housing instead of from inside of the roller housing. We have also changed the description of the tang measurement in figure 4 to more accurately describe the measurement.

(6) Due to wear or deformation of the tangs, inspect the tang length from the inner edge of the tang to the outer edge (the bend area) of the roller housing (see figure 4).

(i) The minimum measurement allowed for the remaining tang length is 0.230 inches remaining on either of the tangs, from the inner edge of the tang to the outer edge (the bend area) of the roller housing. If the measurement is less than 0.230 inches on either of the tangs, before further flight, replace the roller housing.
