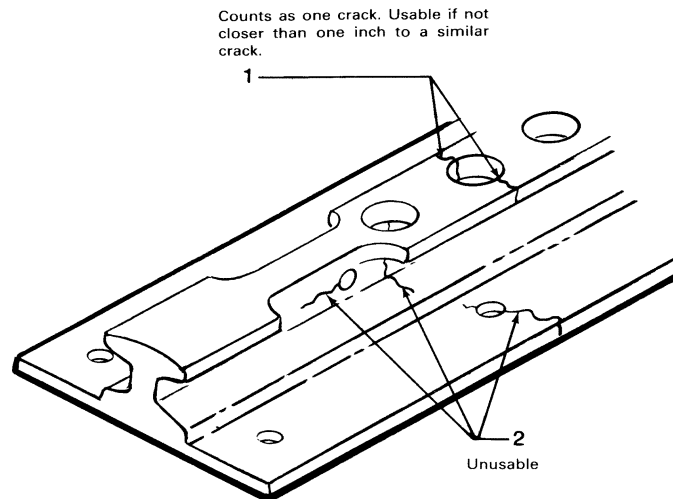
Figure 5. Seat rail

- (1) Any portion of web or lower flange is cracked (index 2).
- (2) Any crack in crown of rail is in any direction other than right angle to length of rail.
- (3) Number of cracks on any one rail exceeds four, or any two cracks (index 1) are closer than one inch.

Use of seat rail cargo tie-downs is not permissible on seat rails with cracks.

REPLACE SEAT RAIL WHEN:
