Airworthiness Directives; Cessna Aircraft Company (Cessna) Models 337, 337A (USAF 02B), 337B, 337C, 337D, 337E, T337E, 337F, T337F, 337G, T337G, M337B, F 337E, FT337E, F 337F, FT337F, F 337G, and FT337GP Airplanes

2011–15–11 Cessna Aircraft Company:

Appendix 1 to AD 2011-15-11

General and Focused Inspection Procedures

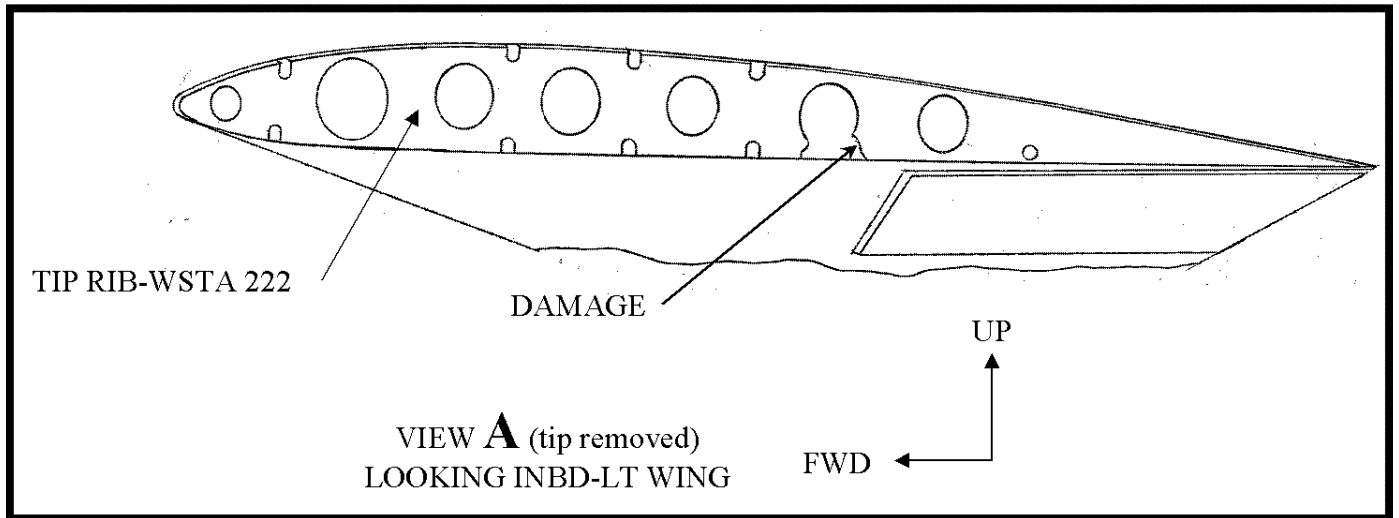
Figure 2

(11) Inspect rib at WSTA 222 for damage. Trimming of the rib may have been done to allow installation of fuel lines (See View A, Figure 2). Repair in accordance with AC 43.13-1B, Chapter 4, paragraph 4-58(g) and Figure 4-14, or by using another FAA-approved method that restores equivalent strength of the wing rib.

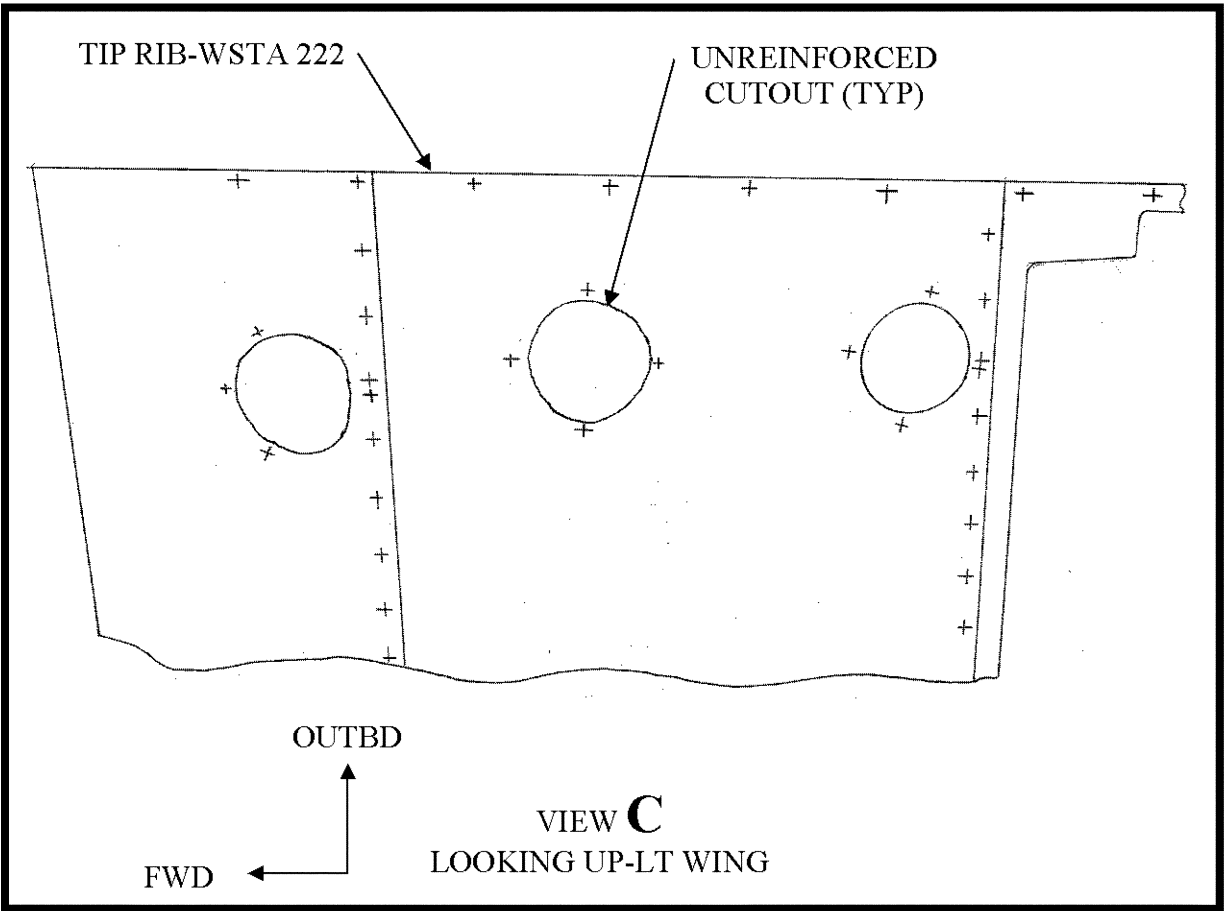
Figure 4

(13) Inspect wing skins for unreinforced cutouts. (See View C, Figure 4).

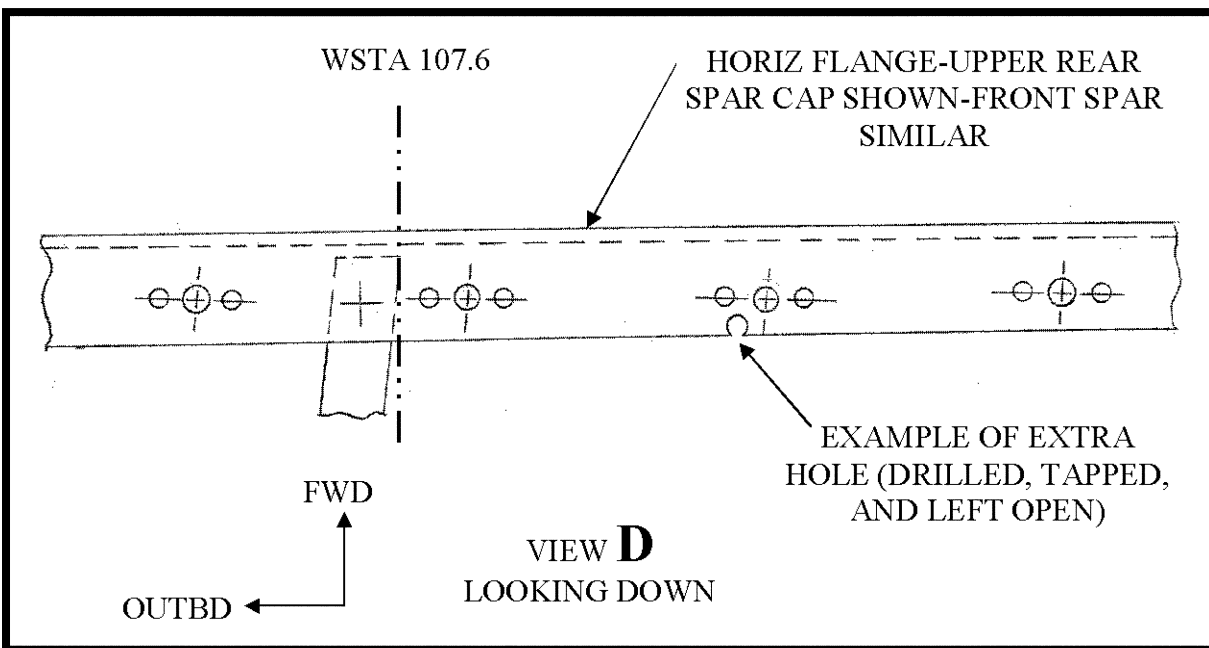
Figure 5

(14) Inspect the upper spar cap horizontal flanges for open holes (See View D, Figure 5).

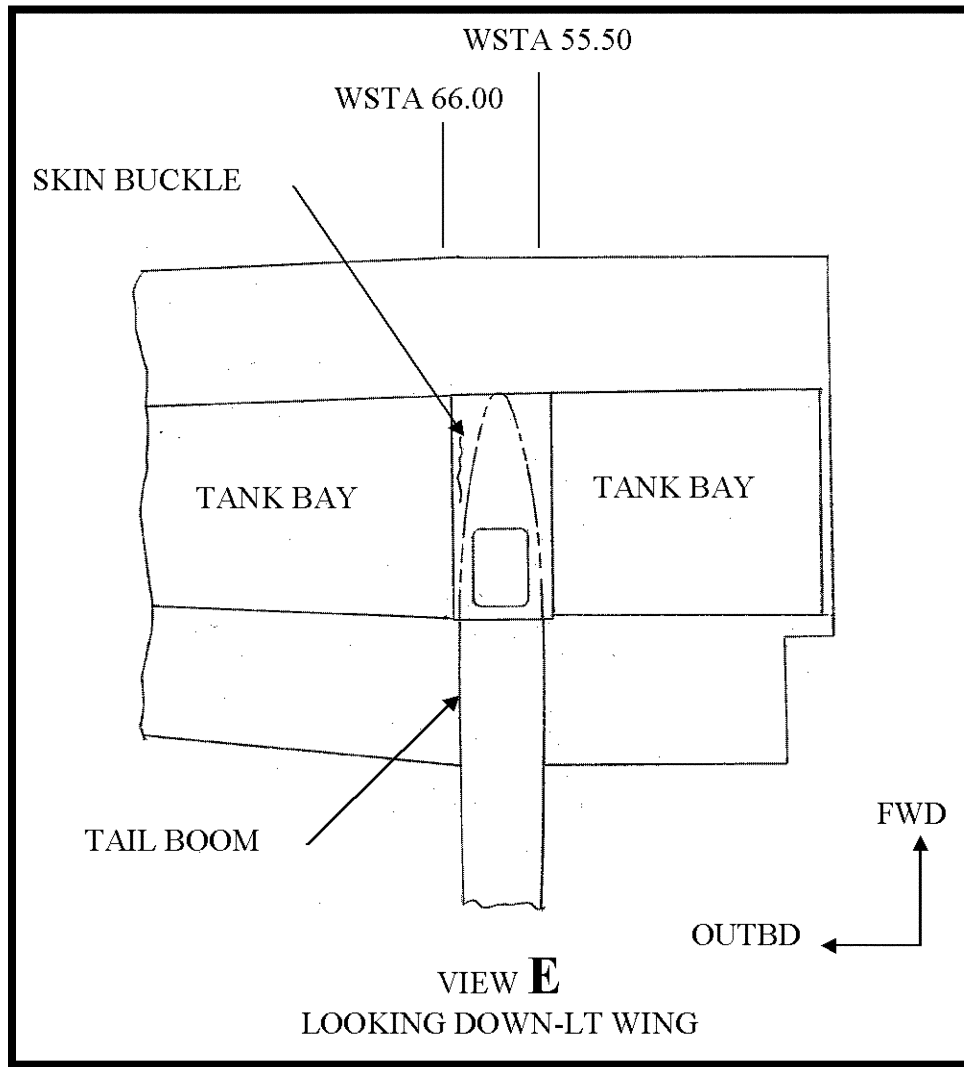
Figure 6

(2) Wrinkles in the upper wing skins from WSTA 55 to 66, adjacent to the booms (See View E, Figure 6).

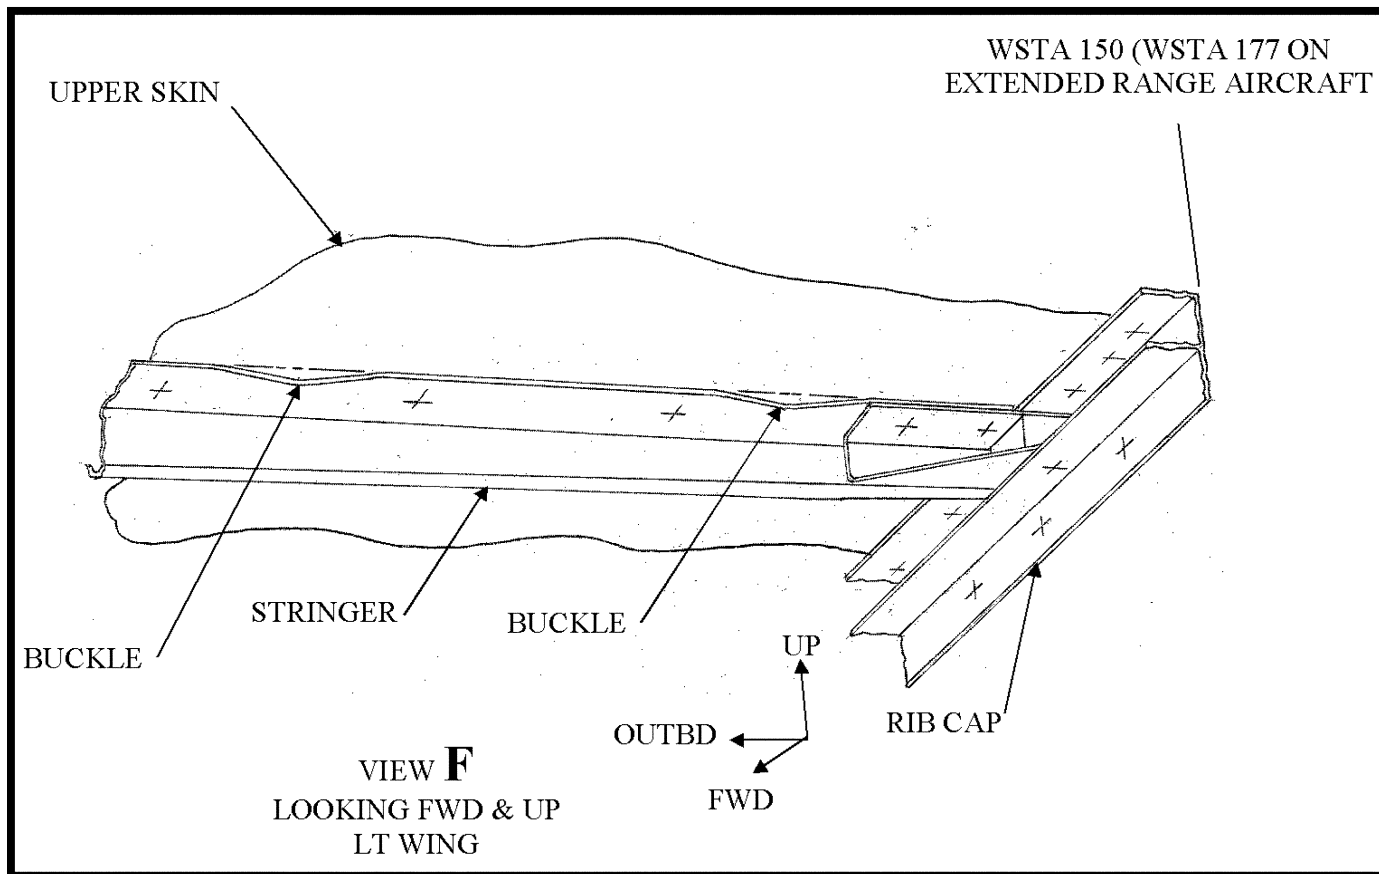
Figure 7

(10) Inter-rivet buckling of the stringers attached to the upper surface skin, outboard of the fuel tank access covers (See View F, Figure 7).
