DEPARTMENT OF TRANSPORTATION**Federal Aviation Administration****14 CFR Part 39**

[Docket No. FAA-2011-0994; Directorate Identifier 2010-NM-143-AD]

Airworthiness Directives; Bombardier, Inc. Model CL-600-2C10 (Regional Jet Series 700, 701, & 702), CL-600-2D15 (Regional Jet Series 705), and CL-600-2D24 (Regional Jet Series 900) Airplanes**AGENCY:** Federal Aviation Administration (FAA), DOT.**ACTION:** Notice of proposed rulemaking (NPRM).

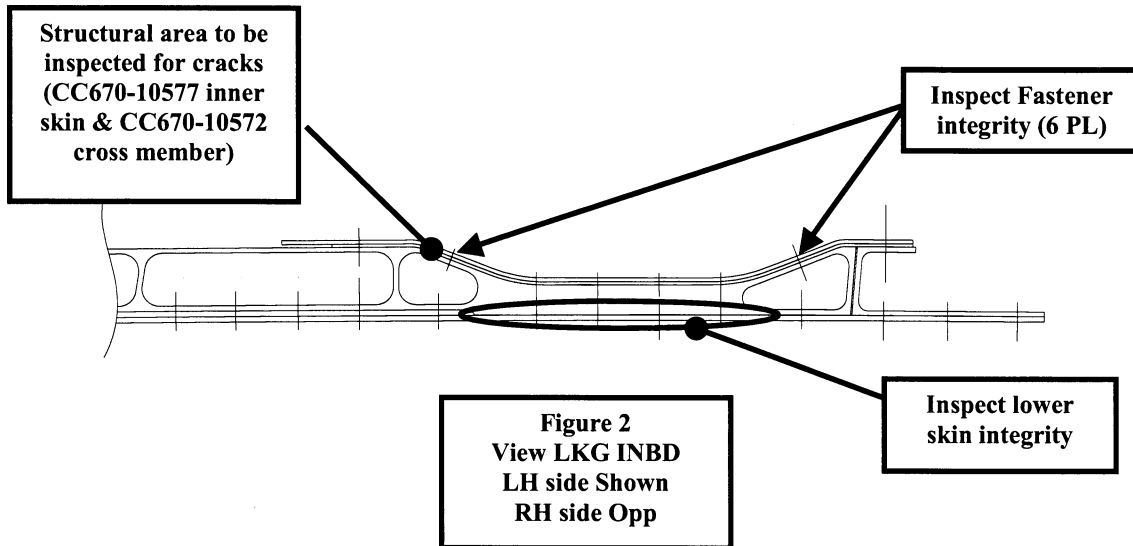
(1) Inspect the cross member, P/N CC670-10572, of the MLG door lower panel for cracking or deformation, in accordance with Figure 2 of this AD.

(2) Inspect the inner skin, P/N CC670-10577, of the MLG door lower panel at the cross member (P/N CC670-10572) for cracking or deformation, or pulled or missing fasteners, in accordance with Figure 2 of this AD.

(3) Inspect the outer skin, P/N CC670-10574, of the MLG door lower panel at the cross member (P/N CC670-10572) for cracking or deformation, or pulled or missing fasteners, in accordance with Figure 2 of this AD.

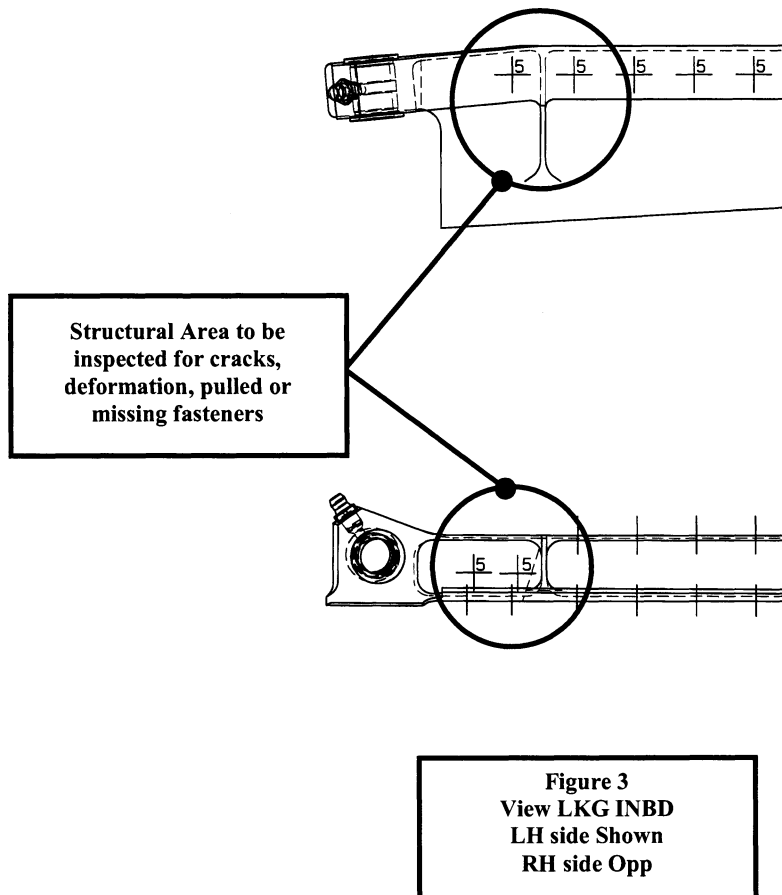
(4) Inspect the forward member, P/N CC670-10570, and aft member, P/N CC670-10571, of the MLG door lower panel for cracking or deformation, or pulled or missing fasteners, in accordance with Figure 3 of this AD. Figures 1 through 3 of this AD follow.
