[Docket No. FAA-2011-1115; Directorate Identifier 2010-SW-011-AD]

Airworthiness Directives; Sikorsky Aircraft Corporation (Sikorsky) Model S-92A Helicopters

ACTION: Notice of proposed rulemaking (NPRM).

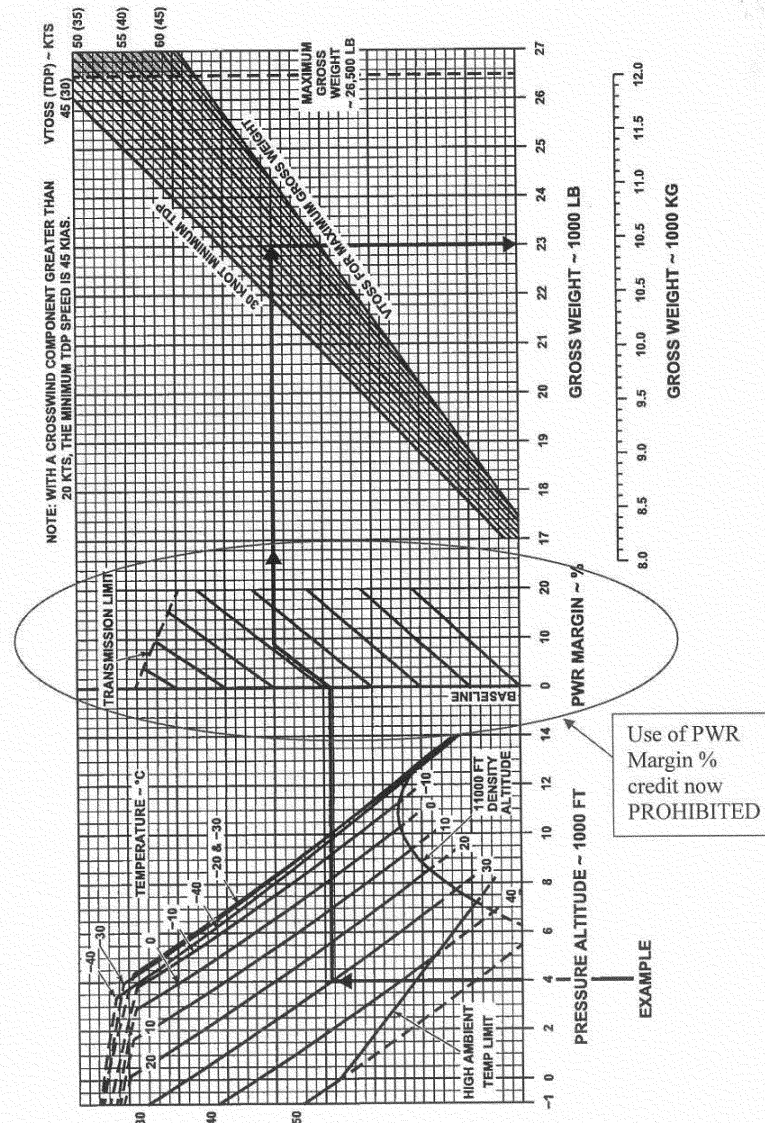
Figure 1. Cat 'A' Takeoff and Landing Gross Weight

(b) If the RFM already contains the revisions appropriate for your helicopter as listed in the following Table 1, all dated April 9, 2008, with the correct performance charts, without the performance credit as depicted in the circled area of Figure 1 of this AD, the operating limitation required by paragraph (a) of this AD does not need to be inserted into the RFM.

Note 1: Previous RFM revisions allowed for the use of above-specification engine power margin as depicted in the circled area of Figure 1 of this AD.

(a) By making pen and ink changes, insert into the Operating Limitations section, Part 1, Section 1, *Weight Limits*, of RFM SA S92A-RFM-002, -003, -004, -005, and -006 the following limitation “Performance credit for above specification engine power margin is prohibited.”
