[Docket No. FAA-2011-1035; Directorate Identifier 2011-SW-038-AD; Amendment 39-16817; AD 2011-15-51]

Airworthiness Directives; Bell Helicopter Textron Canada (Bell) Model 407 and 427 Helicopters

2011–15–51 Bell Helicopter Textron, Inc. (Bell): Amendment 39–16817; Docket No. FAA–2011–1035; Directorate Identifier 2011–SW–038–AD.

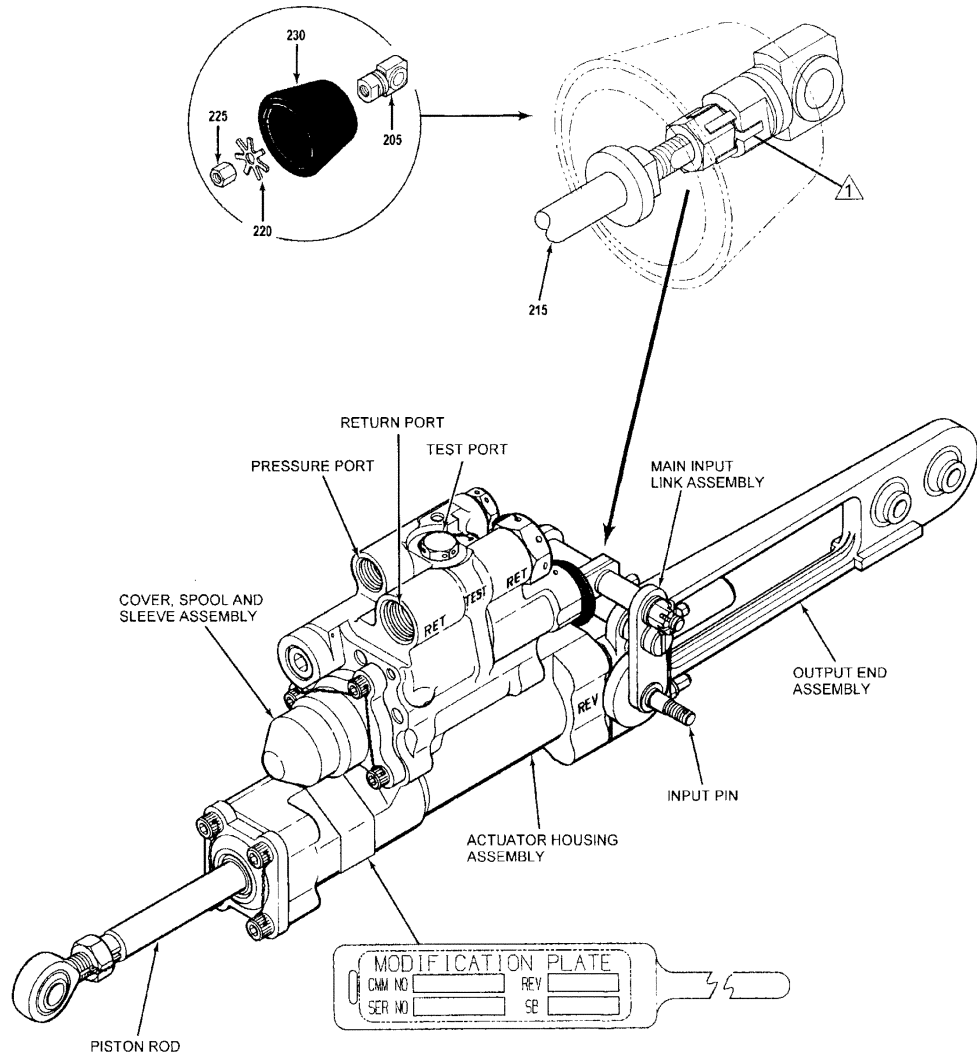
Clevis Assembly
 Figure 1

(1) Retract the boot depicted as “230” in Figure 1 of this AD:

NOTE:
 ▲ ACCEPTABLE CONDITION
 A MINIMUM OF ONE TAB SHALL BE IN LINE AND BENT FLUSH WITH THE NUT FLAT SURFACE AND A MINIMUM OF ONE TAB SHALL BE IN LINE AND BENT FLUSH WITH THE CLEVIS ASSEMBLY FLAT SURFACE

(2) Applying only hand pressure, determine whether the nut, shaft, or clevis assembly, depicted as “225,” “215,” and “205,” respectively, in Figure 1 of this AD, turns independently. If the shaft turns independently of the nut or the clevis assembly, before further flight, replace the servo with an airworthy servo.

(3) If the shaft does not turn independently, inspect to determine whether at least one tab of the lock washer is bent

flush against a flat surface of the nut and at least one tab of the lock washer is bent flush against a flat surface of the clevis assembly.

(i) If at least one lock washer tab is not aligned and bent flush with a nut flat surface and at least one lock washer tab is not aligned and bent flush with a flat surface of the clevis assembly, before further flight, replace the servo with an airworthy servo.

(ii) If any tab of the lock washer is not bent flush against either a flat surface of the nut

or clevis assembly, bend the tab flush against a flat surface.

(4) After accomplishing paragraph (a)(1) through (a)(3) of this AD, reidentify the servo by metal-impression stamping or by vibro-etching “67-01” onto the modification plate.
