[Docket No. FAA-2011-1158; Directorate Identifier 2010-SW-018-AD; Amendment 39-16847; AD 2011-22-05]

Airworthiness Directives; Eurocopter France Model AS350B, B1, B2, B3, BA, C, D, and D1; and AS355E, F, F1, F2, N, and NP Helicopters

2011-22-05 EUROCOPTER FRANCE

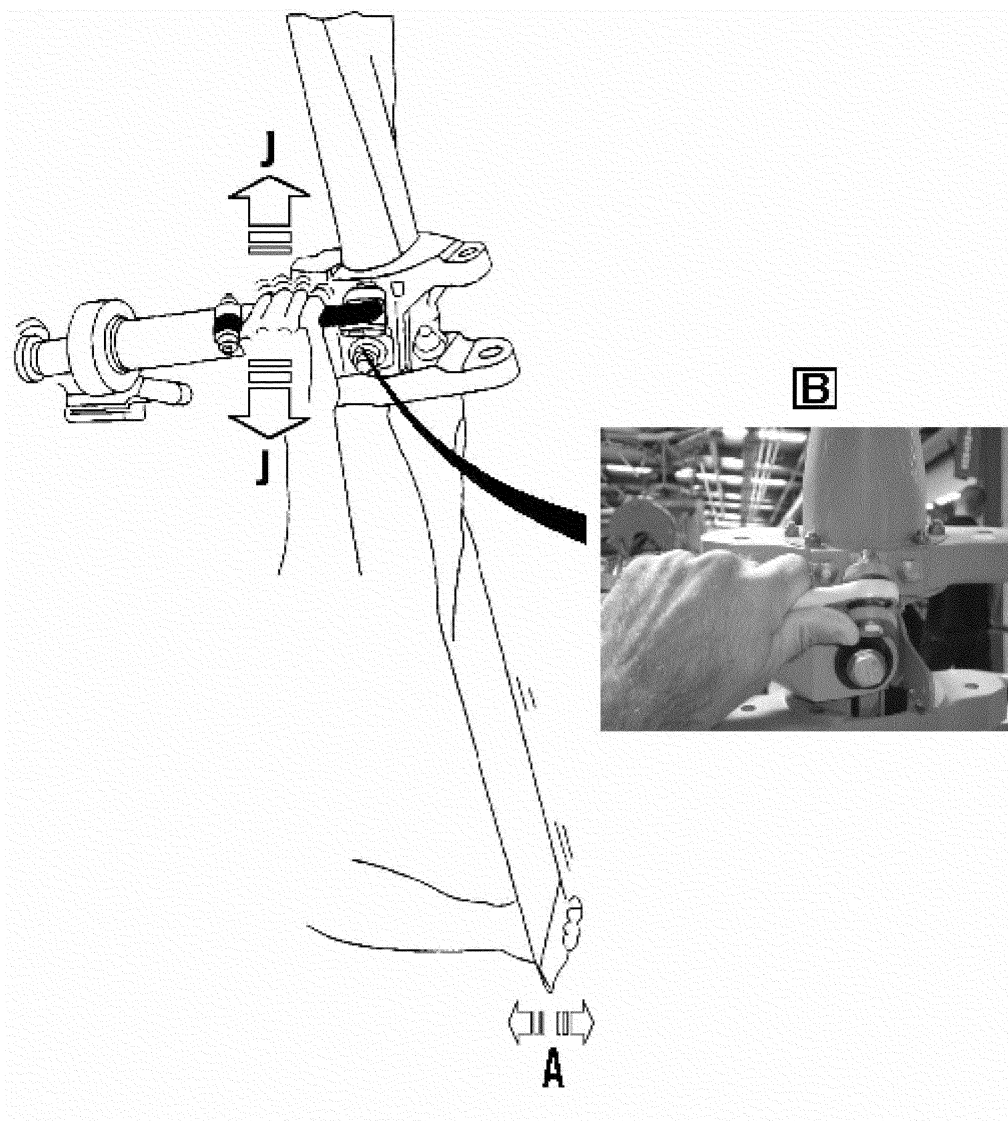
- (a) Before the first flight of each day, place the T/R pedals in the neutral position. If the helicopter is fitted with a T/R load compensator, discharge the accumulator as described in the rotorcraft flight manual. Check the control rod bearing (bearing) for play on the helicopter, by observation and feel, by slightly moving the T/R blade in the flapping axis while monitoring the bearing for movement. See the following Figure 1 of this AD. The actions required by this paragraph may be performed by the owner/operator (pilot) holding at least a private pilot certificate, and must be entered into the helicopter maintenance records showing compliance with this AD in accordance with 14 CFR 43.9(a)(1)-(4) and 14 CFR 91.417(a)(2)(v). The record must be maintained as required by 14 CFR 91.173, 121.380, or 135.439.

Figure 1: Manual Check for Play of the Tail Rotor Pitch Control Rod

(b) If the Teflon cloth is coming out of its normal position within the bearing, totally or partially, or if there is discoloration or scoring on the bearing, before further flight,

replace the control rod with an airworthy control rod.

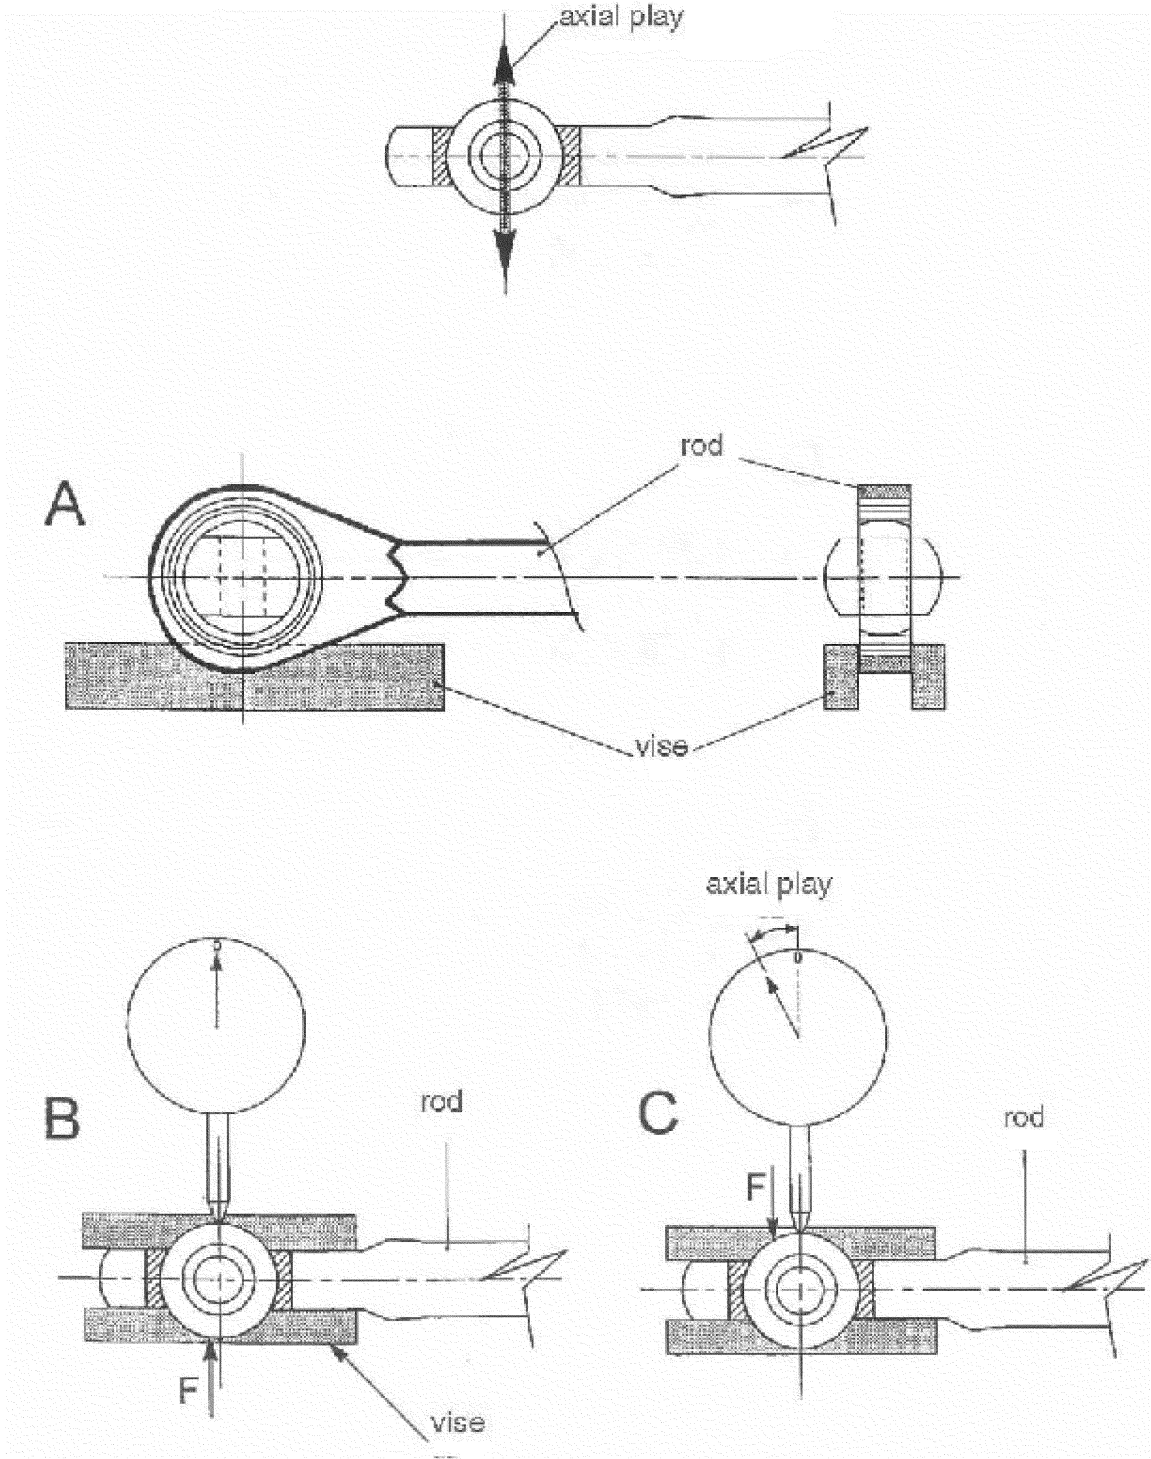
Figure 2: Measurement of the Axial Play (A) of the Bearing

(2) Mount the control rod in a vise as shown in Figure 2 of this AD.

(3) Using a dial indicator, take axial play readings by moving the spherical bearing in the direction F (up and down) as shown in Figure 2 of this AD.

(8) If the radial play exceeds 0.008 inch or axial play exceeds 0.016 inch, replace the control rod with an airworthy control rod before further flight.

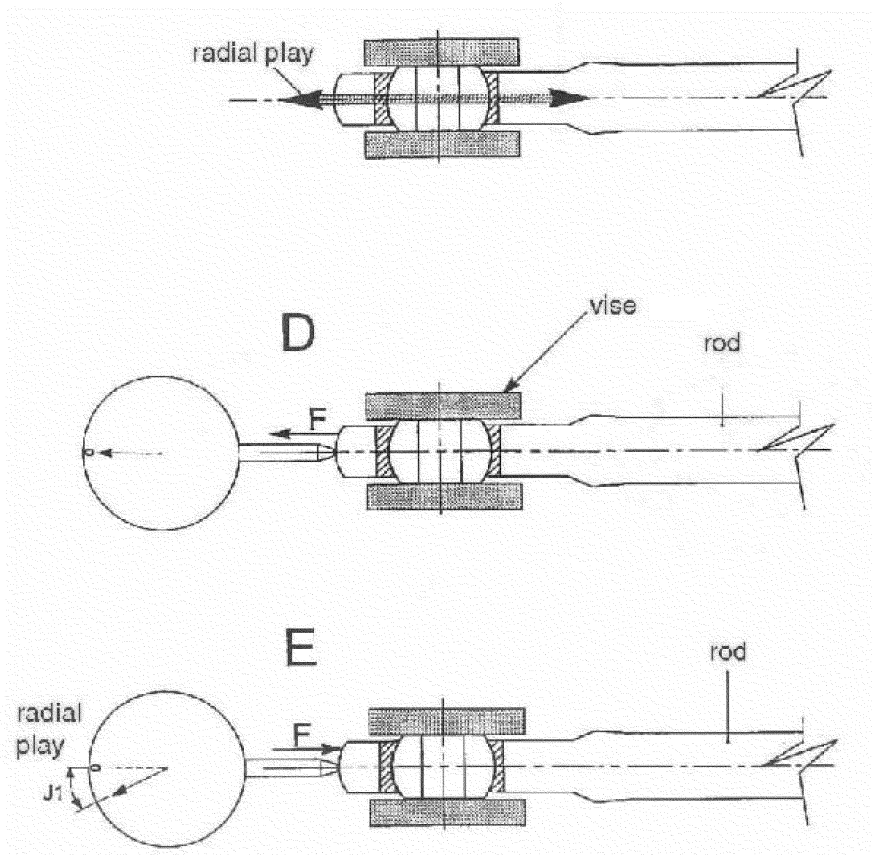
Figure 3: Measurement of the Radial Play (R) of the Bearing

(5) Mount the control rod and bearing in a vise as shown in Figure 3 of this AD.

(6) Using a dial indicator, take radial play measurements by moving the control rod in the direction F as shown in Figure 3 of this AD.
