Federal Register

[Docket No. FAA-2012-0409; Directorate Identifier 2011-SW-055-AD; Amendment 39-17020; AD 2011-18-52]

Airworthiness Directives; Agusta S.p.A. Helicopters

ACTION: Final rule; request for comments.

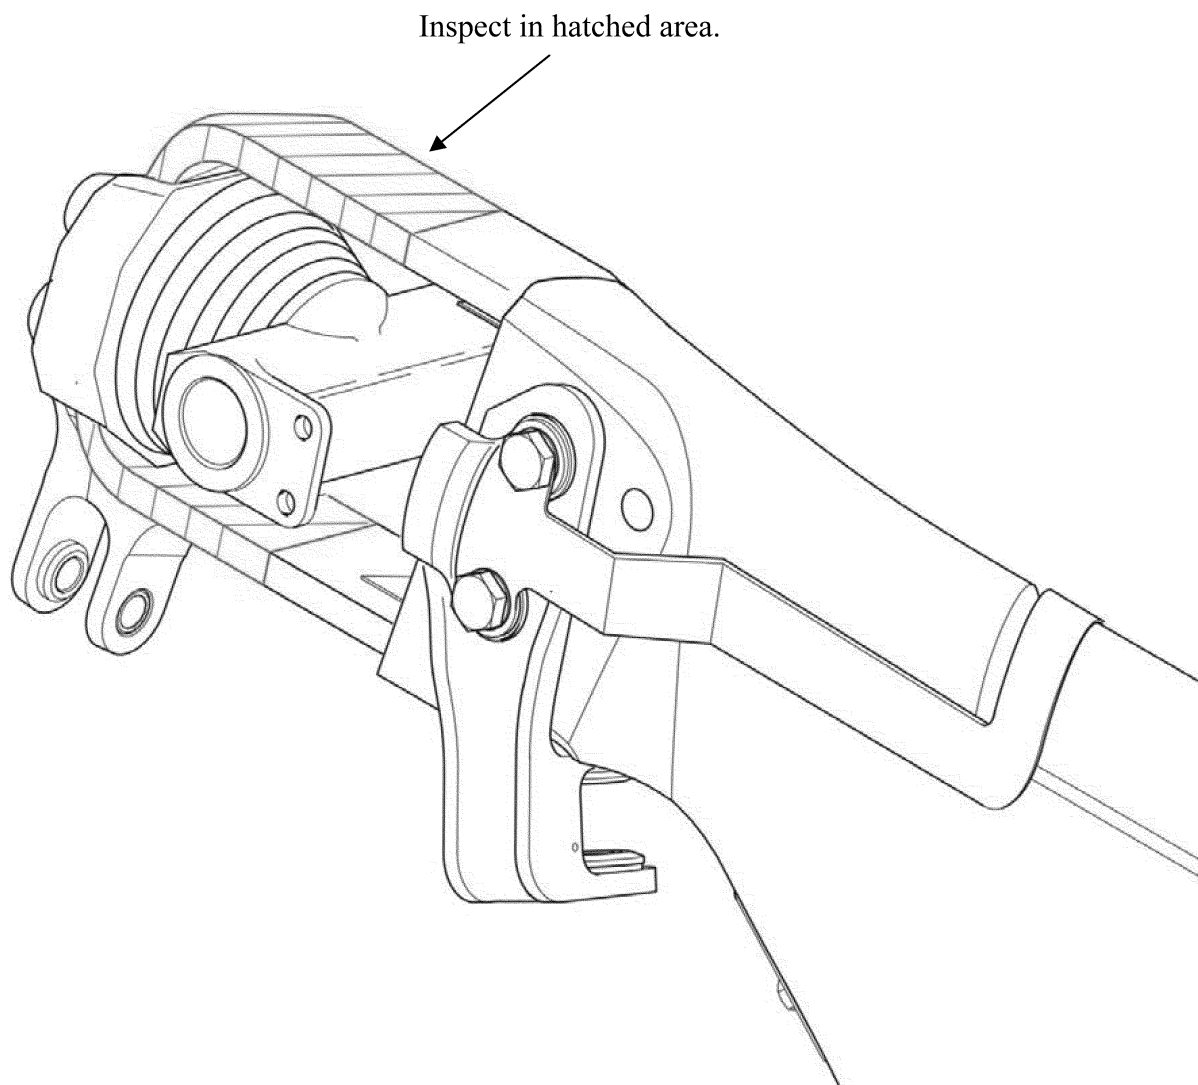
This AD defines the unsafe condition as cracks in a T/R blade. The actions in this AD are intended to detect and prevent a crack in a T/R blade which could lead to failure of a T/R blade and subsequent loss of control of the helicopter.

(3) Within 25 hours TIS, and thereafter at intervals not to exceed 25 hours TIS, visually inspect the T/R blade for a crack or damage that exceeds the limits of the applicable maintenance manual. Inspect in the area depicted in the following figure using a mirror, magnifying glass (5X or greater), and light source, or borescope.

(4) If there is a crack, or if there is damage that exceeds the limits of the applicable maintenance manual, before further flight, replace the T/R blade with an airworthy T/R blade.
