#### Airworthiness Directives; Sikorsky Aircraft Corporation Helicopters

**2012-08-01 Sikorsky Aircraft Corporation:**

Amendment 39-17017; Docket No. FAA-2011-1115; Directorate Identifier 2010-SW-011-AD.

This AD defines the unsafe condition as inaccurate above specification engine power margin data. This condition could result in the use of inaccurate engine performance data in calculating maximum gross weight.

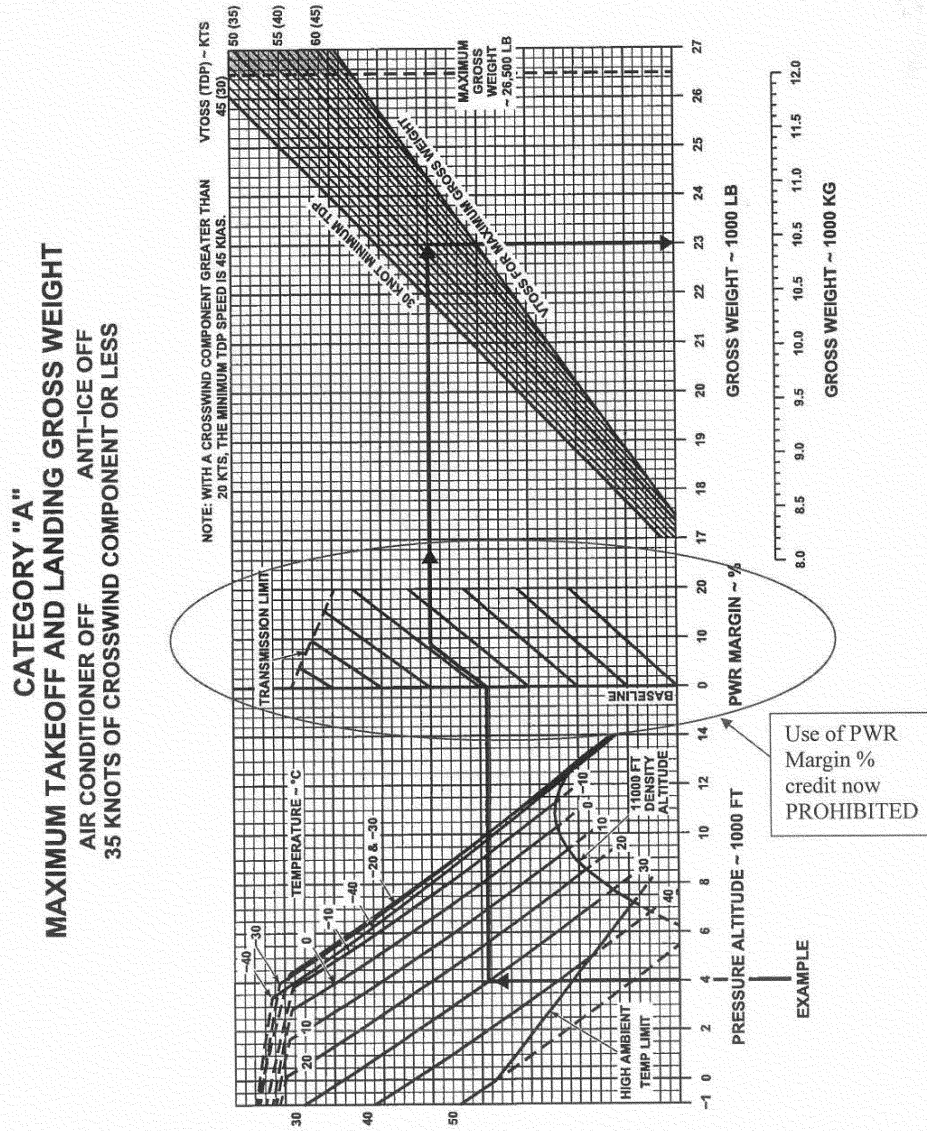
Figure 1. Cat 'A' Takeoff and Landing Gross Weight

**Note to paragraph (e)(2) of this AD:**  
Previous RFM revisions allowed for the use of above-specification engine power margin as depicted in the circled area of Figure 1 of this AD.

(2) If the RFM already contains the revisions appropriate for your helicopter as listed in the following Table 1, all dated April 9, 2008, with the correct performance charts, without the performance credit as depicted in the circled area of Figure 1 of this AD, the operating limitation required by paragraph (1) of this AD does not need to be inserted into the RFM.
