[Docket No. FAA-2012-0415; Directorate Identifier 2008-SW-065-AD]

Airworthiness Directives; Bell Helicopter Textron, Incorporated Helicopters

ACTION: Notice of proposed rulemaking (NPRM).

Bell Helicopter Textron, Inc. (BHTI): Docket No. FAA–2012–0415; Directorate Identifier 2008–SW–065–AD.

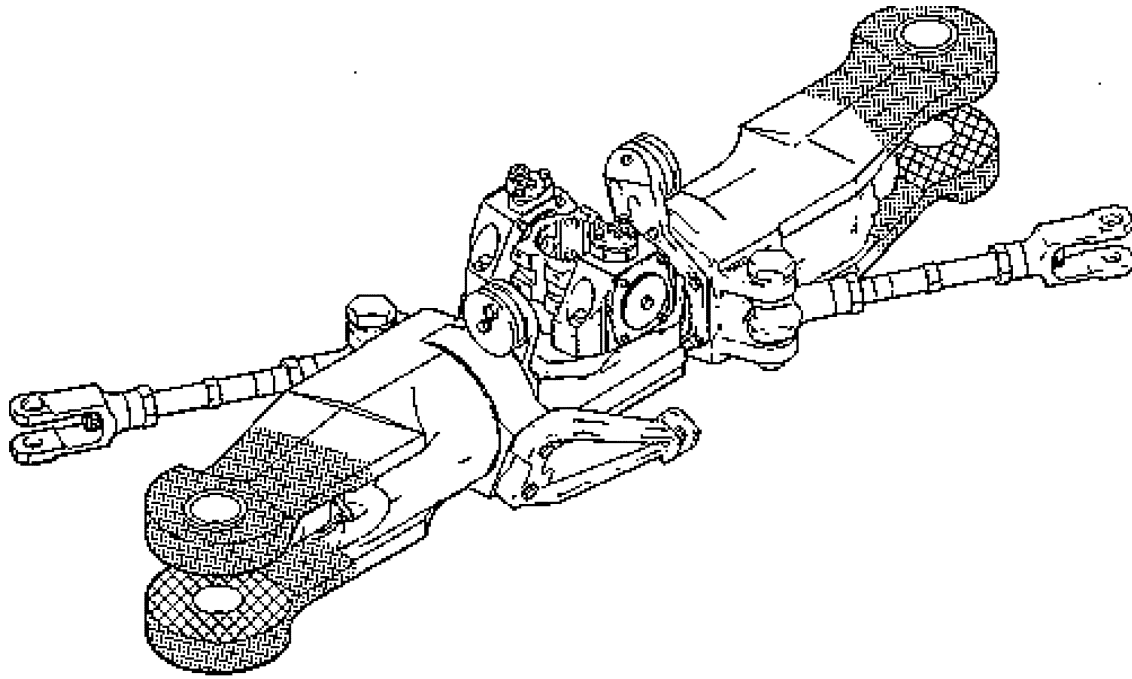
Figure 1. Inspection of Main Rotor Hub Grip Tangs

(ii) Using a 10-power or higher magnifying glass, visually inspect the exposed surfaces of the upper and lower tangs of each grip for a crack. Pay particular attention to the lower surface of each lower grip tang from the main rotor blade bolt-bushing flange to the leading and trailing edge of each grip tang. See Figure 1 of this AD.

INSPECT BUFFER PAD FOR DELAMINATION (IF INSTALLED)

AREA TO BE INSPECTED UPPER AND LOWER TANGS ALL EXPOSED SURFACES

(i) Remove each main rotor blade, and
(ii) Inspect each grip buffer pad on the inner surfaces of each grip tang for delamination (see Figure 1 of this AD). If there is any delamination, remove the buffer pad and inspect the grip surface for corrosion or other damage.

(i) Replace any cracked grip with an airworthy grip.
(ii) Replace any grip with any corrosion or other damage with an airworthy grip, or repair the grip if the corrosion or other damage is within the maximum repair damage limitations found in the applicable Component and Repair Overhaul Manual.
(iii) Replace any grip, P/N 204-011-121-009 or ASI-4011-121-9, which has been in service for 15,000 or more hours TIS.
(iv) Replace any grip, P/N 204-011-121-121, which has been in service for 25,000 or more hours TIS.
